**Phase 1 Inspection Report: National Dam Safety Program.
Missouri - Kansas City Basin. Binder Lake Dam, Cole County,
Missouri**

BINDER LAKE DAM
COLE COUNTY, MISSOURI
MISSOURI INVENTORY NO. 30051

PHASE I INSPECTION REPORT
NATIONAL DAM SAFETY PROGRAM

PREPARED BY
HOSKINS-WESTERN-SONDEREGGER, INC.
CONSULTING ENGINEERS
LINCOLN, NEBRASKA

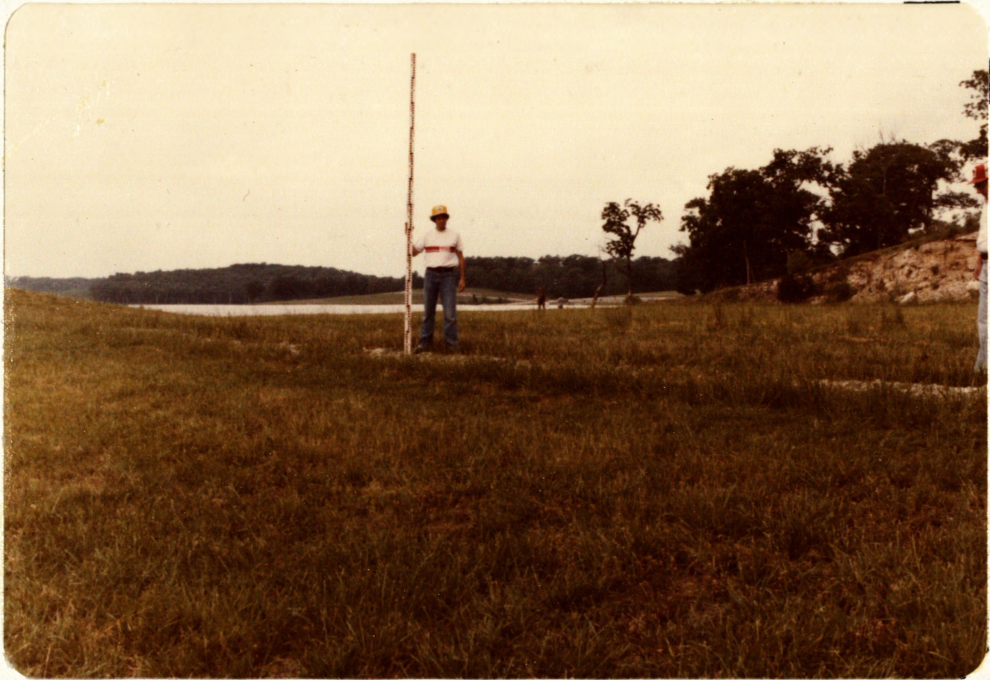
- (2) The emergency spillway. The emergency spillway is well vegetated with adapted grasses and was recently mowed. It looks very good with no evidence of erosion or deterioration. The plans show the crest of the rock gabion structure as 1 foot above the spillway grade line. At the time of inspection the top of the gabion sill was essentially at the same elevation as the bottom of the spillway. This may indicate that the spillway bottom was plated with about 1 foot of topsoil for vegetation purposes. The rock gabion structure looks good with very little deterioration but it has not been used or tested to date.

PHOTO NO. 4 - LOOKING UPSTREAM IN EMERGENCY SPILLWAY

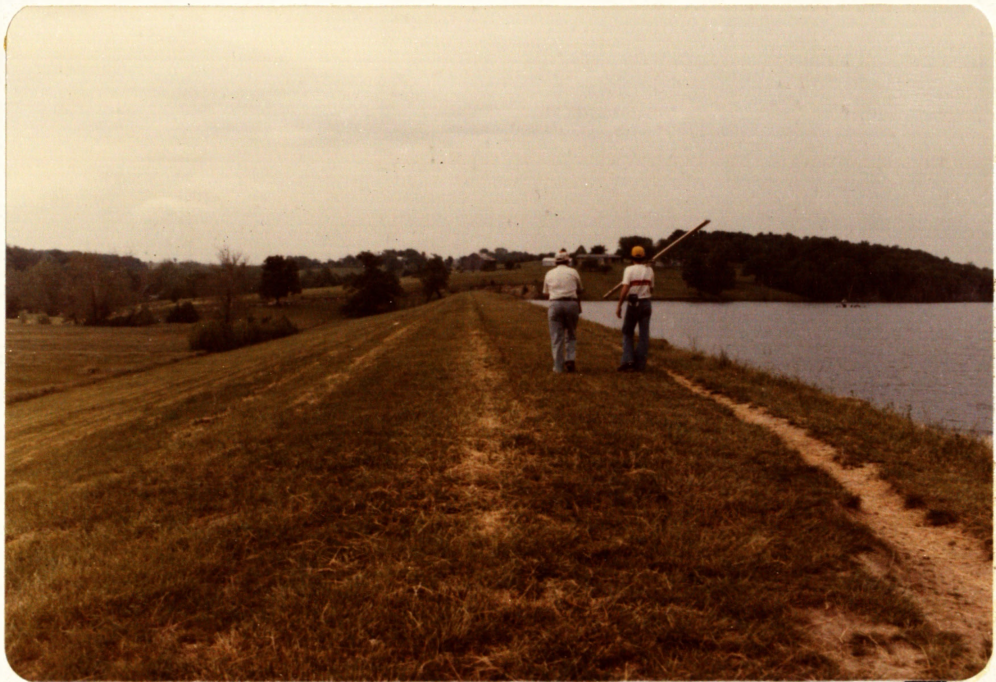
- (3) Crest. The crest is well vegetated with adapted grasses and was recently mowed. No cracks, rodent holes or deformations were noted along the crest.

PHOTO NO. 7 - CREST TAKEN FROM LEFT END

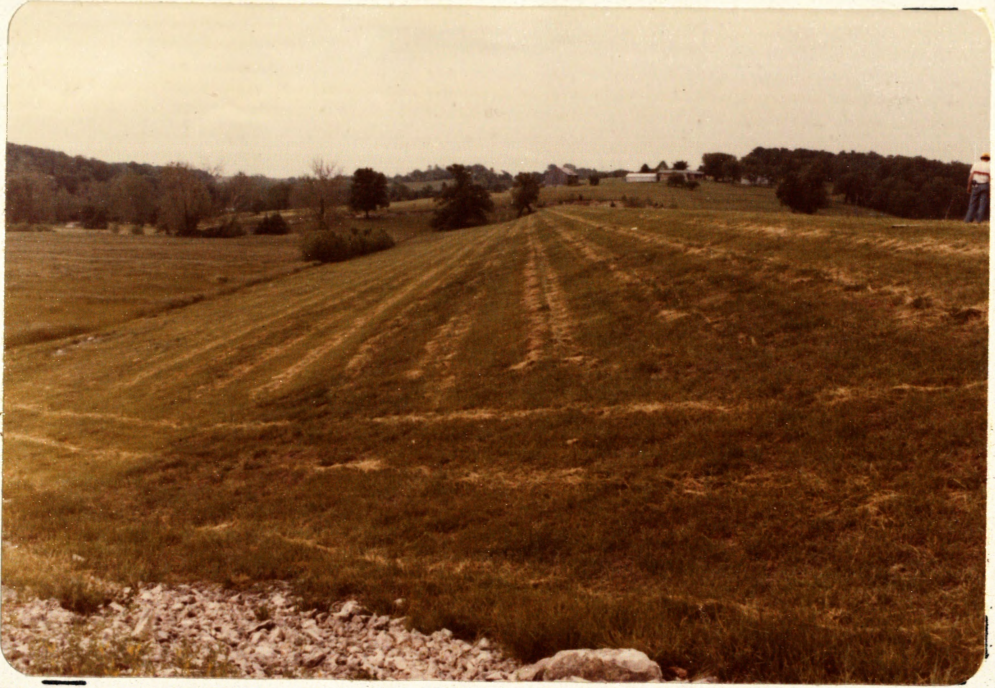
- (4) Downstream Slope. The downstream slope is densely vegetated with adapted grasses and was recently mowed. A few small trees are growing along the toe of the dam downstream from about station 5+00 to 9+00 (stationing according to plans). These trees may be feeding on discharge from the rock toe drain but no water or seepage was observed in the area. No cracks, rodent holes or deformations were observed on the slopes or at the toe. There was no indication of seepage on the slope or at the toe of the dam. No discharge was observed from the trench drain. The bottom of the outlet channel for the drawdown facility, which is some 5 feet below natural ground level, was moist but did not show free water. There was no sign of leakage from the valve on the drawdown pipe.

PHOTO NO. 8 - DOWNSTREAM SLOPE FROM LEFT END

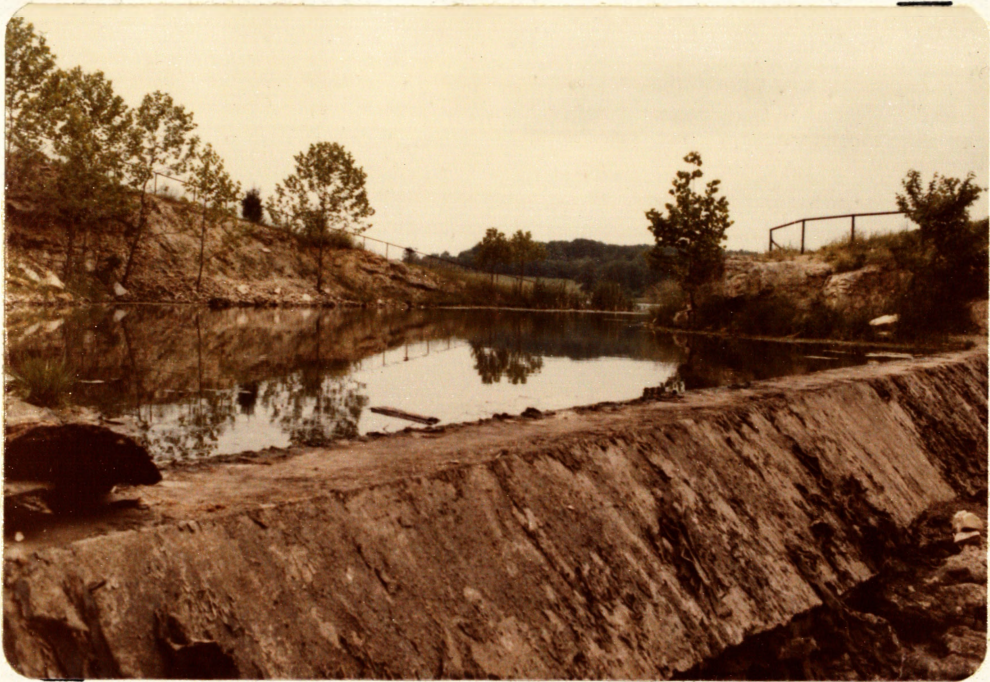
- (1) Principal spillway. Some erosion, spalling, and weathering of the limestone, with resulting undercutting, was observed at and under the downstream toe of the concrete weir control structure. (See photos 10, 11 and 13.) There is seepage outcropping along the downstream edge of the weir, predominately on both ends. All seepage is clear and the total effluent was estimated at $0.5 \pm$ gal./min. The exit channel is eroded bedrock with several small trees and shrubs growing in the cracks and erosion channels. The reservoir level was slightly below the crest of the weir.

PHOTO NO. 10 - UPSTREAM FROM RIGHT END SHOWING CONCRETE SILL
IN PRINCIPAL SPILLWAY

- (1) The present maintenance program is generally adequate.
- (2) Erosion and deterioration of the bedrock foundation under the principal spillway weir should be repaired and controlled.
- (3) The condition of the upstream riprap should be evaluated regularly and rehabilitation measures provided, as needed.

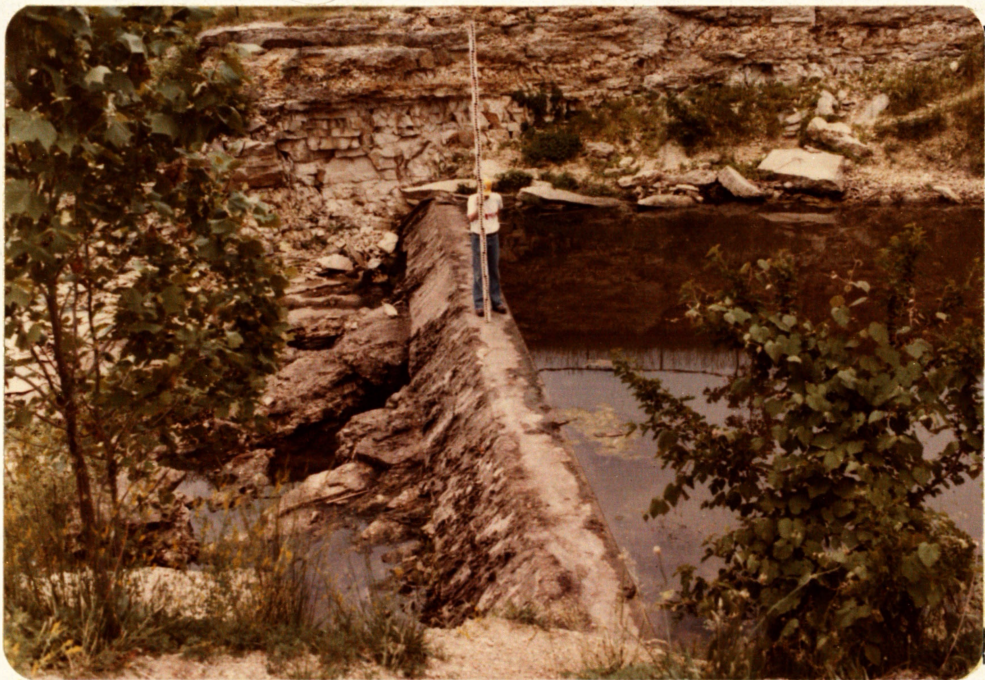
PHOTO NO. 11 - PRINCIPAL SPILLWAY CONCRETE SILL TAKEN FROM
TOP OF DAM

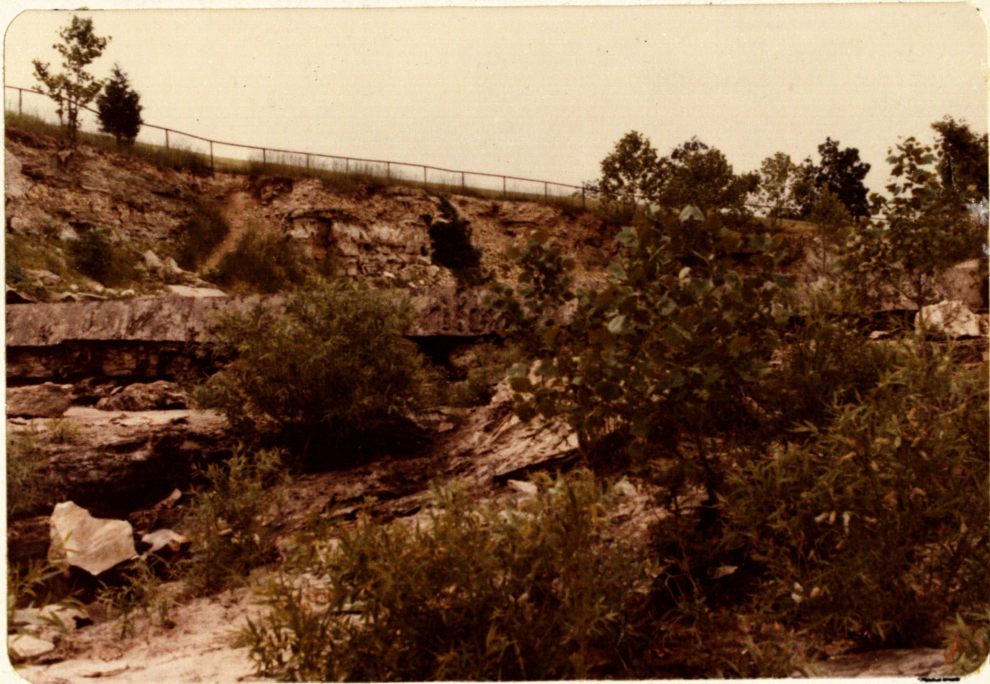
PHOTO NO. 13 - PRINCIPAL SPILLWAY CONCRETE SILL. PHOTO
TAKEN FROM DOWNSTREAM

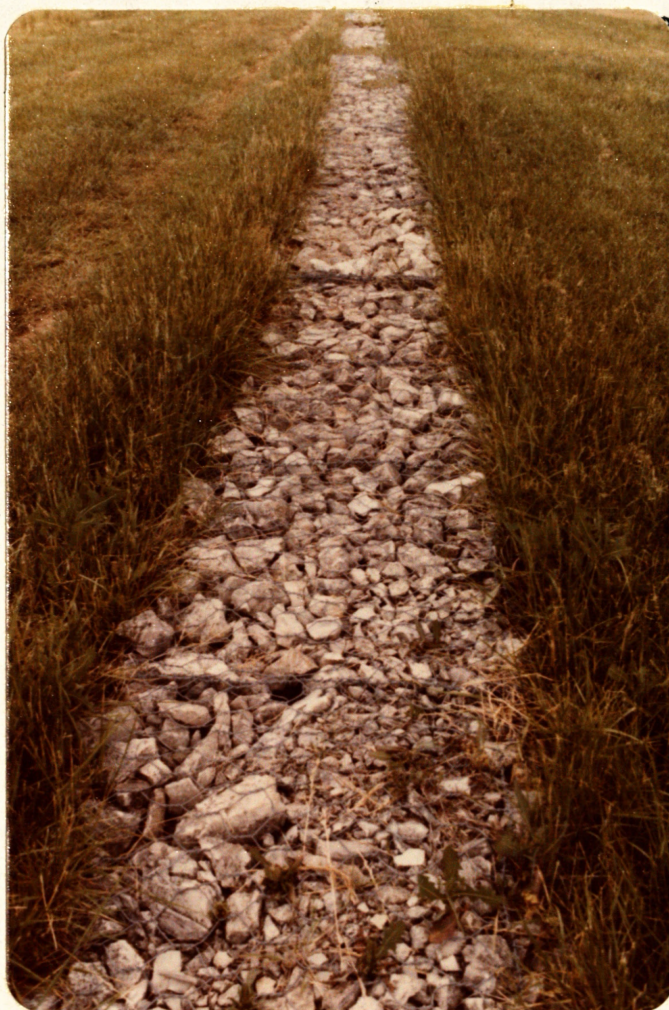
PHOTO NO. 15 -
GABION SILL IN
EMERGENCY SPILLWAY
