Slip Failure of Embankment on Soft Marine Clay

SYNOPSIS The results of an investigation carried out at a site before and after the slip failure of an embankment on soft marine clay are presented. An evaluation of the possible causes for the slip failure and the remedial measures taken after the failure are also included. It appears that overstressing of the ground might have led to the movement of the soft soil. The compressible soils were subjected to an increase in stress without a comparable increase in foundation shear strength. This increase in horizontal stress resulted in the horizontal displacement of the soil as evident by the presence of the tension cracks in the fill just before slip failure occurred.

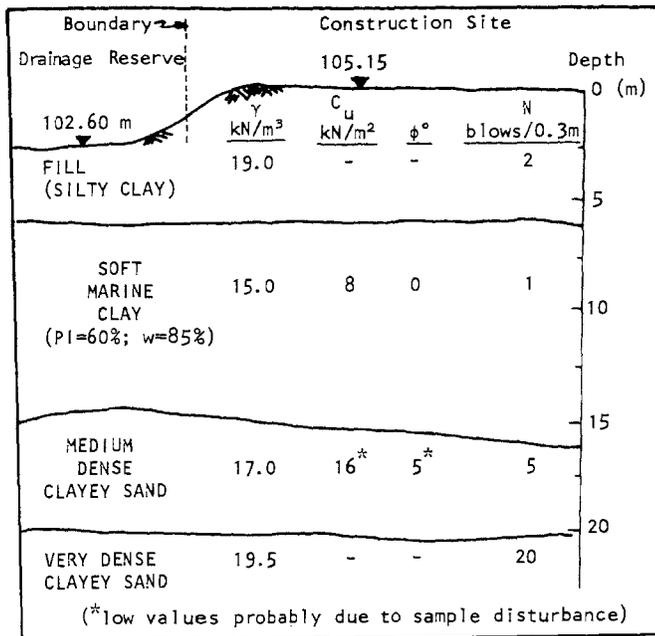
Fig. 2. Typical Soil Profile

Based on earlier site investigation, a typical section of the soil profile at the site is shown in Fig. 2. The subsoil consists generally of a top layer of fill deposits of medium stiff silty clay. Below this top layer is soft marine clay overlying medium dense to very dense clayey sand. Ground water-table observed from the boreholes was about 1.5 m to 2.5 m below the existing ground level at the site.

From the soil information, it appears that the vehicle depot development is founded on soft ground where the thickness of soft clay is typically about 10 m. The shear strength of this layer is so low that large settlement and low stability can be expected.

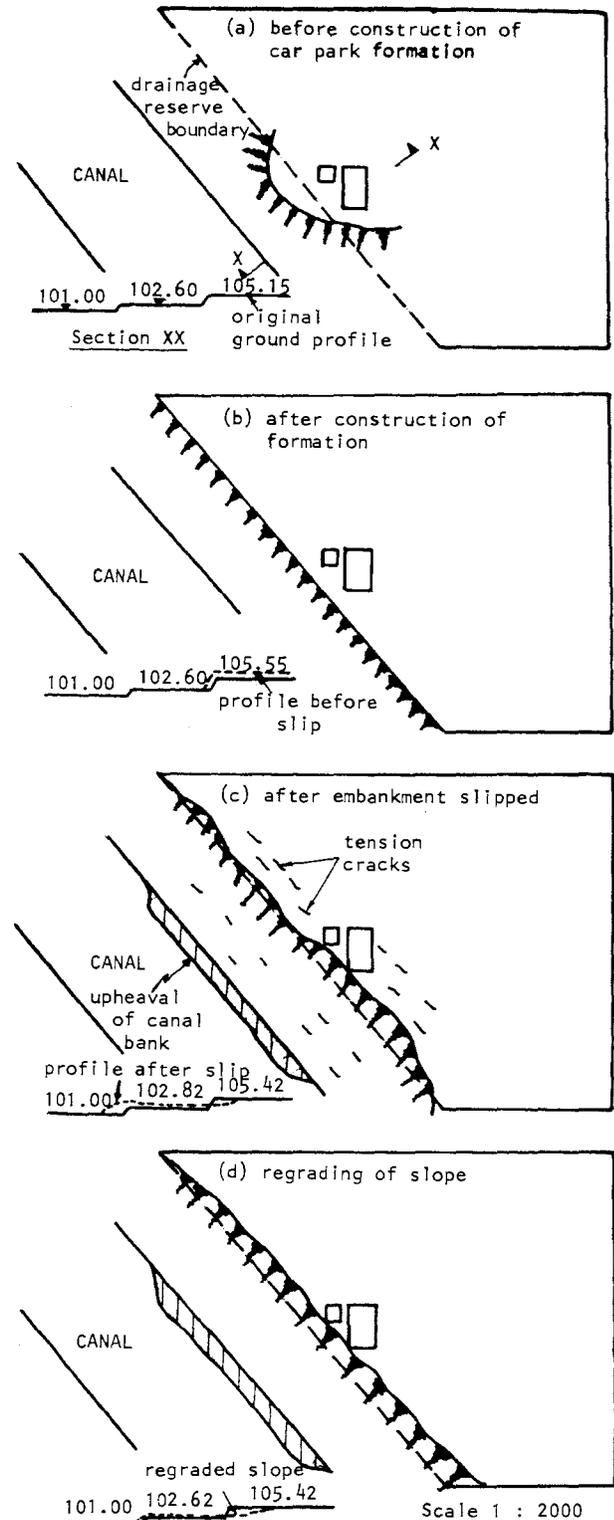
Fig. 3. Sequence in Slip Failure of Embankment

To construct the parking area for vehicles, additional placement of fill was required for the whole site. It can be seen from Fig. 3(a) and (b) that an additional layer of fill of about 0.3 to 0.5 m was placed at the site. In addition, fill of about 2.85 m high was placed at the boundary of the site and drainage reserve, extending about 2 m from the toe of the original slope. Unfortunately, there was no available records to indicate the actual quantity and the rate of placement of fill except the fact that the fill placement and compaction began about two weeks prior to the day of failure.

Eye-witnesses at the site indicated that tension cracks were observed on the fill on the morning of the day in which failure occurred. Moments after this observation, the pipeline burst resulting in water overflowing into the fill at the drainage reserve. This was followed subsequently by the slip failure and upheaval of the banks of the canal as shown in Fig. 3(c). Failure encompassed a length of about 100 m along the canal and extended across the drainage reserve to about 15 m into the construction site. The eye-witnesses further noted that failure took place suddenly with out any perceptible vibration. At the end of failure, settlement of the fill at the

boundary had reached over a metre, while the floor of the canal heaved close to a metre. The bin centre and vehicle washing shed, which are supported by tanalised timber piles showed no structural damage apart from some minor cracks in the floor slabs. The rest of the buildings, which are supported on precast concrete piles, appeared to be unaffected by the slip failure.

To prevent further movement of the slip and additional damage to the canal, construction activities ceased in the vicinity of the drainage reserve boundary and the collapsed soil was removed by the site contractor. The removal of the collapsed soil and the regrading of the slope shown in Fig. 3(d) was completed in five days. Although no records were available on the amount of earth removed, the site contractor estimated that about 480-lorry loads were involved.

The use of counter-berm to stabilise the movement was not possible because of its proximity to the canal. As an expedient measure, the slope was regraded gently to 1:8

as shown in Fig. 3(d) and excess soil removed to relieve some of the stresses on soft marine clay. Inclinometers were recommended to be installed at the drainage re: to monitor any ground movements during regrading and the subsequent repair of canal.

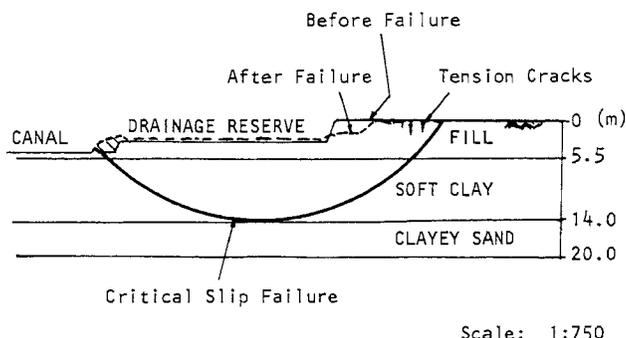
Fig. 4. Results of Slope Stability Analyses

Stability analysis have been carried out considering critical circles using total stress analysis. The approach to stability analyses are by the method of slices and the design charts given in Navfac DM-7 (1982). Results of the analyses are summarised in Fig. 4. The standard slip circle analysis, using undrained shear strength calculated from results of triaxial test and vane tests, is adequate for the prevailing site conditions. In the analyses, the following conditions and assumptions were made:

It can be seen from the results that the critical slip failure passes through the soft clay stratum giving factors of safety ranging from 0.91 to 1.21. This circle is in good agreement with the exterior signs of failure.
