Lessons From Recent Collapses of Metal Buildings

David B. Peraza

By David B. Peraza, P.E.
Senior Associate, LZA Technology, New York, NY

This paper presents case studies of three roof collapses of metal buildings, discusses the most significant features of each case, and summarizes lessons learned that can be used to reduce future failures.

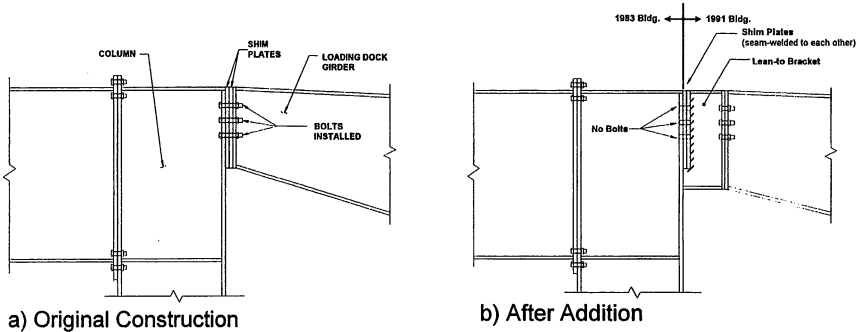
Figure 3: Connection Details at Original Loading Dock

The original loading dock was a "lean-to" structure. The three loading dock rafters attached to the freezer building columns via shim plates, as shown in Figure 3a.

lean-to brackets, and they were erected as shown in as in Figure 3b. The construction of the 1991 freezer was similar to that of the 1983 building.

In addition, three of the lean-to brackets were inadequately fastened to the columns. The engineer overlooked that three of the columns, the ones to which the original loading dock rafters had attached, had shim plates. Originally, these shim plates were bolted to each other. These bolts were removed in order to dismantle the old loading dock, and were not replaced when the lean-to bracket was welded on, as can be seen in Figure 5. The only attachment

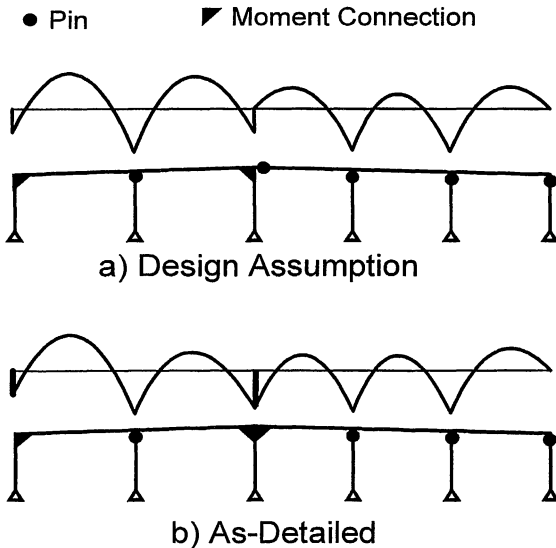
Figure 4 : Moment Diagrams for Frames

Regarding the rafters, serious overstresses were found near each lean-to bracket.

At these locations, the 1983 rafter is overstressed 96% in negative bending, and the 1991 rafter is similarly overstressed 27% for design loads. The severe overstresses are due to the fact that the connections were detailed in a manner inconsistent with the design assumption. The design assumption was that shear connections would be used to attach the new rafters to the original building columns, and therefore the original columns would only have to be designed for the added vertical load. However, the connection was detailed as a moment connection. Figure 4 contrasts these two conditions and the effect on

the negative moment.

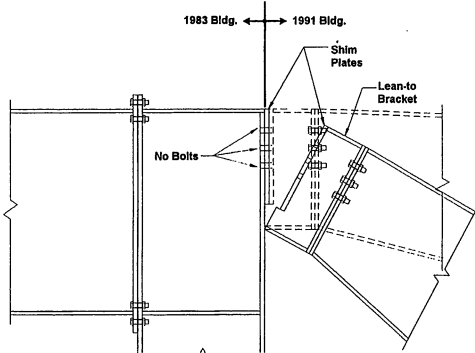
Figure 5: Failed connection.

between the shim plates was then the non-structural “seam welds” around their perimeter. These seam welds had to transfer the shear and the moment from the new rafters. Calculations showed these seam welds, which would never have been relied upon by a design engineer, actually did have substantial strength that prevented the collapse from occurring sooner.

But the most serious deficiencies related to the rafters, more particularly the connections of the new rafters to the original columns. The detailing of these connections introduced moments that the original structure was not designed for, and neglected the fact that there were shim plates present at some columns that required special attention.

- Make sure that the detailing is consistent with the design assumptions. For example, connections that are assumed to transmit shear should be detailed as such, and connections assumed to transmit moment should be detailed as such.
- Provide clear and explicit erection instructions for special conditions, such as when connecting to an existing structure.
- Research regarding the effect of refrigerated roofs on snow load may be needed. In this case, the measured snow weight was more than twice the values required by code, and this magnitude of load is not explainable from weather records. This may be due to the freezer nature of the facility, which experiences minimal melt-off and

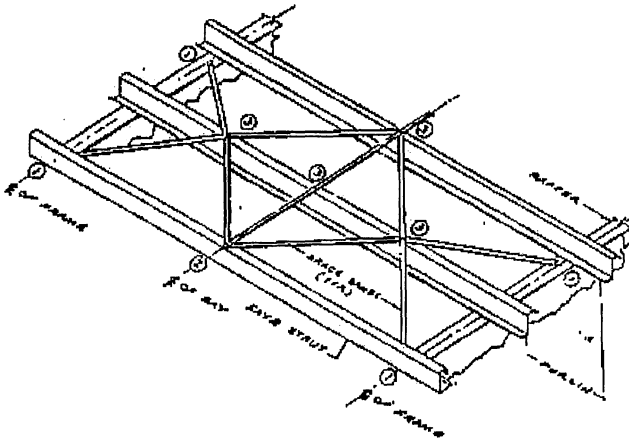
Figure 7: “Isometric View” reproduced from standard detail sheet

An isometric view, reproduced as Figure 7, clearly shows plan bracing along the eaves, anchored the rafters. This arrangement is effective for anchoring the transverse strap that continues up the roof. But what happens to that transverse strap after a few purlins? Does it bend down to the bottom flange of the next purlin, creating the "criss-cross" shown in the elevation? The effectiveness of the bracing provided by such an arrangement is highly questionable, given the interrupted nature of the perpendicular straps and their "anchorage" to tension flanges. Or was it the fabricator's intent to have plan bracing wherever the criss-cross arrangement is indicated? If so, then the arrangement must differ significantly from the plan bracing at the eave, which extends over a pair of purlin bays. And to be effective, the plan bracing would have to be anchored to the rafters, which is not indicated. Or perhaps the intent was to have plan

bracing along the ridgeline. And finally, what exactly is meant by “brace band”? The isometric indicates that the plan diagonals are the brace bands, but a note calls for brace bands at the 1/3 points for a 20 foot span, suggesting that the transverse straps are the brace bands. What this detail sheet means, only the fabricator knows for sure!

Ironically, the transverse bracing would be much easier to erect, and it would be much more effective, if it were simply run continuously from eave to peak, and then down to the other eave, thereby eliminating the criss-crosses.

Engineer/fabricators should carefully review the design assumptions that they make with respect to purlin bracing, and take steps to ensure that the bracing requirements are clearly communicated to the erector.

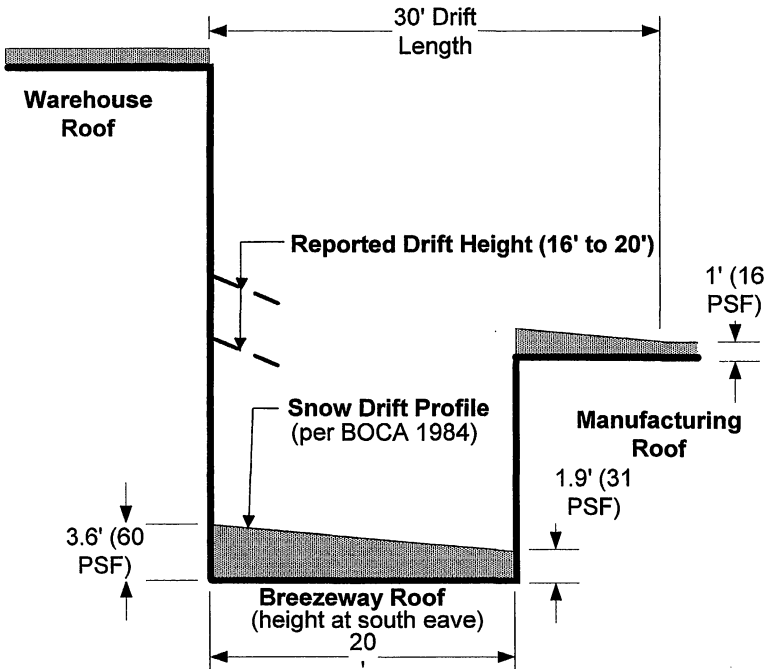
Figure 9: Roof and Snow-load Profiles

Figure 9. The snow heights are based on the BOCA 1996 snow density formula, since BOCA 1984 did not contain a snow density formula.

In this case, it appears that the failure was caused by a drifted snow load that substantially exceeded the code-mandated values. This is based on the fact that the purlin design was adequate, plus the evidence that the snow loads present exceeded the code design values. Even if the strap bracing had not been installed, the purlins received sufficient incidental bracing from the standing seam roof to safely support the code-required loads. Evidence that the snow load exceeded the BOCA values is provided by meteorological data, published literature, and anecdotal observations by employees of the facility.
