A Soil-Structure Interaction Analysis of a Damaged Building

R.F. Wilson-Fahmy

SYNOPSIS: A twenty years old reinforced concrete building suffered from fracture of one of its ground floor corner columns. The extent of damage resulting from fracture of the column is examined. Plane frame structural analysis is used in the interpretation of the signs of damage of the building. Soil compressibility is incorporated in the analysis by assuming the footings to rest on Winkler type subgrade. The theoretical analysis is assessed by comparing the results with the actual behaviour of the structure.

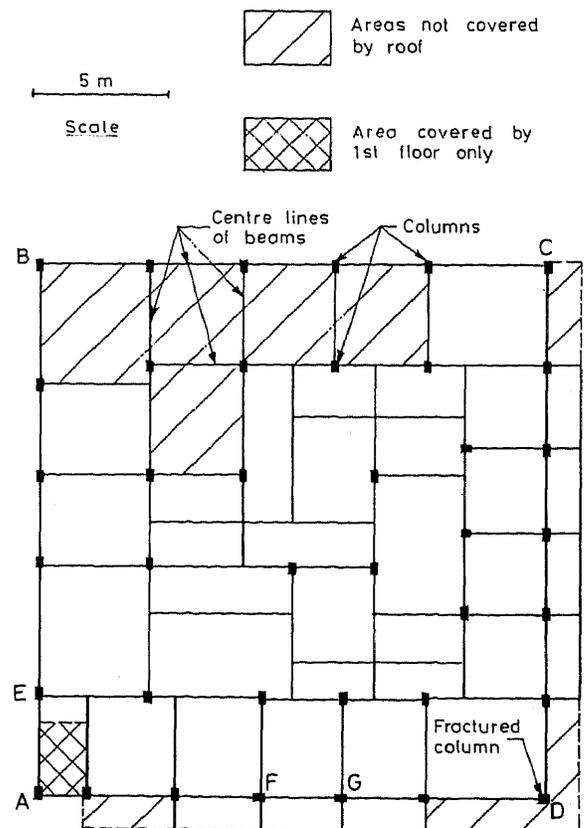
Fig.1 Locations of Columns and Beams

The building suffered from fracture of the ground floor corner column marked D in Fig. 1 after about 20 years in service. After the incident, the first floor was extensively supported by timber props to stop further deterioration of the building resulting from the column fracture.

Inspection of the fractured column indicated that it was weakened due to drilling of several relatively deep and large holes through the concrete for the purpose of fixing a heavy steel door.

Visible cracks in the reinforced concrete elements were limited. Serious cracks appeared only in the column marked B in Fig. 1 which is located at the farthest point from the fractured column. The cracks could be seen in all the floors just below the intersection of the column with the beams.

Inspection of facade AD (Fig. 1 and 2a) indicated that the building was leaning towards the fractured column. The horizontal movement of the point marked E in Fig. 1 and 2a at the roof was nearly 100 mm measured with reference to the adjacent building. The movement decreased downwards to reach a zero value at ground floor.

Settlement of the ground inside the building area was another sign of damage. The settlement was particularly irregular near side AD, Fig. 1. In the zone between columns F and G, the ground settlement was greater than in the surrounding area by about 150 mm. This figure may be indicative of the order of magnitude of the settlement and differential settlement of the foundations.

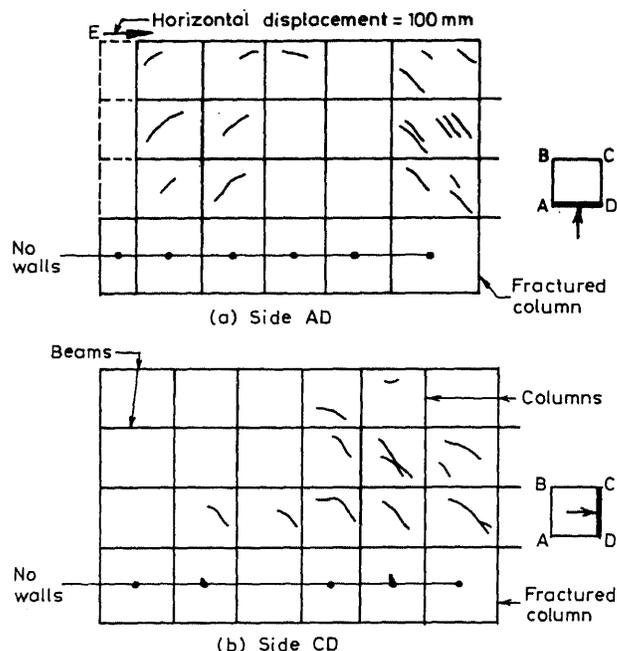
Fig.2 Cracks in Exterior Walls

The whole building was affected by the column fracture as evidenced by the wall cracks appearing everywhere in the building. Fig. 2 shows the pattern of cracks in the exterior walls at the faces AD and CD of the building. The inclination of the cracks indicates that the walls were subjected to shear deformations. As with the exterior walls, most cracks in the interior walls were also inclined. The crack width exceeded 10 mm in various parts of the building.

The predicted results shown in Fig. 6b for the wall panels in frame AD follow in general the same trend as those of frame CD. The observed crack pattern shows, however, some difference. Cracks are absent in panel P3 and P4 and the inclination of the crack in Panel P2 (Fig. 2a) contradicts that predicted. This is probably due to the high differential settlement between the columns in this zone. As previously mentioned, ground settlement in the region between columns F and G, Fig. 1 is greater than that in the surrounding area. Higher settlement of the columns in this zone with respect to the neighbouring columns could cause shear strains of signs opposite to those predicted in Fig. 6b and hence could be responsible for any local deviation from the overall pattern of deformations of the frame. It may be noted that the predicted direction of crack in wall panel P1 is in agreement with that observed, again, at low values of the modulus of subgrade reaction.

No predictions are made for the crack directions in panels M6 and P5 in Fig. 2a. It is interesting to note, however,

that the direction of the cracks in these panels would have been at right angle to those observed if related only to the deflection of the supporting beams which are acting more as cantilever beams after column fracture. This shows that the walls are probably subjected to the deformation mode shown in Fig. 5c as a result of the horizontal sway suffered by the building.

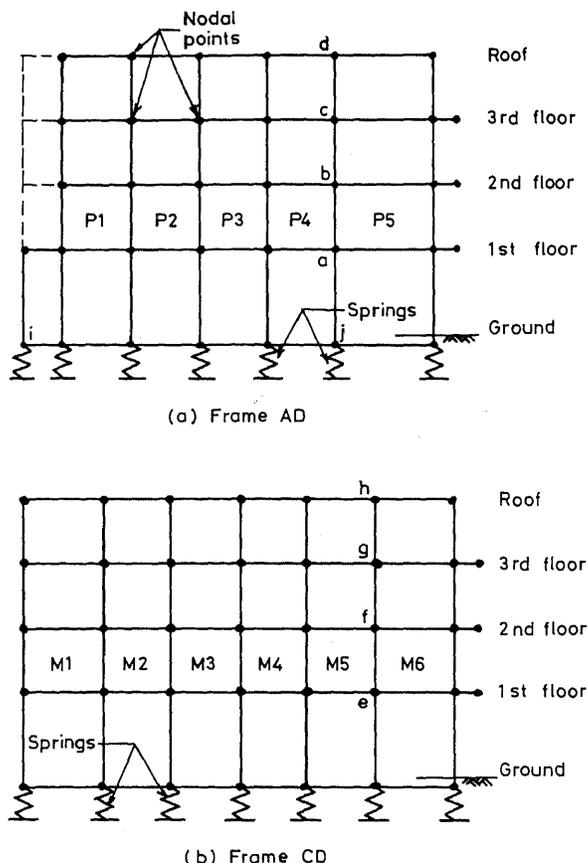
Fig.3 Idealisation of Frames AD and CD in Frame Analysis

The plane frame analysis was applied to the two exterior frames AD and CD intersecting at right angle at the fractured column, Fig. 1. The idealized representation of the two frames in the analysis are given in Fig. 3. The effective flange widths of T-beams and L-beams and the loads transmitted from the slabs to the beams were determined according to the Egyptian Code of Practice. The moment and shear just to the right of the nodal points marked a, b, c, d, e, f, g and h in Fig. 3a and b after column fracture were calculated in an approximate manner by treating the slab with the two beams originally supported by the column (Fig. 1) as a plate supported on two sides. The tables compiled by El-Behairy (1974) for plates under different support conditions were used in the calculations.

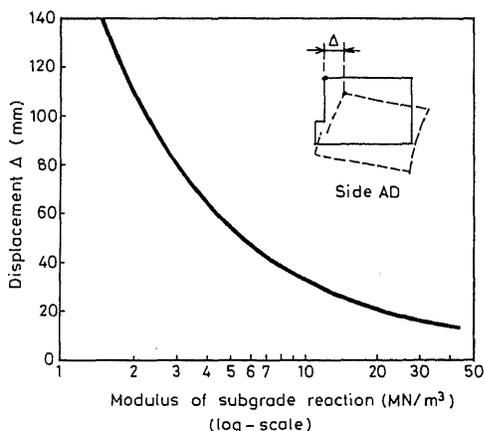
Fig.4 Relationship Between Modulus of Subgrade Reaction and Horizontal Displacement of Frame AD at Roof Level

The predicted relationship between the horizontal movement at the top of frame AD and the modulus of subgrade reaction k after column fracture is given in Fig. 4. It can be seen that the horizontal movement decreases greatly with the increase of the modulus of subgrade reaction k . The limiting case corresponding to unyielding supports gives a value of 6.5 mm only which is considerably smaller than the measured value (100 mm). Referring to Fig. 4, the modulus of subgrade reaction corresponding to this latter value is 2.2 MN/m³. The corresponding predicted settlements at nodes i and j , Fig. 3a are 2.7 and 13.2 mm respectively. These values are of the same order of magnitude of the observed ground settlement inside the building area.

The predicted horizontal movement at the roof level in the plane of frame CD is less than that in the plane of frame AD at all values of k . For example at k equal to 2.2 MN/m³, the former value is 51 mm while the latter is 100 mm. Unfortunately, verification of the ratio between the horizontal movement of frames AD and CD was not possible since no measurement was made of the movement in plane CD. Surveying instruments would have been required for taking the measurement.

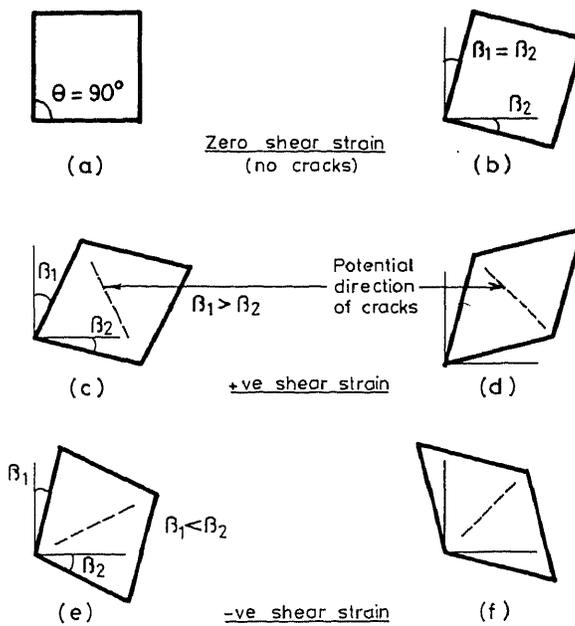
Fig.5 Wall Distortion and Potential Direction of Cracks

In order to overcome the difficulties involved in relating cracks solely to foundation settlements, the method shown in Fig. 5 is used. Each wall panel is considered as an element undergoing shear strain. The potential direction of cracks in the wall will depend on whether the angle θ , Fig. 5a, increases or decreases with reference to its initial value (90°). The increase or decrease of θ is assumed equal to the shear strain experienced by the wall element. Various modes of deformations and tilt are shown in Fig. 5 together with the corresponding potential directions of cracks and the sign convention adopted.

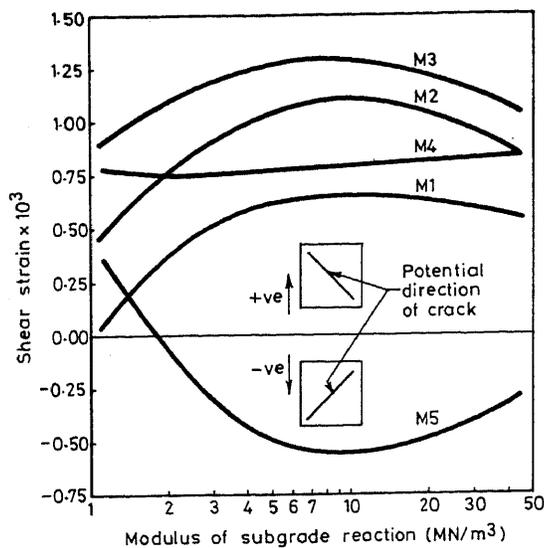
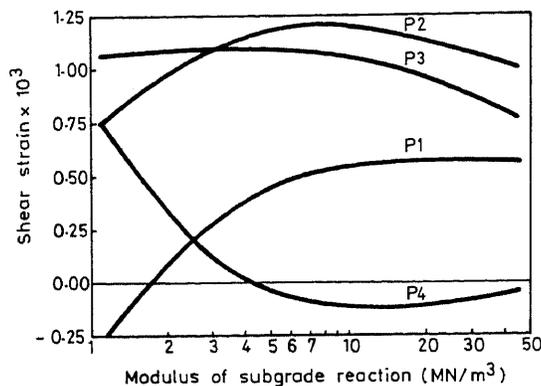
Fig. 6 Relationships Between Modulus of Subgrade Reaction and Shear Strains in Walls

The predicted relationships between the shear strain and the modulus of subgrade reaction k for the first floor wall panels of frame CD (marked M1, M2, M3, M4 and M5 in Fig. 3b) and those of frame AD (marked P1, P2, P3 and P4 in Fig. 3a) are given in Fig. 6a and Fig. 6b respectively. The predicted horizontal and vertical displacements of the nodal points at the corners of each wall panel are used in determining the shear strains. As already mentioned, the beams to the right of nodes a and e in Fig. 3 were treated in a simplified manner in the frame analysis. The shear strains for the wall panels above these beams could not, therefore, be determined. The relationships between k and the shear strains for the wall panels above the second and third floors are found to follow the same trend as those for the first floor wall panels.

Referring to Fig. 6a, it can be seen that the shear strain is greatly dependent on soil compressibility. The shear strain sign and hence the potential crack direction may differ according to the value of k . Comparison with Fig. 2b indicates that the potential crack directions become in accordance with the actual crack pattern as soil compressibility tends to high values. Agreement between predictions and observations of horizontal movement is also obtained at high soil compressibility as previously noticed. As the modulus of subgrade reaction decreases, the shear strain of panel M5, for example increases until it changes its sign, thus leading

to the same direction of crack as that observed. Also the shear strain of panel M1 decreases sharply which conforms with the absence of cracks in this panel.
