A Study on Failure Mechanism of Embankment Dams for Irrigation Damaged by the 1995 Hyogoken-Nanbu Earthquake

A STUDY ON FAILURE MECHANISM OF EMBANKMENT DAMS FOR IRRIGATION DAMAGED BY THE 1995 HYOGOKEN-NANBU EARTHQUAKE

The objects of this investigation are to examine the following mechanism of embankment dams for irrigation damaged by the 1995 Hyogoken-Nanbu Earthquake; 1) the mechanism and process of collapse for the Idenoshiri-Ike embankment dam using the effective stress earthquake response analysis; 2) the mechanism of upper slope failure for the Sugatadani-Ike embankment dam using the total stress earthquake response analysis as well as the slope stability analysis with seismic intensity. As a result, the following conclusions are obtained for each objects; 1) the mechanism and process of collapse due to liquefaction can be analyzed that the liquefied areas initially occurred at the toes of upper and lower slopes are extended and connected to make flow downward the volume of embankment and that the result of this analysis is consistent with the real damaged situation; 2) the mechanism of upstream slope failure can be explained only with considering the increase of excess pore

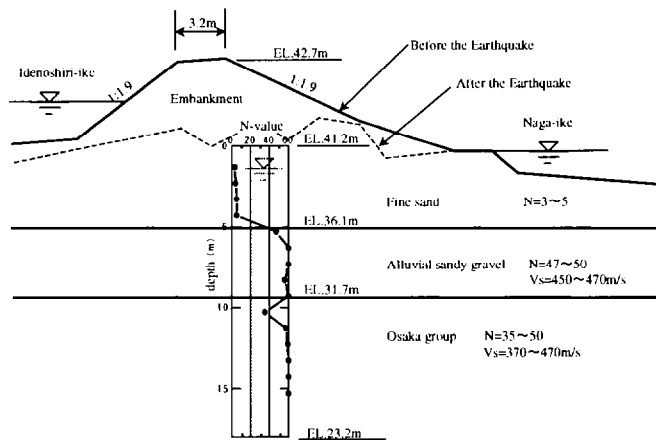
Fig. 2. Cross section of Idenoshiri-Ike embankment dam

The mechanism and process of the collapse of Idenoshiri-Ike embankment dam by soil liquefaction during the 1995 Hyogoken-Nanbu Earthquake was examined by an effective stress analysis. The Idenoshiri-Ike dam is located in the northwestern part of Awaji Island. It was a homogeneous type earth-fill dam with 155m long, 5.5m high, and 17,500m³ storage capacity of reservoir. At the time of the earthquake, the center part of dam collapsed completely; many cracks in the longitudinal direction appeared as showing in Fig.2. A cross-section of collapsed embankment and SPT N-value are also shown in Fig.2 [The Department of Agriculture, 1996]. Soil liquefaction of the foundation ground was supposed to be the cause of the failure because many sand boils were observed on the reservoir bed and at the downstream paddy field.

sandy gravel layer, development of excess pore water pressure in this layer was not considered because SPT N-value is very large to be more than 47 as seen in Fig.2.

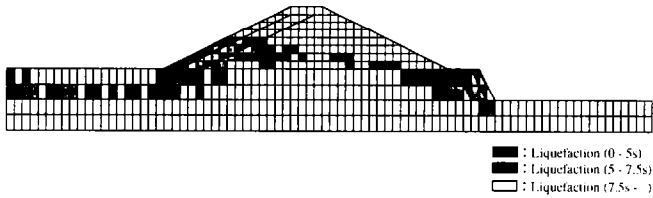
Fig. 6. Liquefied zone during shaking

Liquefied areas are shown in Fig.6. Time histories for response acceleration are shown in Fig.7. and ones for excess pore water pressure in Fig.8. Judging from analyzed displacement, the whole embankment moves toward the downstream side. From these results obtained by the analysis, the process of the collapse of this embankment dam is estimated as follow;

- Until about 3.5 seconds passing from the beginning of the earthquake, amplification of acceleration from the bottom to the crest is about two times as shown in Fig.7 and the liquefaction doesn't occur in all elements (as seen in Fig.6).
- During 3.5-4.0 seconds, the element E1 (see Fig.8) near the upstream slope is liquefied, then elements in the downstream side are liquefied. The liquefaction area expands in nearby areas in the subsequent large pulse at about 4.5 seconds.
- Liquefied area expands to the center part until 7 seconds when input acceleration shows peak values. At 7 seconds, liquefaction area form upstream to downstream sides jointed,

resulting in very weak layer of the bottom of the embankment dam.

The failure of the embankment dam is supposed to be caused by the formulation of this weak layer (liquefied layer).

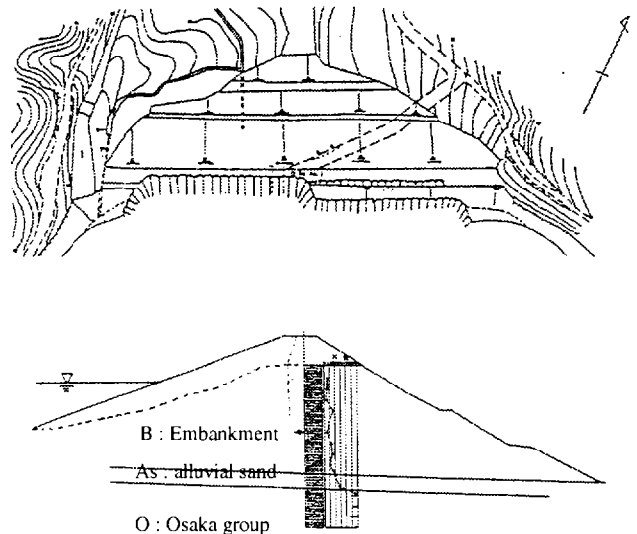
The Sugatadani-Ike embankment dam is located on a hill with elevations of about 90m in the southeast area of Ono City in Hyogo Prefecture. It was a homogeneous type earth-fill dam with 98m long and 12m high. Fig.9 shows an overview of the cross section of this damaged embankment. The water level of reservoir during the earthquake was about half of the design high water level, and the upstream slope was damaged by the slide along the whole length of the embankment dam with gaps of about 4m at the crest.

Since the closest distance from the fault line to this embankment dam was estimated to be 26.4km, from the relationship between the horizontal acceleration and the closet distance from the fault line in the region [Toki et al, 1995], the maximum acceleration at the site is estimated to be approximately 200Gal (0.20g) (160Gal (0.16g) for stiff ground and 230Gal (0.23g) for soft ground). It is considered that liquefaction was not caused due to the earthquake because of the acceleration was relatively small and no sand boils were observed near the reservoir.

Fig. 9. Damage of the Sugatadani-Ike embankment dam [The Department of Agriculture, 1996]

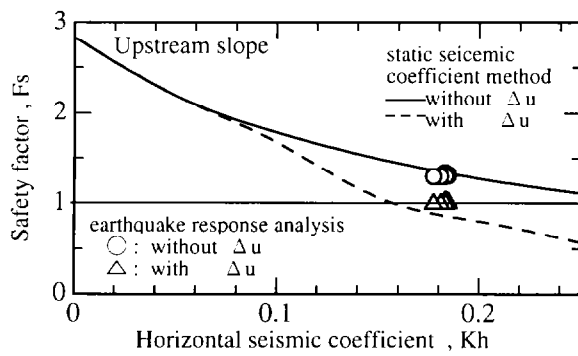
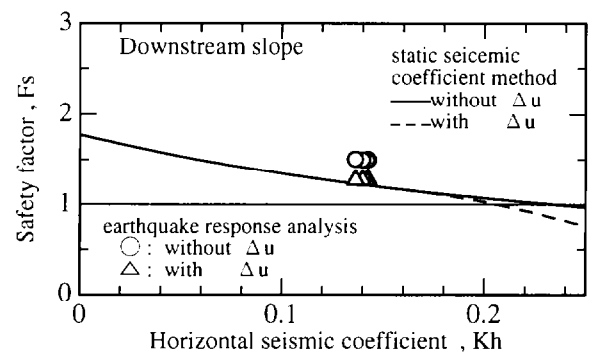
Fig. 12. Relationship between safety factor and horizontal seismic coefficient

Relationship between horizontal seismic coefficient and safety factor. The solid lines in Fig. 12 show the relationship between safety factor F_s , which was obtained from equation (1) by assuming $U_e=0$, and horizontal seismic coefficient Kh . The calculations are conducted with only a circular arc given the minimum safety factor where $Kh=0.1$. The shape of seepage surface was calculated by saturated and unsaturated seepage analysis. As shown in Fig. 12, the safety factor of the downstream slope is smaller than that of the upstream slope, with the limit horizontal seismic coefficient Khc (horizontal seismic coefficient for $F_s=1.0$) for the upstream slope being 0.29, and Khc for the downstream slope being 0.23. Considering that the maximum ground acceleration at the site was approximately $200Gal(0.2g)$, the upstream slope of this reservoir theoretically should not collapse if the horizontal seismic coefficient is about 0.2. In addition, the lower safety factor for the downstream slope contradicts the fact that the failure occurred only on the upstream slope. Records of this earthquake also show that there were several cases where the upstream slope of the embankment or the whole embankment collapsed, but no case where only downstream slope collapsed. This indicates that the above calculation based on the static seismic coefficient method cannot explain the actual damage, where only the upstream slope collapsed. The possible reason for this is that the effect of excess pore water pressure was not taken into consideration in the above calculation.

The dot lines in Fig.12 show the relationship between F_s , for which the effect of excess pore water pressure Δu obtained from Fig.11 is taken into account, and Kh . In this figure, the effect of Δu is observed, where Kh is equal to or larger than 0.1 for the upstream slope, and equal to or larger than 0.2 for the downstream slope. Khc is 0.15 and 0.2 for the upstream slope and downstream slope, respectively. Therefore it can be concluded that the cases where only the upstream slope collapses can be explained by static seismic coefficient method if the effect of pore water pressure is taken into account.

stress analysis was incorporated into the results of the total stress response analysis. When the effect of excess pore water pressure is considered, F_s is calculated to be approximately 1.0 for the upstream slope and more than 1.0 for the downstream slope, which is in agreement with the actual case where only the upstream slope collapses.

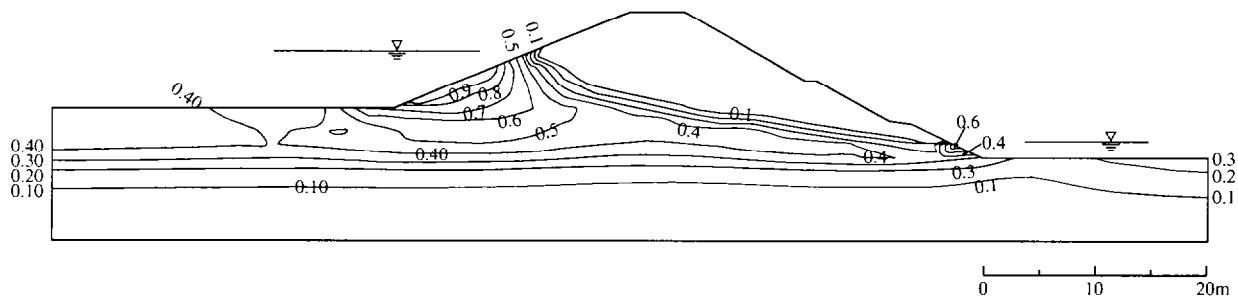
Effective stress response analysis. The effective stress response analysis (TARA-3) was carried out to verify the mechanism of upstream slope failure. Fig.13 shows the distribution of excess pore water pressure obtained from this analysis. This figure indicates that excessive pore water pressure tends to develop near the upstream slope. It can also be seen from this figure that the location where the excess pore water pressure ratio develops close to 0.9 is limited to a small area near the surface of the upstream slope, so liquefaction of the whole embankment does not occur. The symbol \triangle in Fig.12 shows F_s , for which the effect of excess pore water pressure obtained from the effective

Fig. 13. Distribution of excess pore water pressure ratio $\Delta u / \sigma_m'$ obtained from the effective stress response analysis
 (Δu : excess pore water pressure, σ_m' : mean principal stress)

As described above, it was found that the embankment damage where only the upstream slope collapsed could not be explained without the development of excess pore water pressure in the upstream slope of embankment during the earthquake. It is therefore concluded that the collapses of embankment caused by the increase of pore water pressure as well as the low shear strength of the embankment materials.
