A Field Study and Dynamic Finite Element Analysis of Railway Retaining Structures Damaged by the Hyogoken-Nambu Earthquake (1995)

A FIELD STUDY AND DYNAMIC FINITE ELEMENT ANALYSIS OF RAILWAY RETAINING STRUCTURES DAMAGED BY THE HYOGOKEN-NAMBU EARTHQUAKE (1995)

ABSTRACT

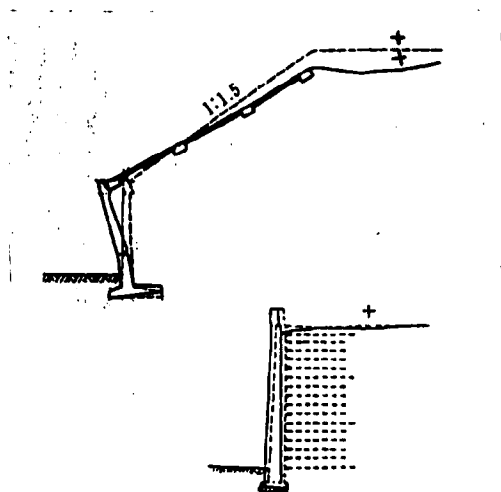
Fig.1. Collapse of RCW (above) and tilt of GRW (below)

some examples of combination of structural type and degree of damage. That is, the above figure shows an example of collapse of RCW, and the below an example of tilting of GRW.

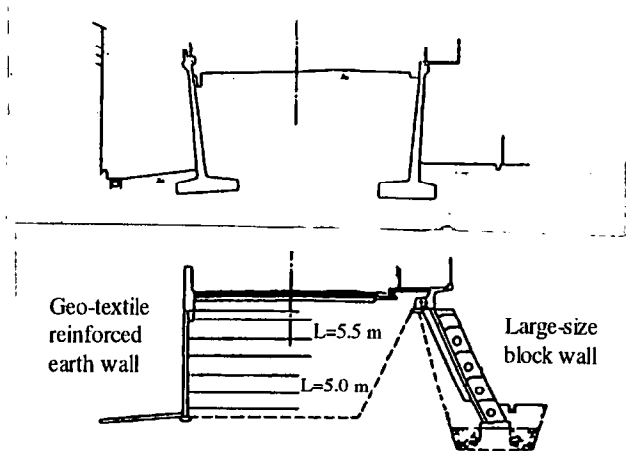
Fig.2. Restoration of a highway embankment: before (above) and after (below)

Restoration of damaged retaining walls of a municipal highway was conducted, using a geo-textile-reinforced earth wall and a large-size block wall, as shown in Fig.2.

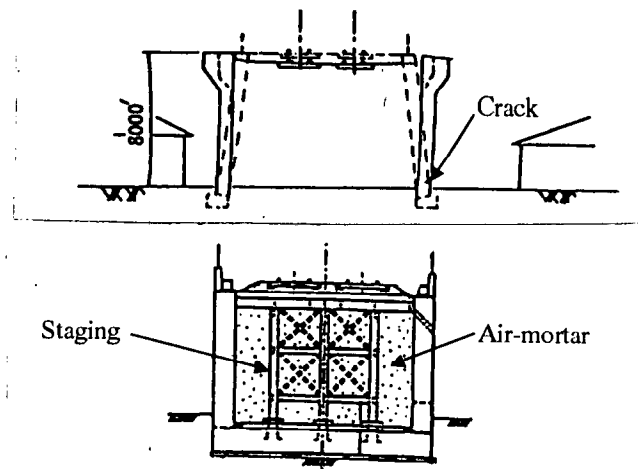
Fig.3. Restoration of a Hankyu Railways leaning-type wall: before (above) and after (below)

Collapsed retaining walls of Hankyu Railways are shown in Fig. 3. As for the restoration, the damaged walls were removed, the railway tracks were temporarily supported by staging, then a U-shaped concrete wall was constructed, and finally air-mortar was poured into the space inside the U-shaped wall.

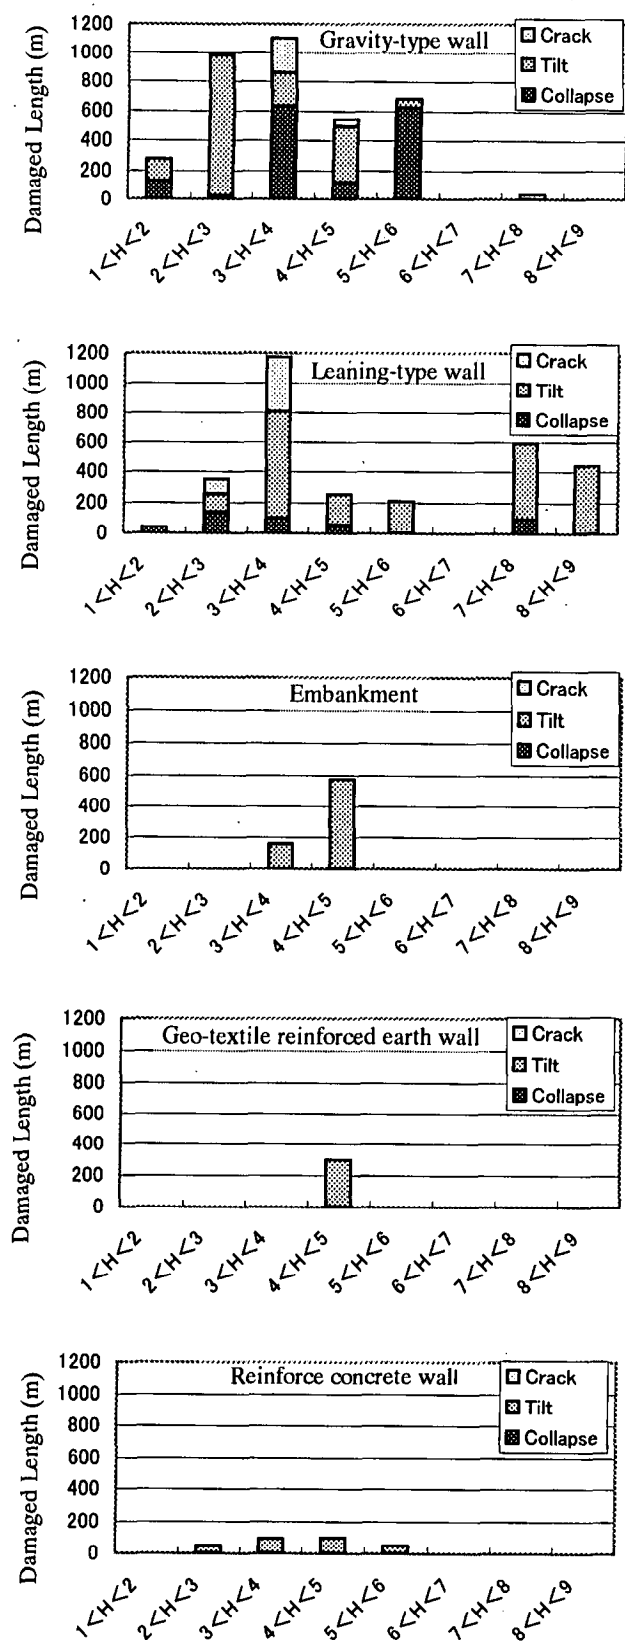
- Damage to embankments, GRWs, and RCWs was smaller than that to gravity-type or leaning-type walls,
- RCWs suffered internal damage but had no external damage, and
- Gravity-type walls of higher than 5 meters tend to collapse but leaning-type walls of higher than 7 meters remained tilted without collapse.

Fig.4. Degree of damage according to the height H (m) and type of retaining structures

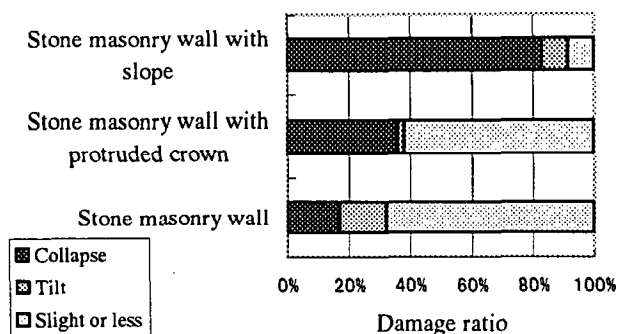
In a smaller limited section, all stone masonry retaining structures including non-damaged ones were analyzed, and the damage ratio was calculated. The retaining structures in this section were composed from stone masonry wall, stone masonry wall with protruded crown, and stone masonry wall with slope as shown in Fig.5. Figure 6 shows that the damage ratio of stone masonry wall with slope is twice greater than that without slope. The ratio of collapse in stone masonry wall with protruded crown is nearly twice greater than stone masonry wall. But even if tilted structures are included to the collapsed, the damage ratio with protruded crown does not change so much. From this figure, it is suggested that in the

Fig.6. Damage ratio of stone masonry walls

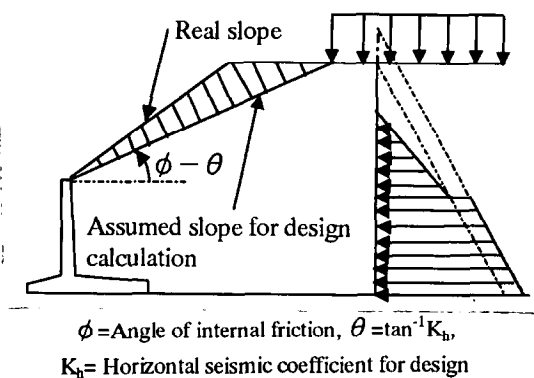
applied aseismic design of retaining walls with slope, seismic active earth pressure can be estimated to be too small. Figure 7 shows the assumed slope for calculating seismic earth pressure in the applied seismic design. The shaded triangular soil mass over the assumed slope is considered to slide during earthquake, and neglected in the calculation of seismic earth pressure. This underestimation of seismic earth pressure may contribute to the large ratio of collapse. Moreover, some other factors such as slope protection works might accelerate the damage.

Fig. 7. Assumption of slope for applied aseismic design of retaining wall with slope

Aseismic design codes for railway structures were revised in 1999, and the concept of sliding soil mass in the calculation of seismic active earth pressure to retaining walls with slope was abandoned. The necessity of this revision coincides with the findings presented in this paper.

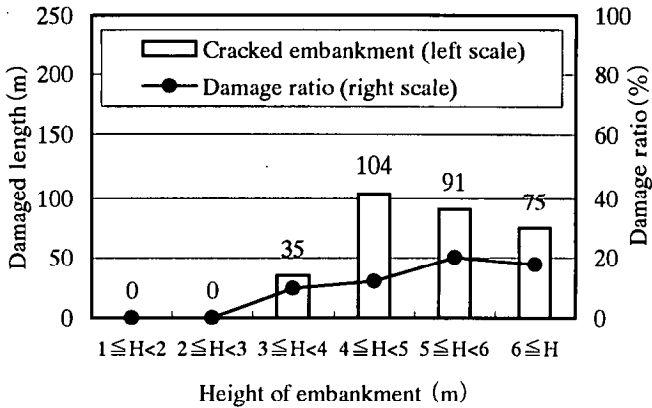
Damage to embankments of national highways was analyzed. Figure 8 shows the relationship between height of embankment and damaged length or damage ratio. The damage ratio is found to become greater as increasing the height of structures (Kunitomi *et al* 1998).

Fig.8. Damage to highway embankment

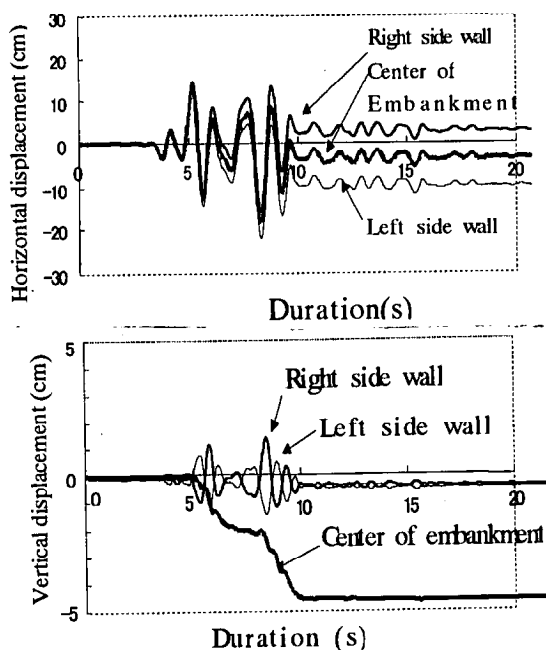
Figure 12 shows response of the gravity-type wall and the backfill. The gravity-type walls and the backfill horizontally oscillate in the same phase as shown in the upper figure of Fig.12. But, as shown in the lower figure of Fig.12, the settlement of backfill accumulates from the earlier stage, and the surface of embankment can not hold the original level.

Fig.12. Response of the gravity-type wall and the backfill: horizontal (above) and vertical (below)

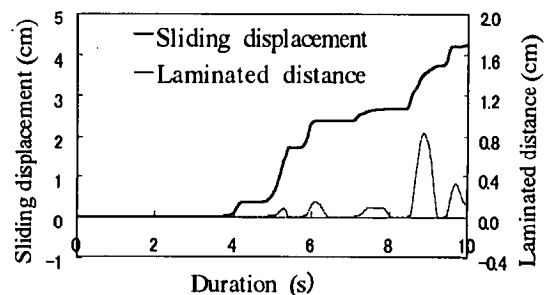
The gravity-type walls develop de-lamination at the contact plane to backfill as shown in Fig.13. This soil-wall slippage displays non-reversible character. This type of relative displacement is also developed in the leaning-type walls.

Fig.13. Relative displacement between the gravity-type wall and the backfill

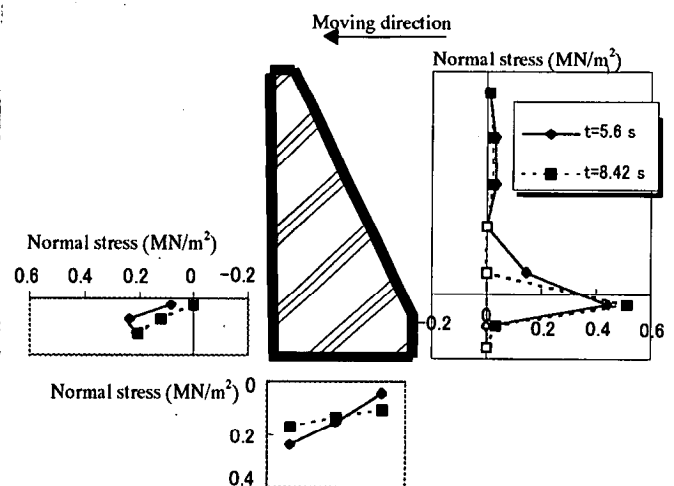
Figure 14 shows stress distribution at the contact face between gravity-type wall and backfill. The gravity-type wall develops earth pressure when the whole structure is moving from backfill side to wall side as shown in Fig. 14, but has no earth pressure when moving the other way around. This means that the gravity-type wall suppresses the movement of the backfill.

Fig.14. Stress distribution at the contact face between gravity-type wall and backfill

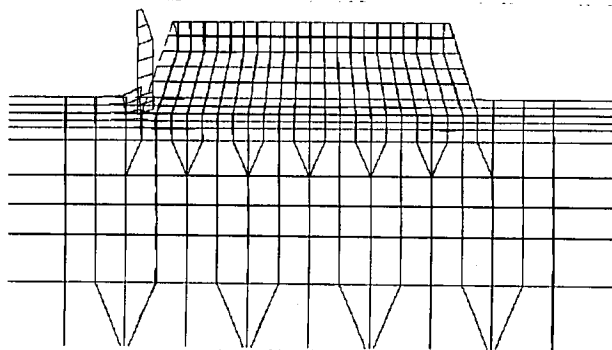
Figure 15 shows displacement of leaning-type wall at 9.7 seconds. The leaning-type wall does not develop any earth pressure at the contact face with the backfill whether it is moving right or left. It moves as if it was on the side slope of the embankment and toppled after as shown in Fig.15.

Fig.15. Displacement of leaning-type wall at 9.7 seconds

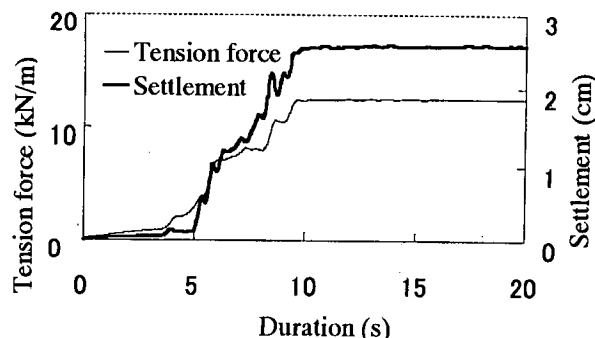
Figure 16 shows tension force in the geo-textile and settlement of reinforced embankment. The geo-textile material develops tension force in accordance with the settlement of backfill as shown in Fig.16. The distribution of the tension force in geo-textile does not change so much

Fig.16. Tension force in the geo-textile and settlement of reinforced embankment

whether the wall is moving right or left. Therefore, the tension force is not directly caused by the horizontal movement of the wall, but by the settlement of backfill. This tension force suppresses sliding of the wall. Figure 17 shows the distribution of tension force when the whole structure is moving from the left to the right.
