## Sinkholes in Earth Dam Kota Barrage [India]

## SINKHOLES IN EARTH DAM KOTA BARRAGE [INDIA]

**Paper No. 3.16**

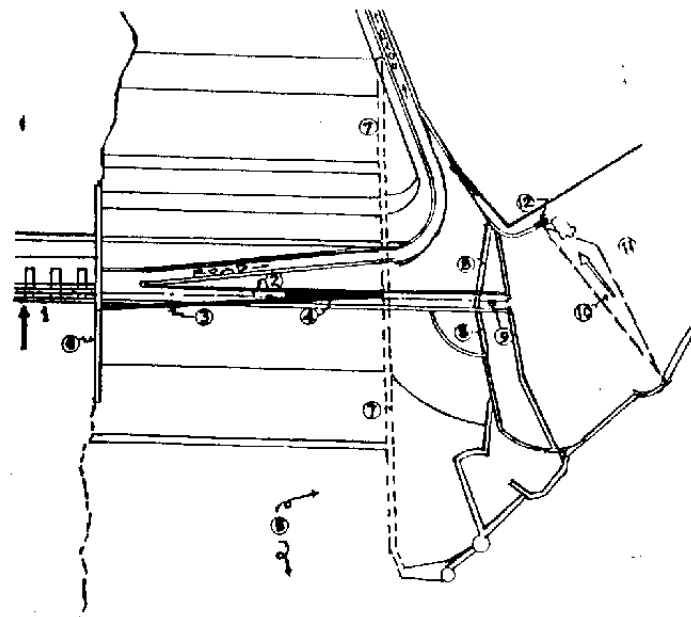
Fig. 1 General Layout Plan Kota Barrage.

In the year 1990, five boreholes were drilled in the right abutment in the Garh Complex to know about the geological conditions of the region. The investigations revealed that the depth of the overburden in the region varied from 4m to 9m and the overburden materials comprised of low density silty soil mixed with pieces of stones bricks, etc. These drillings showed a very good to excellent core recovery (90% to 100%) of fresh, hard and massive sand stone, but bed rock was found highly fractured. Tracer studies carried out in these bore holes indicated that the seepage exit at EL. 254.2m, was hydraulically connected to the reservoir (Fig. 1).

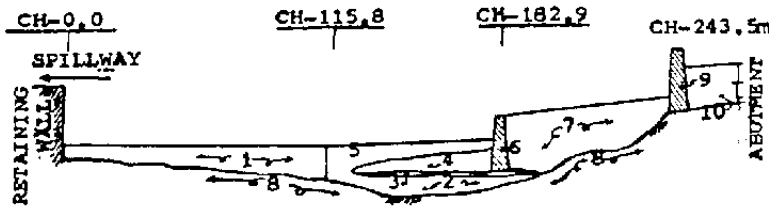
Fig. 3 Geological Section of Dam Foundation

The spillway rests entirely on hard quartzitic sandstone whereas the dam is founded on the old river bed of Chambal having different soil characteristics which have thereby necessitated different type of treatments. The dam between the Retaining wall and the Lower Fort Wall (Ch. 0.0 to Ch. 182.9m) rests partly on hard rock and partly on pervious strata comprising of silt, sand, gravel and boulders. An impervious clay-tongue of about 5m thick protruding into the river for a length of about 55m from the Lower Fort Wall and extending both upstream and downstream for a long distance is sandwiched in between two bouldery strata as shown in Fig3

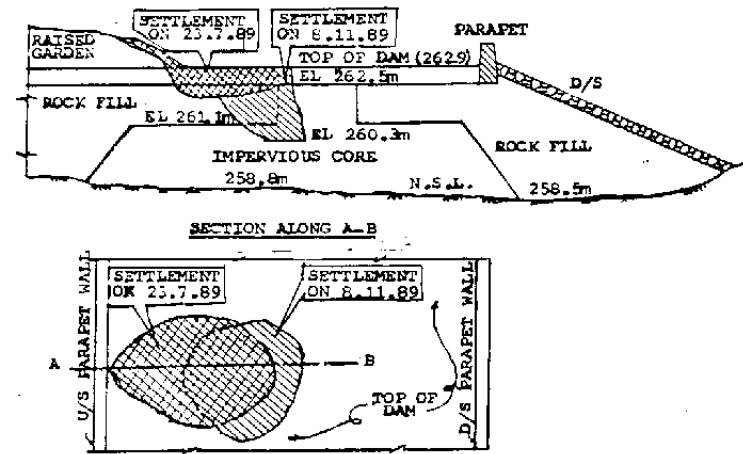
Fig. 4 Sinkholes at Ch. 253m. Kota Barrage

During initial filling of the reservoir to EL. 258.2m, some leakage of water emerged out from the Upper Fort Wall at downstream toe at EL. 247.2m. Some Water spots were also observed in the downstream edge in the vicinity of the Upper Fort Wall. With the increase of the pond level to EL. 259.7m and maintaining it almost constant, seepage started through the rock crevices in the Garh area at EL. 254.2m. Gradually it increased to 0.28 cumecs due to widening and washing off the seams in the rock with the passage of time. [Presently seepage is to the tune of about 0.23 cumecs with its water clear and free from suspended particles.] In 1968, the staircase from the top of the Upper Fort Wall to the approach road in downstream got damaged due to settlement. In 1983, a settlement was also observed in the rockfill slope at EL. 251.5 m. across Ch.246.9m

Following a continuous downpour for three consecutive days (112mm rainfall was recorded), a sinkhole was observed on 20.7.89 on the downstream toe of the dam in the right flank followed by another sinkhole on 23.7.89 in the form of a crater on the top of the embankment at Ch.253.0m. These sinkholes were of about 1.8m to 2.4m in diameter and 1.8m in depth. Even after refilling the settlements with earth and boulders, a sinkhole reappeared on 08.11.89 at the same location (Fig.4). This time, depth of sinkhole was about 2.7m. It was again refilled with earth and boulders. Another settlement was also observed on 23.5.90 at about 12m downstream from the dam axis across Ch. 254.5m. Thus repeated settlements/sinkholes have led to a great concern for the safety of the dam.

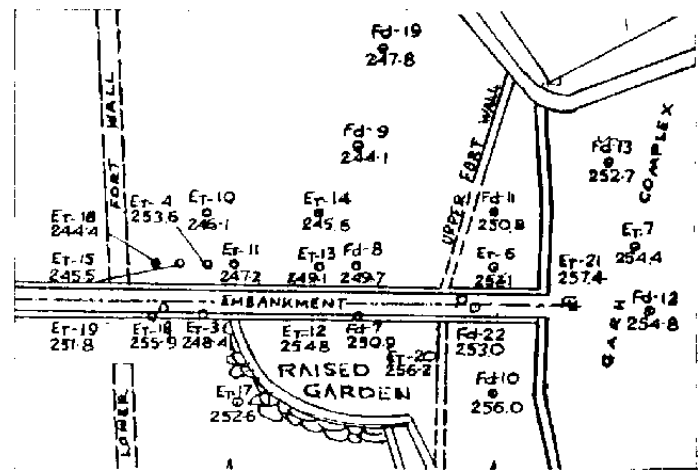
Fig. 5 Piezometer Water Levels on 29.03.96

Study of the piezometric levels revealed better effectiveness of the masonry cut-off wall than the existing clay-grout curtain. Water levels in the piezometers E<sub>1</sub>-18 and E<sub>1</sub>-4 (Fig. 5) were found to be much higher than those in the other piezometers in the same line. Both of these piezometers are located near the Lower Fort Wall. Possibility of hydro-fracturing at the contact of the interfaces of the wall with the embankment are also not unlikely and the same might have contributed to such higher piezometric levels. Similar phenomena were also observed in the vicinity of the Upper Fort Wall. These events confirmed the existence of the weak zones/lenses in the dam body which are directly connected to the reservoir. Again, incidences of sudden sinking of 3m deep sand filling inside a vertical Sand Drain at Ch. 249 m on 27.11.95 followed by another sinking of 0.7m on 28.11.98 in the same Drain contradicted against the soundness of the embankment body. Despite to these facts, seeping of water through the downstream toe of the embankment at Ch. 231m and Ch. 236m during injection of water inside the backfilling of the pit at sinkhole re-affirmed the existence of some paths which might have resulted in settlements/sinkholes due to ingress of rain water or otherwise flow of reservoir water through the dam body. Fig. 5 shows some piezometric water levels in the vicinity of sink hole at dam top.
