Geotechnical Aspect of Damage In Adapazari City During the 1999 Kocaeli, Turkey, Earthquake

GEOTECHNICAL ASPECT OF DAMAGE IN ADAPAZARI CITY DURING THE 1999 KOCAELI, TURKEY, EARTHQUAKE

This report summarizes detailed investigation on the structural damage and its geotechnical condition in the Adapazarı City, Turkey, during the 1999 Kocaeli earthquake by the reconnaissance team of the Japanese Geotechnical Society. Damages to individual buildings were investigated along several streets in the downtown area. A little rough investigation was made almost all downtown area, in which damages were classified by its cause, i.e., inertia force or soil liquefaction. These investigations as well as hearing investigation and areal investigation by means of helicopters made clear the area where there was an island a few hundred years ago by which the name of Adapazarı, i.e., ada (island) + pazary (market), came from. In addition, the damage in the Adapazarı City is shown to be strongly affected by the ground condition because damage caused by liquefaction was observed only outside the old island and areas where significant structural damage was observed were concentrated near the boundary betw

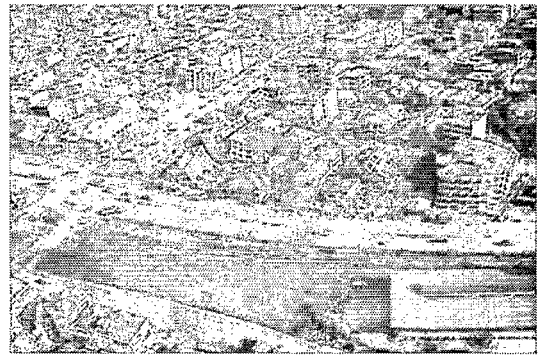
Looking at the damages in the investigated area, damage can be classified into two types. The first one is totally or partially collapsed building because of the failure of the column as typically shown in Fig. 7. These damages are supposed to be caused by inertia effect of the earthquake shaking, therefore will be referred to be an inertia type damage hereafter. Another type is tilt and/or settlement of the building as typically shown in Fig. 8. Soil liquefaction may be the predominant reason of this kind of damage, which will be referred as a liquefaction type damage hereafter. It is also noted that there are many

Fig. 7. Damage to buildings by inertial force.

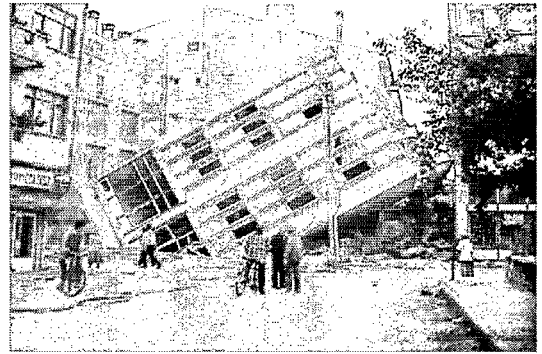
Fig. 8. Damage caused by soil liquefaction.

Liquefaction type damage was especially severe in the north of Cark Cadesi and east of Sakarya Cadesi. Wide cracks runs crossing the road damaging buildings on it as shown in Fig. 9 in the north of Cark Cadesi. A building tilted for more than 60 degrees as shown in Fig. 8. It is noted that tilt of this building was about 30 degrees on the day next to the earthquake and increases to present state taking for about 10 days. Settlement of the buildings was very large near this building. Sewage pipelines were going to replace in the Izmit Cadesi at the time of our visit, which indicates that ground deformation was significant in this area. These areas were supposed to be the old riverbed of the Sakarya River.

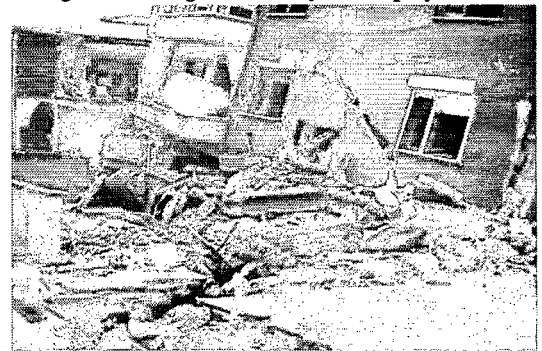
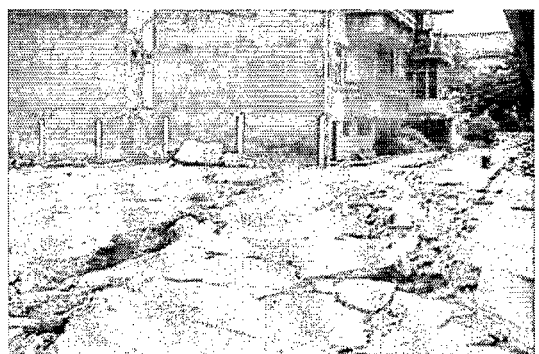
Fig. 9. Damage caused by large ground fissure

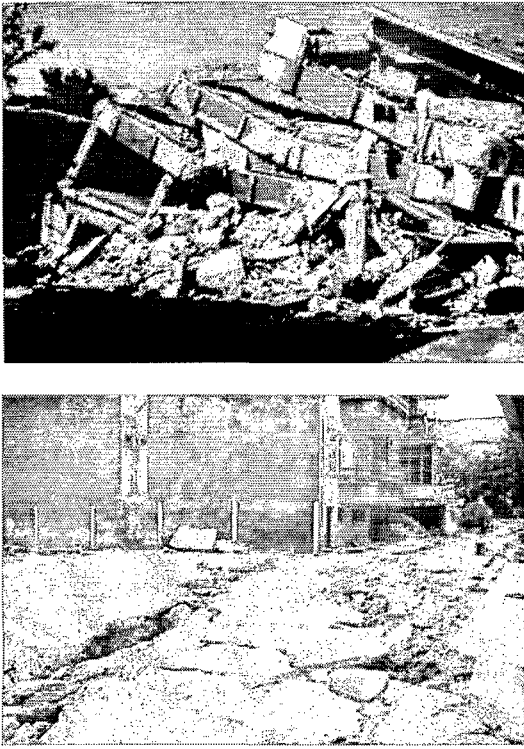
Fig. 10. Typical inertia type damage. Pancake crash (top) and soft first story collapse (bottom) damage.

Inertia type damage was frequently observed in the non-liquefied area. Fig. 10 as well as Fig. 7 shows typical damage of the inertia type damage. This types of damage was especially severe along the road running to the EW direction

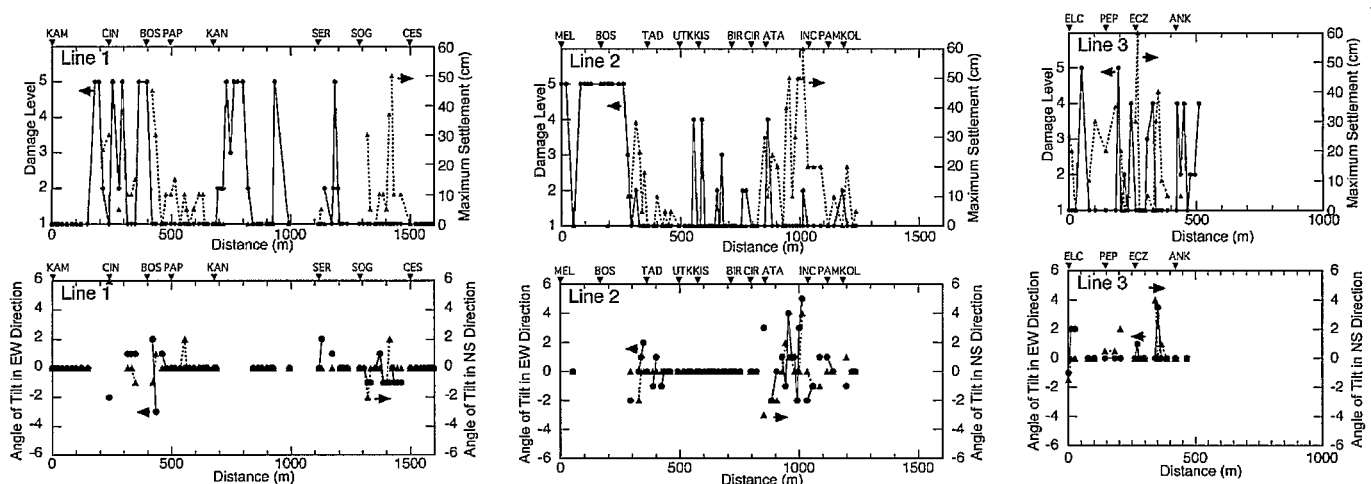
Figure 13 shows the result of damage investigation along three lines; damage level, maximum settlement and angles of tilt in the EW and NS directions are shown in terms of the distance from west or south end of each line.

No severe damage was found in the west end of Line 1 (Cark Cad.) for about 200 m. Damage suddenly becomes significant near Bosna Cad. where many 3 to 5 storied buildings were significantly damaged. There is strong contrast of damage

Fig. 13. Result of detailed damage investigation

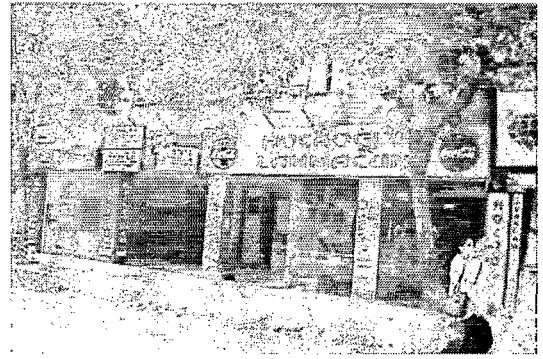
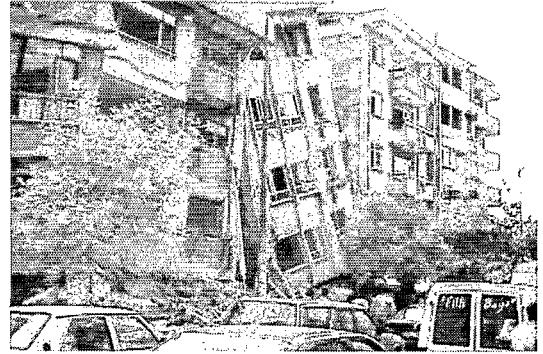
between both side of road from Bosna Cad. to KAN1 point. Buildings in the north of the road are severe liquefaction type damage, whereas buildings in the south of the road are severe inertia type damage as shown in Fig. 14. Structural damage was hardly observed from KAN1 to Line 3 crossing the Sakarya Cad. Buildings again suffered damage in the east of Line 3. The damage is liquefaction type damage without any structural damage. Structural damage was not observed in the east end of Line 1.

Fig. 14. Contrast of damage between the north side (top) and south side (bottom) of Cark Cadesi.

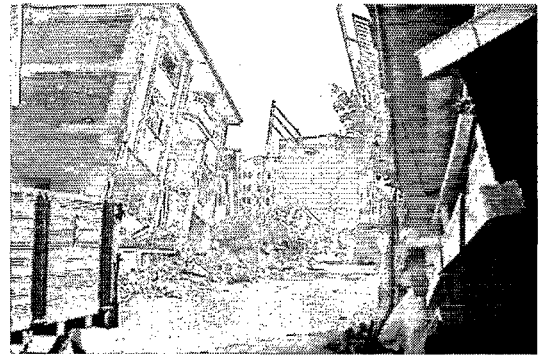
(Fabrika Cad.) was one of the severe one. Almost all buildings except one timber house were collapsed by first story failure or complete failure as can be seen in Fig. 7, where Fabrika Cad. runs horizontally, and 15, and is classified to be damage level 5. Damage, then, becomes moderate and liquefaction type damage comes to be seen; this area is classified as liquefied area. Small damages were observed from the east of the liquefied area to Sakarya Cad. Liquefaction type damage suddenly appears east of Sakarya Cad. Buildings with 4 to 6 stories were settled for 10 cm to 1 m. Center of the road and ground between two buildings was

Fig. 15. Damage to building on Fabrika Cad.

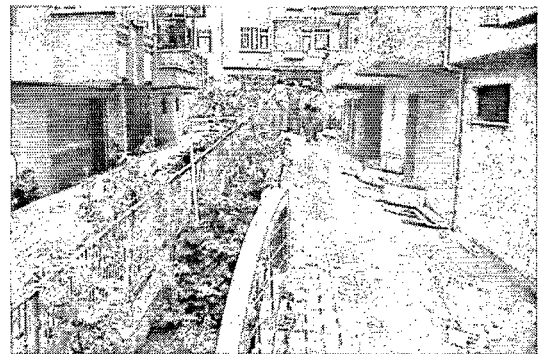
heaved up and ground cracks were frequently observed. Examples of damage in this area are shown in Figs. 8 and 16.

Fig. 16. Heaving between buildings
