Change of Waterline and Water Depth at Izmit Bay Due to 1999 Kocaeli Earthquake in Turkey

CHANGE OF WATERLINE AND WATER DEPTH AT IZMIT BAY DUE TO 1999 KOCAELI EARTHQUAKE IN TURKEY

ABSTRACT

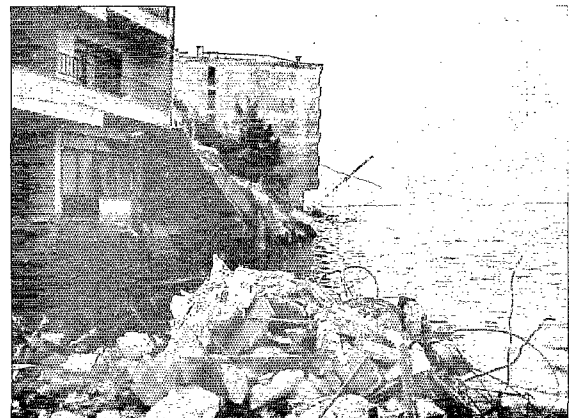
Photo 2. Slip away area in Halidere

Figure 5 shows location of land submergence in Halidere located on west of Degirmendere City. Part of nose of alluvial cone, about 200-250m long and 20m wide, was slipped away into the sea. According as slipped away area is mainly reclaimed land and the gradient of back ground is relatively small, collapse of reclaimed land seemed to affect to natural ground. Similar measurements of water depth were carried out in two cross sections in Halidere as indicated in Figure 5. The section 1 passed through the mouth of a small river across the

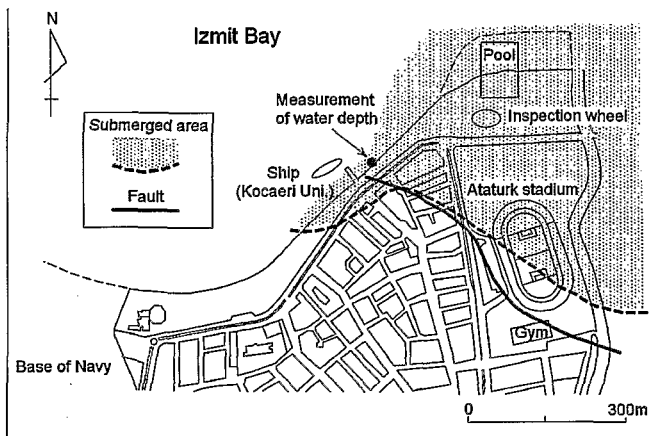
Fig. 7. Location of the fault and the submerged area

Figure 7 shows a schematic map of Kavakli district in Gölcük City. Traces of the fault was observed on the ground at several sites in this district, whose direction is roughly shown in the same figure. The fault line passed through the road along the west of football stadium. The vertical offset amounted to about

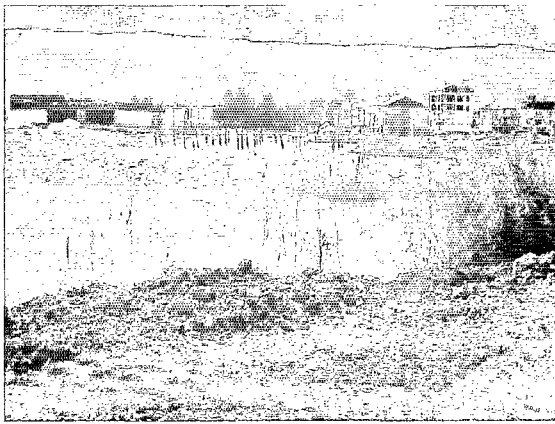
Photo 4. Submerged area in Kawakli

There was a Ford Gölcük automotive factory south east of Kavakli district and the fault reached to at least this factory and submerged area was spread far east from here as shown in Photo 4. Several damages such as cut-off of the buried pipes under the road and heavy destruction of the mosque standing on the fault due to the ground deformation directory induced by the fault movement were found.

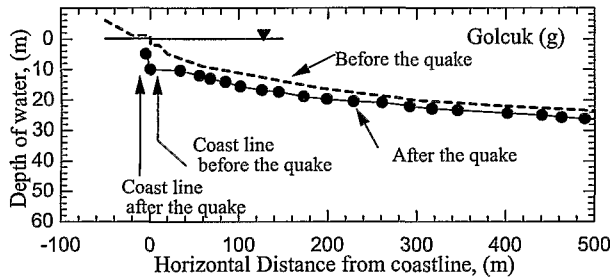
Fig. 9. Result of Measurement of water depth (Golcuk)

Measurement of water depth was carried out along the cross section toward offshore in this district. Although water depth becomes steep just in front of the shoreline, it may be seen to subside beneath except these as shown in Figure 9. Amount of the change of water depth was only 3m-4m. Shape of the seabed after the earthquake could not be seen like submarine slide, and inclination of seabed toward offshore keep tendency before the earthquake. The cause of which the coastland disappeared and the seabed settled down after the earthquake is different from the cause in another sites mentioned previously.

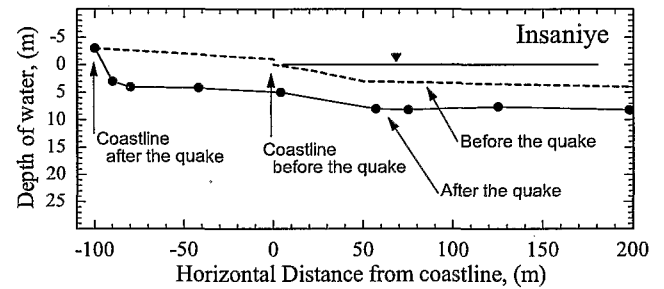
Fig. 10. Result of Measurement of water depth (Yenikoy)

electric pole, fences and houses were subsided almost straight up to several meters. Parallel cracks toward the sea could also be observed. Water depth measurement was also carried out in Yenikoy. The result shows in Figure 10. The depth of the water after the earthquake is constant within 5m-8m in depth. Judgment from the shape of seabed, sliding does not seem to be the cause of the subsidence.

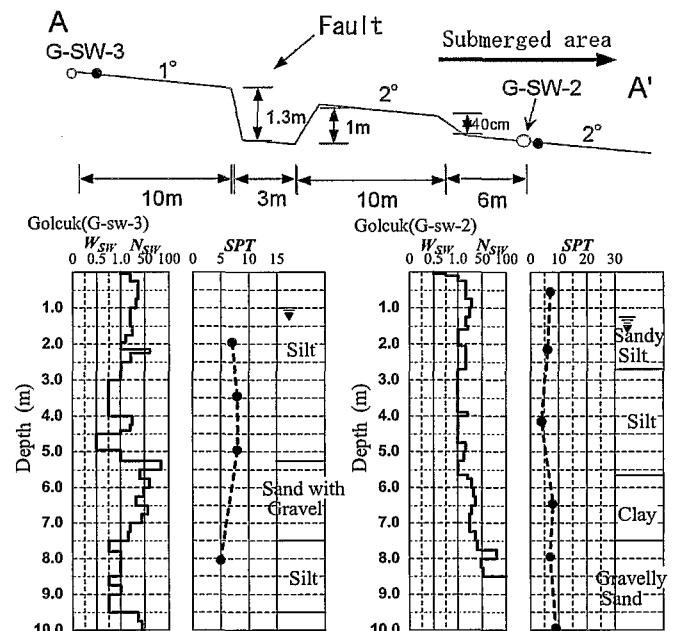
Fig. 11. Result of in-situ tests and Soil Profile in Yenikoy

Swedish cone penetration (Swedish Sounding) test and standard penetration test (SPT) were conducted for soil survey in order to clarify the cause of land loss along two sites stepped over the fault. The schematic drawings of the site and the sounding log from the tests are shown in Figure 11. Loose silt was deposited up to 10m in depth from the surface, and gravely sand was interstratified between silty layers. There is no significant difference soil profile between upper and lower sites. Therefore, the change of soil profile does not seem to cause to the subsidence, but fault movement caused to it directly. The existence of the soil layer indicates the possibility of the occurrence of soil liquefaction during the earthquake. It is however not sufficient to consider only volumetric change in sand layer due to soil liquefaction in order to explain the observed subsidence. Considering to the amount of subsidence from the water depth measurement, it seem to be that compressive volume change was taken place due to development of pore water pressure in silty layers during the earthquake. It is no doubt that the slip plane with soil liquefaction in interstratified sand layer, promoted the ground deformation.

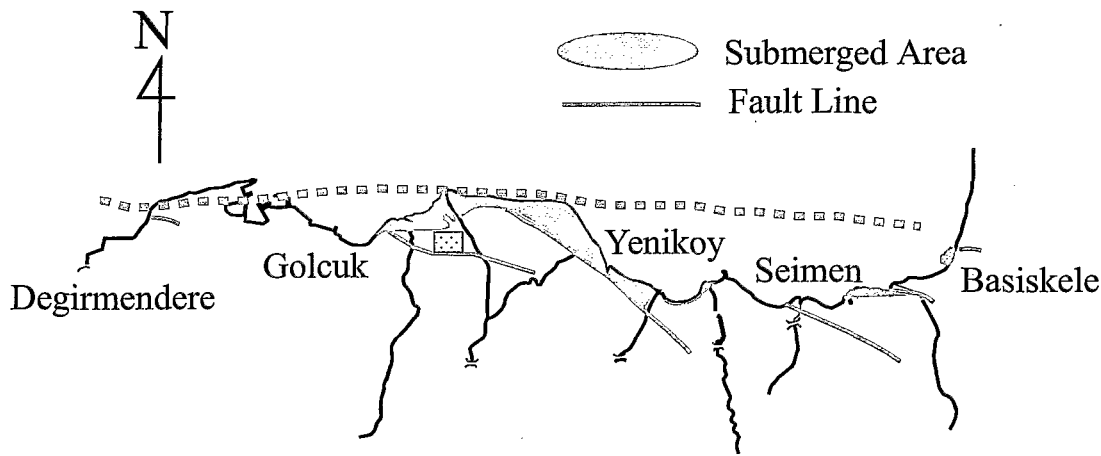
Fig.12. Location of submerged area of the south of Izmit Bay

The schematic drawing of the submerged area during Kocaeli Earthquake, which was inspected in this survey, is shown in Figure 12. It can be seen that large-scale submergence and subsidence were occurred in many places. From this figure, the terrain, which was surrounded between main- and sub-fault, was mainly subsided. Especially, submerged area concentrate to the coastland around river mouse and/or top of triangular of alluvial cone.
