## Damage to Water Supply System and Surface Rupture Due to Fault Movement during the 1999 Ji-Ji Earthquake in Taiwan

# DAMAGE TO WATER SUPPLY SYSTEM AND SURFACE RUPTURE DUE TO FAULT MOVEMENT DURING THE 1999 JI-JI EARTHQUAKE IN TAIWAN

## ABSTRACT

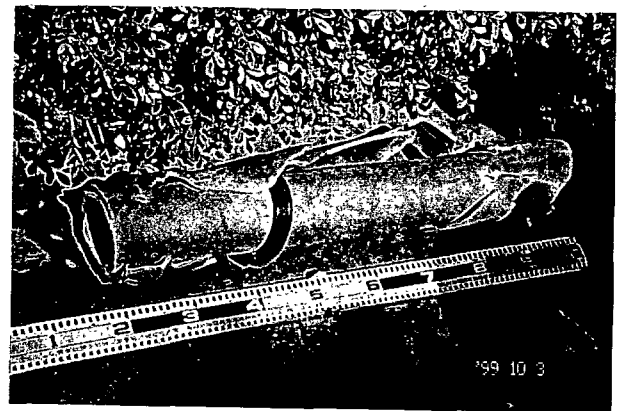
Photo. 3 indicates the damage to water conveyance steel pipe with 2000mm of diameter which was buried cross the fault line. Photo. 4 shows push in each distribution PVC pipe at joints. The displacement was about 80cm. These damages suggest that the ground displacement induced by fault movement was remarkable at the areas close to the fault.

*Photo. 4* Push in each distribution pipe (Vinyl pipe) at joint.

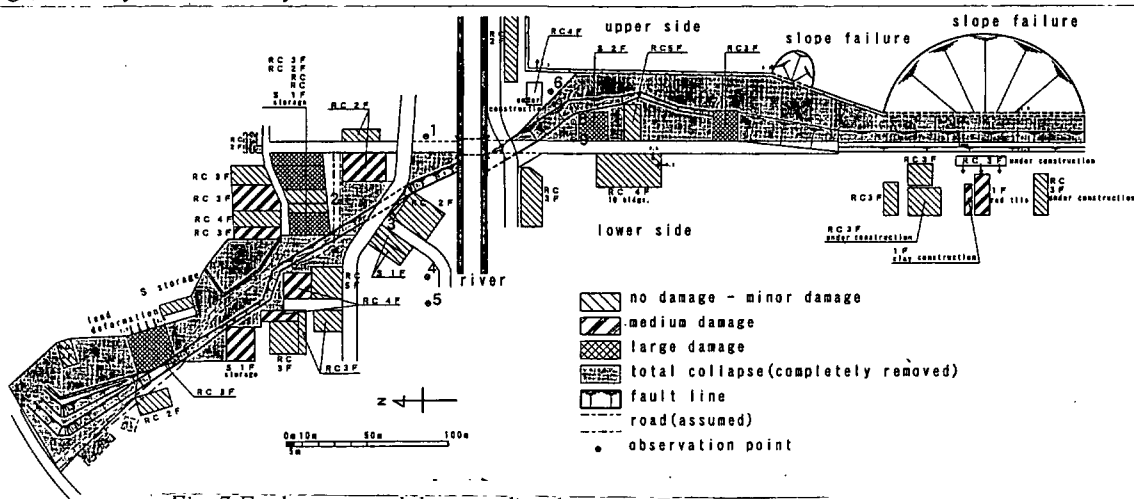
Due to hard soil in Fonyuan city area, steep deformations of 4-5m were observed as shown in Fig. 7. Further, building damage in the lower side of the heaved fault scarp was minimal, whereas the same in the upper side was found severe, with diminishing pattern as far away from the fault scarp.

Fig. 7 Fault scarp and damage distribution in Fonyuan area.

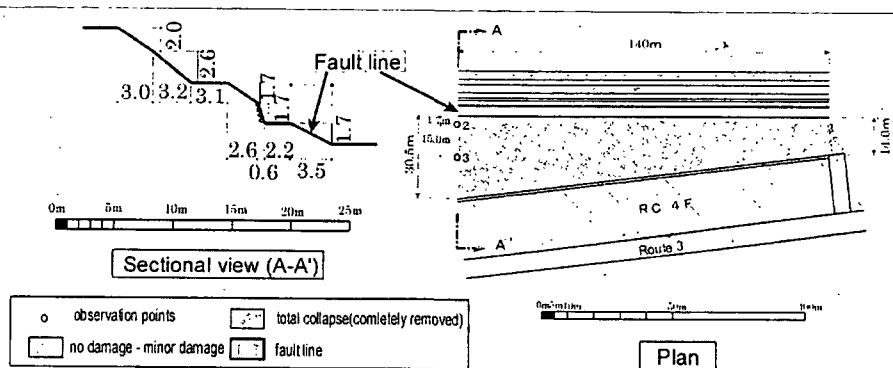
This area between the present slope and State Route 3, consists of slope footage that heaved about 2 m, and though damage was limited to upper side of this upheaval, basically no damage was seen in most locations of lower side. However, there were certain locations of soft soil that lower side too moved with the upper one causing damage to buildings therein.

Fig. 8 Fault scarp and damage distribution close to slope in Chaotuen area.

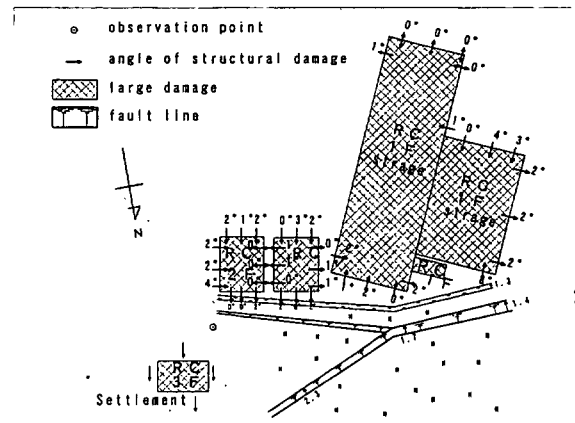
In the area of the paddy field located east of State Route 3 due to the existence of soft soil, curvy deformations in small magnitude were observed. Further, fault branches of extended into the paddy field have caused damage in an area, rather than a linear one. Damage at distances of 50 and 90 m away from the fault was similar, with inclined buildings, while those areas sandwiched by two fault lines showed ground settlement of around 1.0m causing severely inclined buildings.

Fig. 9 Fault scarp and damage distribution at paddy field in Chaotuen area.

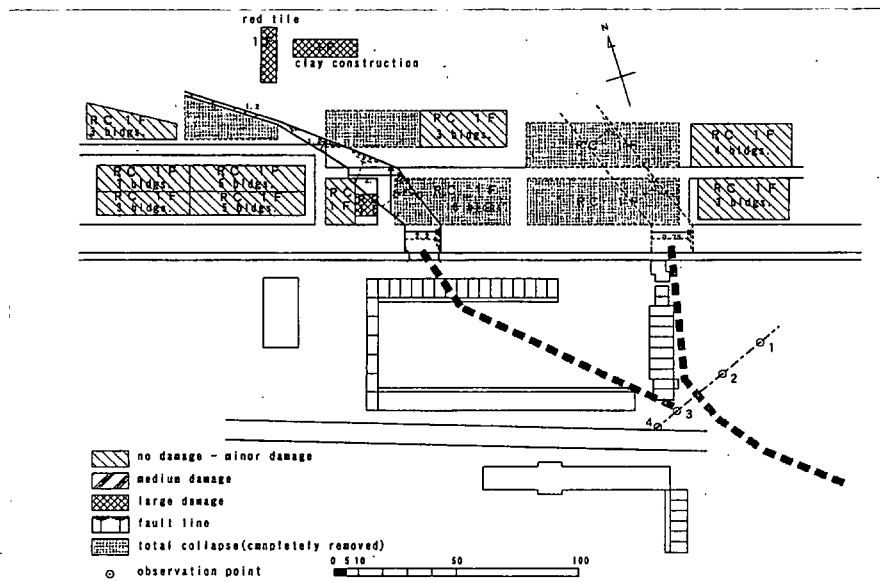
In this area, Architectural Institute of Japan has already conducted a damage survey on a location near a school, as shown in Fig. 10. Continuing on this, the present conducted survey on the north part of the school. It was revealed that deformations of 2-3 m were presented at zones encompassed by two branches of faults and building damages therein were severe.

Fig. 10 Fault scarp and damage distribution in Wufong area.
