DAMAGE FROM COLLAPSED BACKFILL ROCK AND SOILS BEHIND RETAINING WALLS CAUSED BY EARTHQUAKE SHAKING

Chester A. Carville, P.E.
Carville Engineering & Construction
Cardiff-by-the-Sea, CA 92007

ABSTRACT

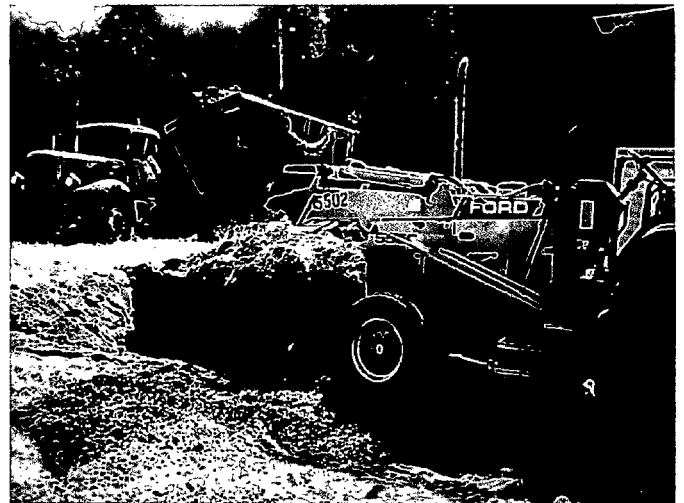
Fig. 2 – Crushed Rock Dumped into Test Trench

Crushed rock was then dumped directly on the pipe from a height of up to ten feet with a half yard bucket and brought to a

level of three to four foot above the pipe. A 10 ton tractor was then used to compact the gravel at the three to four foot level and to bring the gravel up to the six to seven foot level (Fig. 2).
