China Earthquake Reconnaissance Report: Performance of Transportation Structures during the May 12, 2008, M7.9 Wenchuan Earthquake

PUBLICATION NO. FHWA-HRT-11-029

OCTOBER 2011

U.S. Department of Transportation
Federal Highway Administration

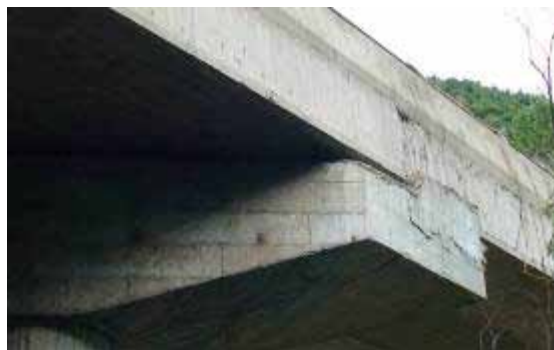
Figure 31. Photo. Damage in Shear Key.

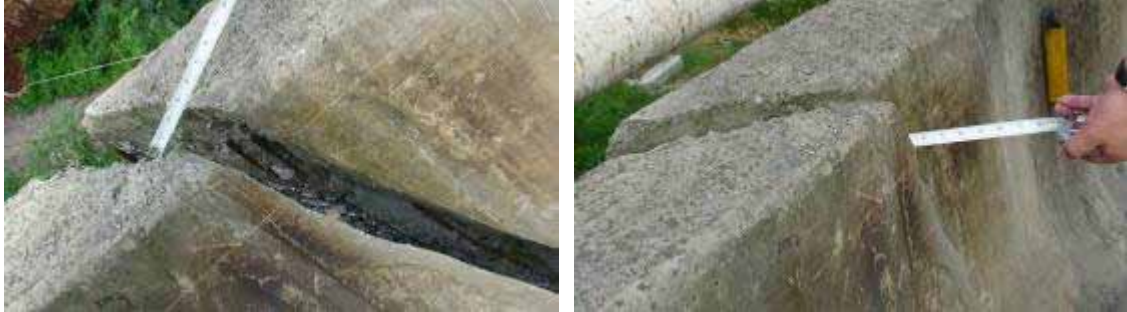
Figure 32. Photo. Measurement of Expansion Joint Offset.

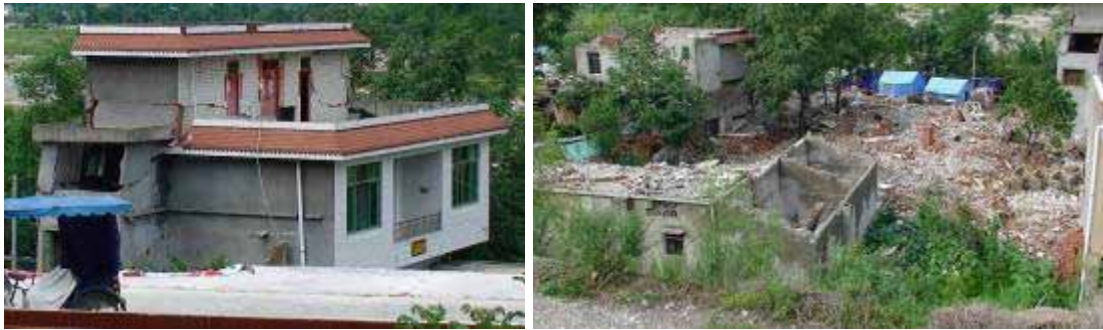
Figure 33. Photo. Building Damage in Nearby Town.

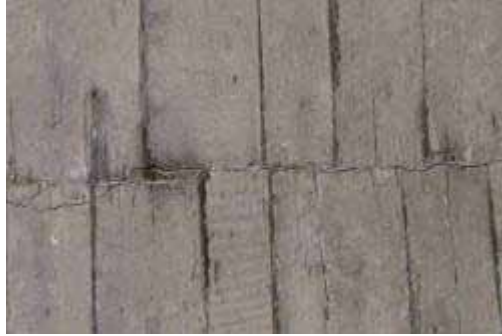
Figure 39. Photo. Transverse Crack at the Crown of Secondary Arch.

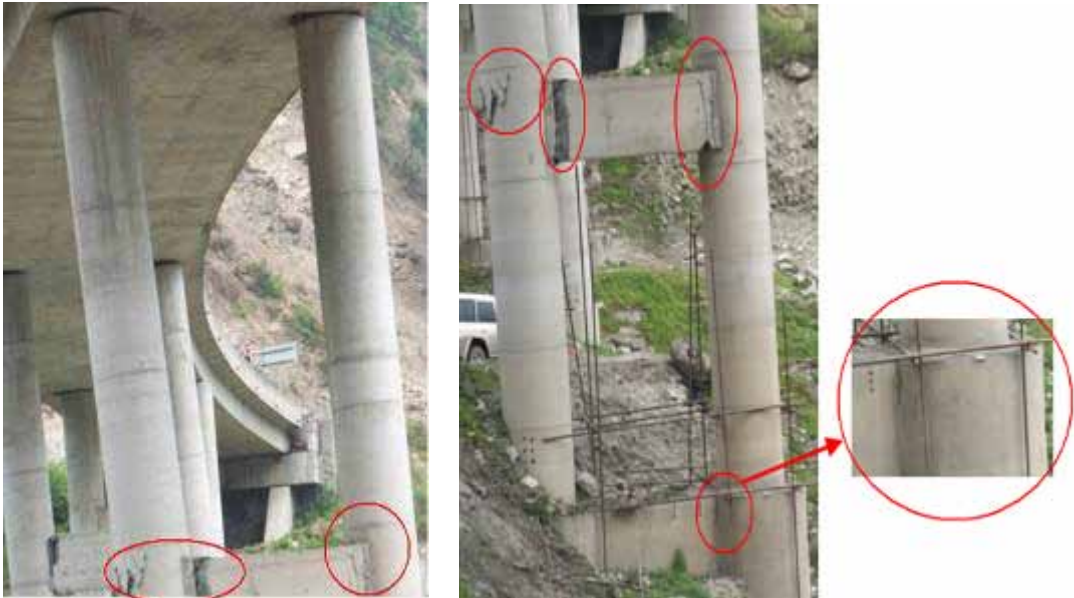
Figure 65. Photo. Damage at Bent 3.
