Damage of a Broadcasting Station Due to Shrinkage of Soil

SYNOPSIS This paper discusses the causes of damage of a broadcasting transmission station suffered from settlement cracks. The station buildings were low-rise reinforced concrete structures with isolated footings founded on alluvial deposit. Investigations revealed that the main causes of the observed nonuniform settlement were the existence of silt pockets below some footings, and the shrinkage of clayey soils due to dryness of the subsoil after ceasing the cultivation of land and using it as construction site. Rehabilitation scheme included structural repair of the cracked columns, beams and walls, and injection grouting of the foundation soil beneath the settled columns.

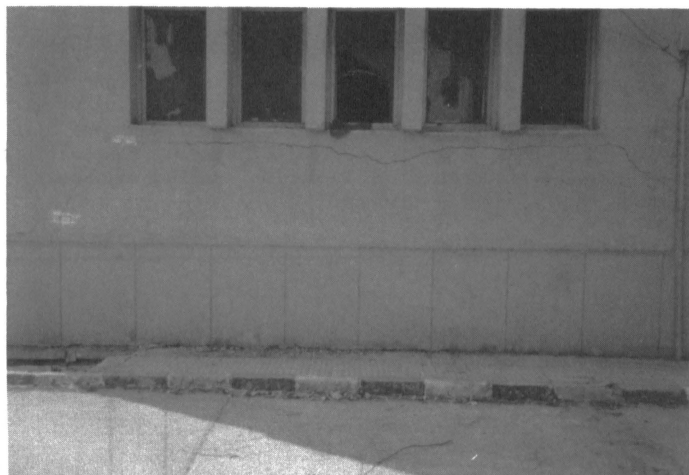
Fig. 2. Horizontal Crack in the Facade

During inspection of the buildings, it was noticed that there were numerous wide cracks in the brick walls as shown in Figures 2 and 3. There were also vertical and inclined cracks in two corner columns. Noticeable cracks were found in some grade beams. Floors were deformed and settled inside the station.

It was obvious that the station buildings were subjected to differential settlement which caused these damaging cracks. The laboratory investigation disclosed that the settlement was not due to compressibility of clayey soils, but it was a result of the desiccation of the top clay layer located above the water table and the unequal settlement due to the compression of the weak silt pocket below some footings.

2. Establishing several measurement points at crack location on walls and columns to detect further movement or settlement as shown in Figure 7.
3. After ceasing of differential movement, the silt pockets beneath the cracked columns could be injected by cement grout to increase the bearing capacity at these spots.

4. Increasing the size and the reinforcement of footings located on the silt pockets to reduce the foundation pressure to less than 0.5 kg/cm^2 . jacketing the cracked columns. Retieing the repaired columns and footings with new rigid grade beams at the foundation level. Refilling of the soil surrounding the footings with well-graded, well-compacted sand up to the level of the ground floor.

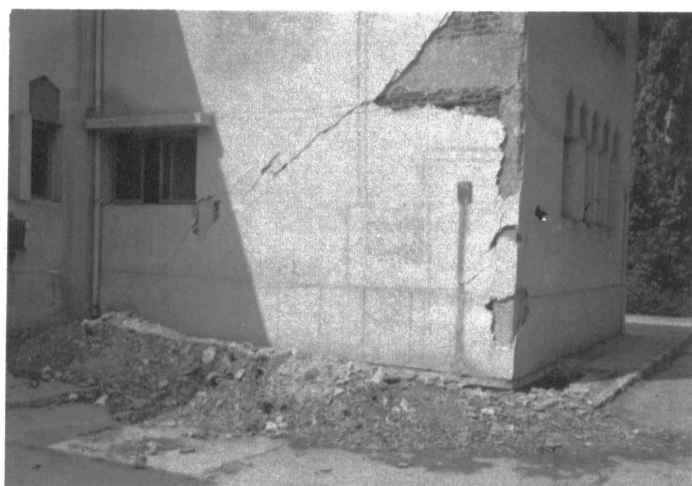
Fig. 3. Inclined Cracks in Walls

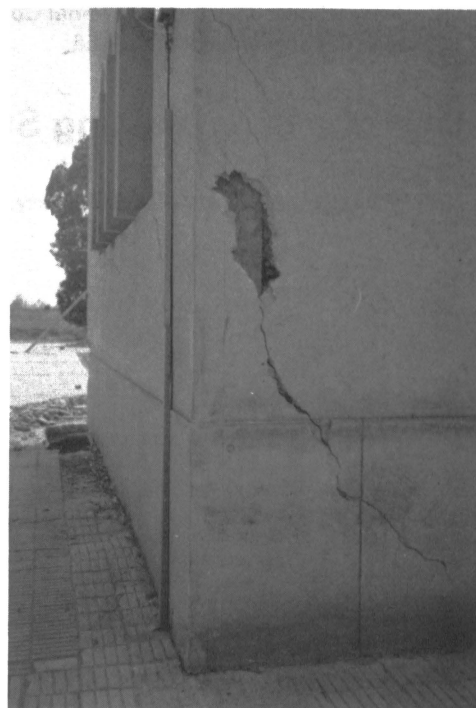
Fig. 4. Cracks in Columns and Walls

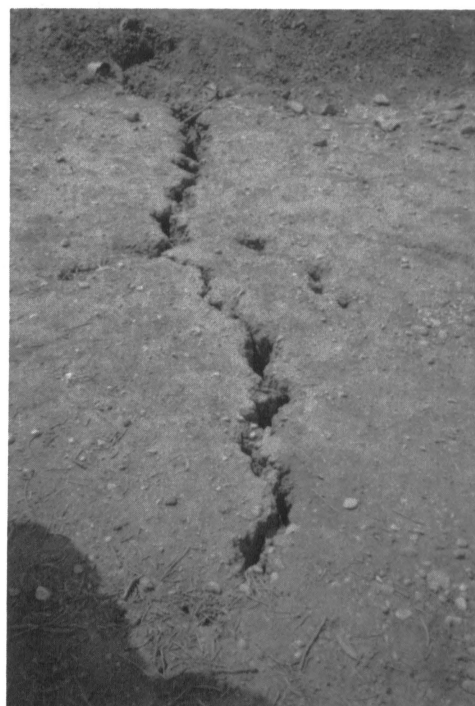
Fig. 5. Shrinkage Cracks on the Ground Surface

Many wide shrinkage cracks were clearly observed on the ground surface in the area surrounding the station buildings. The depression passing through the site in the vicinity of the building was completely dry.

In general, changing the function of this area from a cultivated land to a construction site stopped the irrigation process for many years and resulted in lowering of water table and desiccation of the top clayey soil. This desiccation was not in equal rate or distribution below the covered area of the building. The behaviour of the silt pocket upon drying and its weak bearing characteristics have worsened the problem and magnified the unequal settlement.

5. It was also recommended to build a wide, water-tight, side-walk, surrounding the buildings, and sloped outward to direct any surface water away from the soil beneath them.

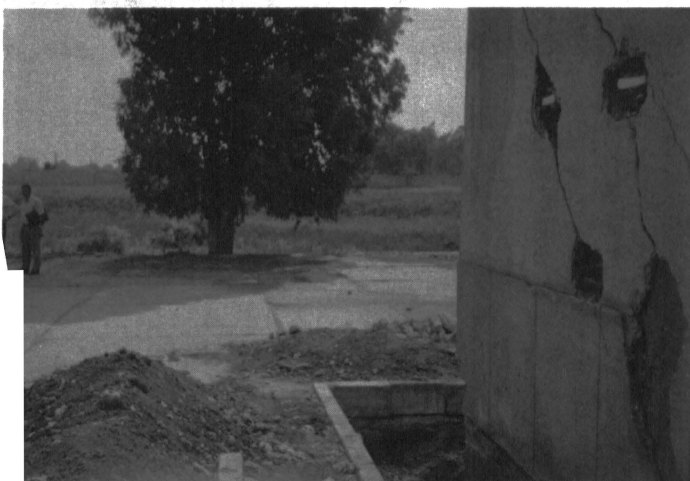
Fig. 7. Measurement Points on Cracked Walls
