Damages to a Five-Storied Building Founded Over Peat Layer

Damages to a Five-Storeyed Building Founded Over Peat Layer

SYNOPSIS In the paper is presented a history of the long-term process of deformations and damages to a five-storeyed apartment building in Gliwice, one located over a thick lens of a young, very weak peat deposit. The evolution of deformations is defined by changes in time of representative foundation movement components (the angular distortion, deflection ratio, etc). Relationships given and analysed in the paper are based on the results of settlement monitoring performed since 1970, and failure escalation descriptions make use of crack documentations included in the expert opinions. The case history also comprises not quite efficient attempts of object protection. The description is completed by data concerning the building structure and soil conditions. In conclusion an idea for ground stabilization is recommended by the authors.

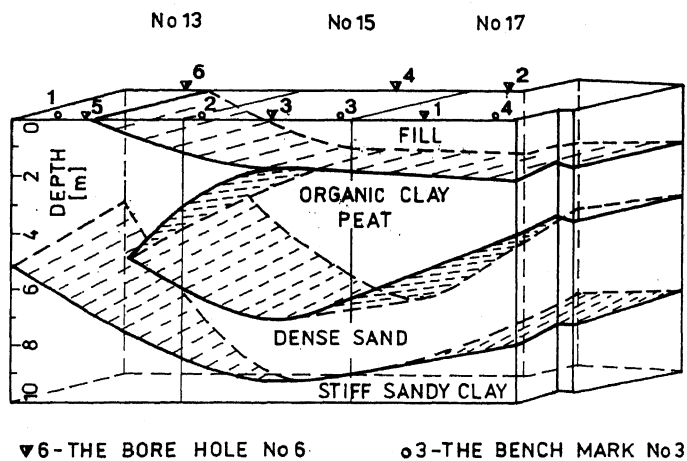
Fig.2. Block-diagram of the building subsoil

As can be seen, the geometry of the weak organic layer is extremely unfavourable from the foundation engineering point view. Its maximal thickness falls beneath a central part of the structure (in the area of expansion joint). Moreover, in this part, the top surface of organic lens is situated on the minimal

depth. Towards both gable ends of the building this surface lowers and the thickness of lens rapidly decreases. Under an external part of the segment No.13 organic soils do not occur at all. It is quite evident that a such layering favours differential settlements which are far larger beneath the central area of the building than under its ends.

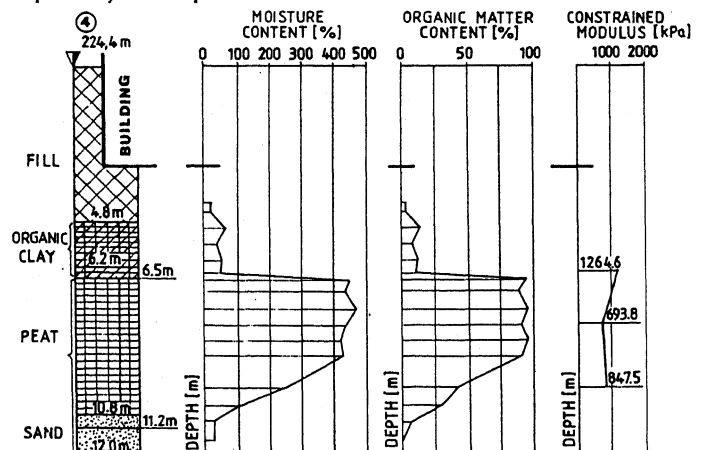
Fig.3. Variations of organic soil engineering properties with depth, a) organic matter content, b) moisture content, c) constrained modulus

The organic soil lens is non-homogeneous. Soil, in the top part 1.7m thick, has been identified to be organic clay. Some of its engineering properties have been evaluated on the basis of the authors' laboratory tests, and are as follows: average organic matter content - 10.4%, analogical moisture content - 52.2%, and constrained modulus - 1260 kPa. Organic soil occurring in the sublayer 4.3m thick is a very soft and weak peat characterized by the following average engineering properties: organic matter content - 93%, moisture content - 370%, and constrained modulus - 540 kPa. Fig.3 shows variations of the above features with depth. As can be seen, peat appears to be quite homogeneous. The organic matter content is particularly high, which is a distinct sign of an unusually low bearing capacity for peat.

There is no doubt but that the building failure and destruction process is a consequence of applying shallow foundations over the organic soil lens, as describing above. Its particularly unfavourable geometry (the shape and situation) as well as an immense deformability and strain ageing of peat are responsible for the scale of failure.

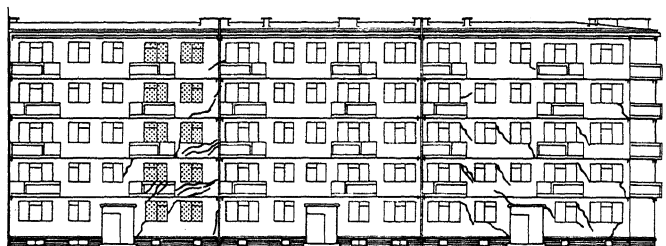
Fig.4. State of the front wall cracks till the general renovation and applied protections

In these circumstances, the ultimate limit state in structural elements of the building was inevitable. Indeed, severe damages to the structure appeared almost at the beginning of the construction stage and increased together with the growth of differential settlement. In 1968 the structure condition, in the segment No.13 proved to be catastrophic, particularly in the zone comprising the staircase and apartments adjoining to the segment No.15. All interwindow pillars suffered cracks through walls, running obliquely from one window to another. Their widths reached 25 mm. At the same time, the basement walls and the beams crowning floors of lower storeys were tearing apart and the walls of the top floor storey suffered crushing. All these failures indicated that the total collapse of the structure happened in a zone of the staircase of segment No.13. Some cracks of walls also occurred in another part of the building. However, these were local and of little importance.

Finally, the general renovation performed in 1976-1978 years comprised the following reconstructions and repairs (Fig.4):

- the additional division of the building by the expansion joint between segments No.13 and No.15, including the foundation,
- excluding from use all apartments in the segment No.13 adjoining the new expansion joint,
- over-stiffening to the structure in the zone of these apartments by bricking up all windows and doors,
- prestressing all longitudinal and transverse walls of the building with horizontal anchoring rods of the diameter of 25 mm, performed on the levels of all floors and the roof,
- levelling floors, spraying cracks with cement grout, repairing doors and windows.

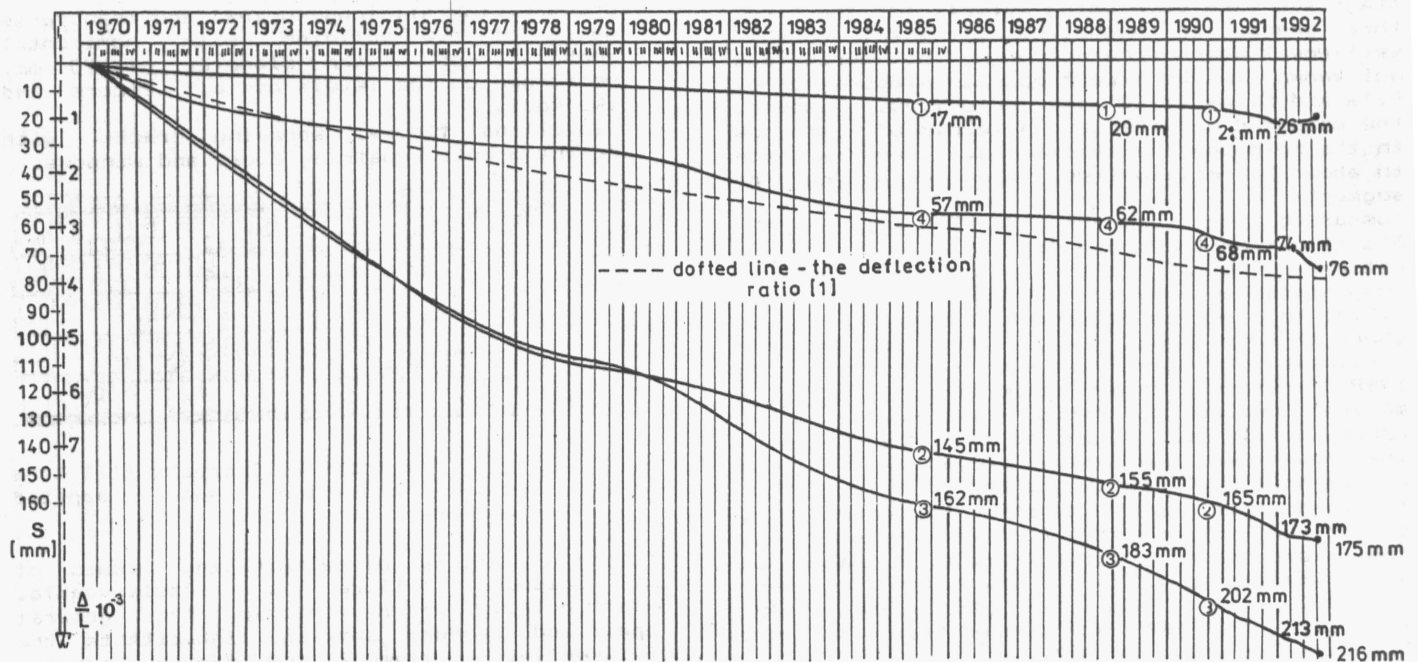
Fig.5. Results of monitoring of settlement process of the front wall

Unfortunately, this rather optimistic forecast has not come true. As can be seen in Fig.6, after the period of stabilizing tendency till 1985, the settlement rate began increasing and this trend continues to date.

belongings. The analysis of diagram in Fig.5 (dotted line), presenting changes in time of the maximal deflection ratio, points to progressive characteristic of this dependency. This is the effect of volume strains in peat following the process of biodegradation of organic matter. The process is far from ending, and even a small increase of deflection can cause a disaster. An immediate intervention comprising the structure strengthening and subsoil stabilization is necessary.

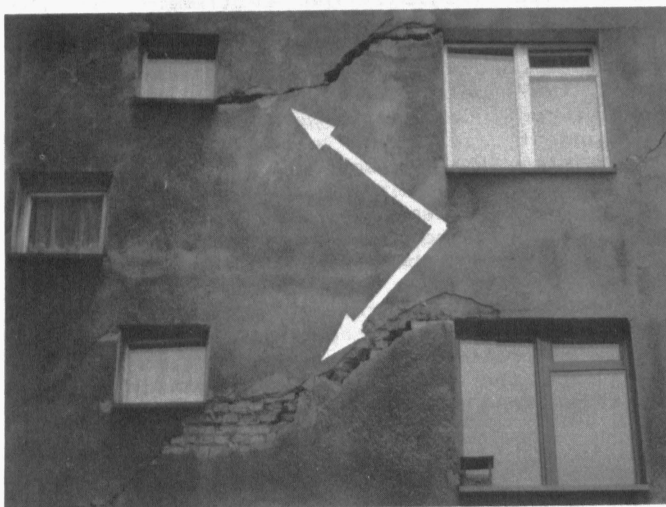
This is reflected in the current state of the damages to the segment No.17. A network of oblique cracks comprises the majority of interwindow pillars of the front (Fig.7) and back walls, and also a part of the transverse ones. These are wide, continuous fissures (Fig.6) running through brickworks. The direct cause of cracks in the longitudinal walls of the segment No.17 are their angular distortions. They are induced by the passive pressure of the walls of the segment No.15 transmitted through the compressed expansion joint. This is the response to the differential settlement of the No.17 one. The present state of building structure is a source of serious threat for people and their

Fig.6. Crack in the back wall

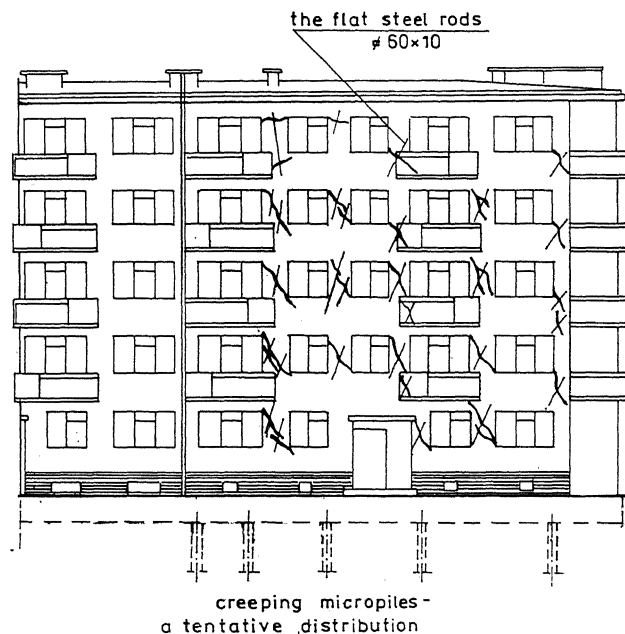
Fig.7. Distribution of the present cracks in the front wall and the applied protection means

Last year the authors undertook an attempt of saving the building in the above range (Gryczmański and Sękowski, 1991). Its general strategy is outlined in Fig.7. This is composed of reinforcing weakened wall areas with flat

steel rods situated across cracks, and of stiffening soft subsoil with the help of micropiles.

First of the proposed protection means has been designed by Gryczmański (1992). It is worth enlarging the information contained in Fig.7 by some details. The flat steel rods 60 mm wide, 10 mm thick and of various length are to be placed in special grooves hewn out on both sides of the given wall. The rods are to be inserted into grooves so that their width are perpendicular to the facades.

The micropiles are being just designed in detail. Therefore, Fig.7 only shows their tentative distribution and lengths. At any rate, these are the s.c. creeping micropiles which are conceived to be interacting with fill and organic soils. They are assumed to carry only a part of the subsoil loads following from their relative stiffness, as compared with that for surrounding soil. Their application will cause a significant general stiffening of subsoil and a favourable stress distribution (a relaxation of effective stress in peat). Selecting the suitable number, distribution and lengths of micropiles one can reduce further increase of settlement to a small magnitude not dangerous for the reinforced structure of the segment No.17. The detailed solution will be presented in an other paper after some time of building use, when further settlement monitoring results will be available, evaluating the efficiency of subsoil stabilization.
