Failure of Buildings Founded on Fills

Failure of Buildings Founded On Fills

CASE-1: FAILURE OF A DOUBLE STOREY BLOCK OF FLATS

CASE II: FAILURE OF SEVERAL FOUR STOREY BLOCKS OF HOUSES

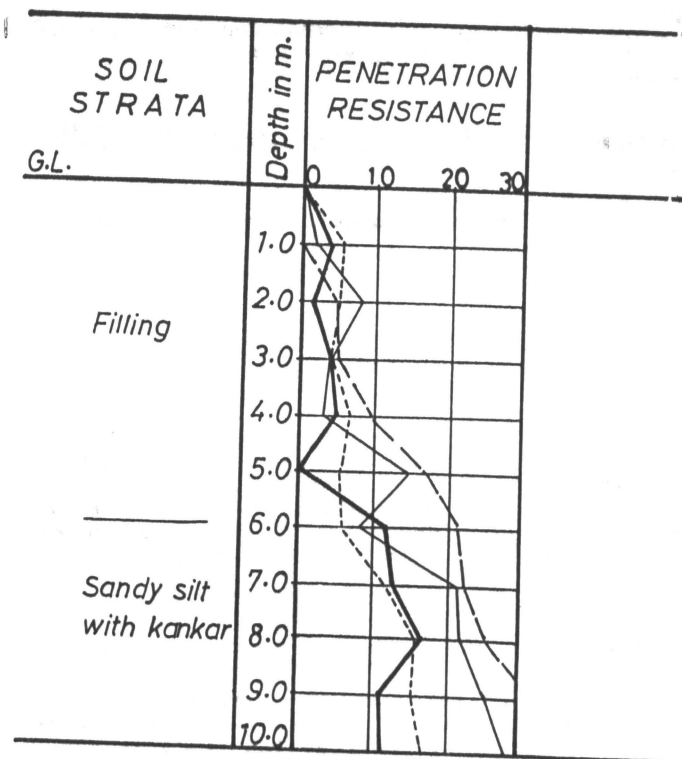
FIG.3. CASE I: VARIATION OF SPT & CPT.

The soil at this site is loose silty sand (SM-ML) with N-values less than 4 upto 7.0 m depth; followed by medium-dense sandy-silt with $N > 10$. (Fig.3) In one borehole at 5.0 m depth, the sampler penetrated the full length under its own weight. Ground water table was not met with upto the depth of excavation.

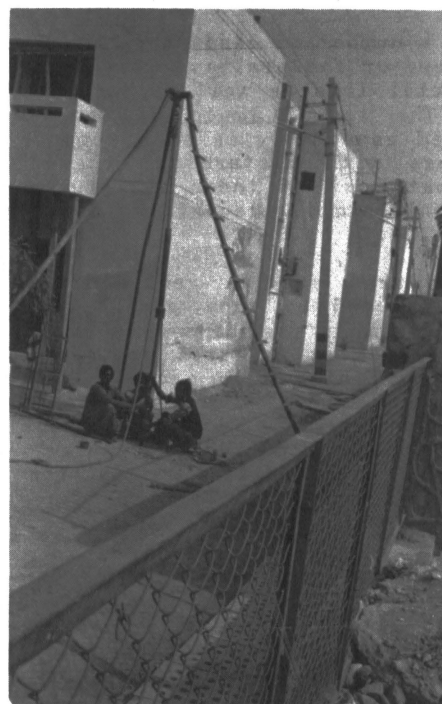
Fig 2 : Cracking on Walls - Case I

after their construction several blocks suffered cracks especially in the load bearing walls. In one particular block, cracking progressed rapidly and cracks as wide as 8.0 mm, appeared on the external as well as internal partition walls. Extensive damage has since occurred. (Fig.2).

Foundations of the failed blocks are located at 1.5 m depth whereas soil is loose and very weak upto a depth of at least 7.0 m at this location. Comparison with the original contour map of this location revealed that some of the blocks are standing on a filling. Uneven features with many depressions and a deep ravine existed at this site before the filling and levelling operations were carried out.

Several remedial measures were considered eg soil stabilisation, jacking up the walls, or providing piles. (C.B.R.I: 1980 Bureau of Indian Standards, 1985; Chand, 1979) But in each case the estimate of cost of providing the remedy was prohibitive. There is, therefore, no alternative but to demolish such blocks.

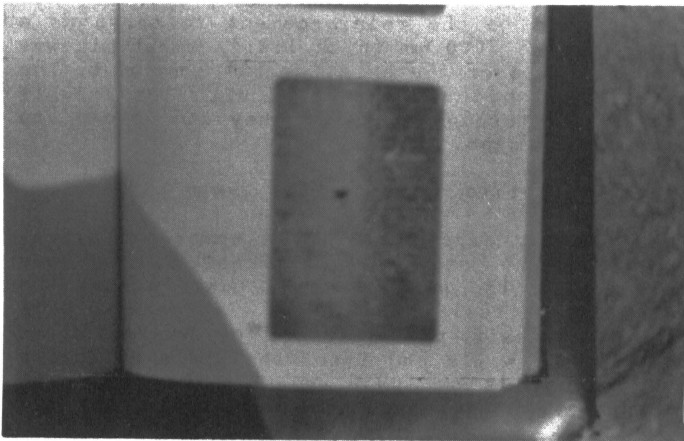
Fig : 4 : Cracks on Outer Walls - Case II

- i) Outer load bearing walls, (23.0 cm thick) suffered extensive cracking due to sinking. Tilting of walls resulted in their getting out of plumb. At several locations there was differential settlement as well. (Fig.4).
- ii) Interior partition walls, 11.5 cm thick, suffered cracking in most cases, and substantial sinking in some cases.
- iii) Beams on various floors sagged.
- iv) Cracking occurred in the slabs at most of the junctions. There was excessive sagging (3.0 to 4.0 mm) at the center of many slabs. Lintels also showed shear cracks.
- v) Staircases separated from the main walls and the gap increased with height.

Enquiries revealed that a brick kiln existed at this site. The kiln was demolished and the area filled up with earth without proper compaction. The contractor who also happened to be the designer as well, started construction without proper site investigation. The result was that wherever the foundations happened to be on the hard kiln foundation, no distress was observed. But in places where foundations of houses came to rest on filled up area, it suffered extensive settlements manifesting distress noted above.
