Foundation Strengthening and Protective Measures for Sri Sangameshwar Temple at Kudal Sangam, Karnataka

Devendra Sharma
Central Building Research Institute, Roorkee, India

SYNOPSIS : Sri Sangameshwara temple situated at the confluence of two rivers developed noticeable tilt. Also the temple site be inundated by the back waters of the dam during floods. An elaborate plan of dismantling the temple and reconstructing it by the same stone pieces and statuary could be carried through partially only and the sanctum sanctorum portion housing the 'Lingam' had to be retained. Now the entire temple is to be reconstructed as and where it was. The temple was founded on a boulder platform with heterogeneous river deposits below it. Honouring the constraints of uninterrupted daily worship rituals in the temple and the underside of the pedestal supporting 'Lingam' not to be disturbed, strengthening by providing a double row of piles around the existing structure and a protective wall around the site were recommended. The choice and design aspects of these measures are discussed.

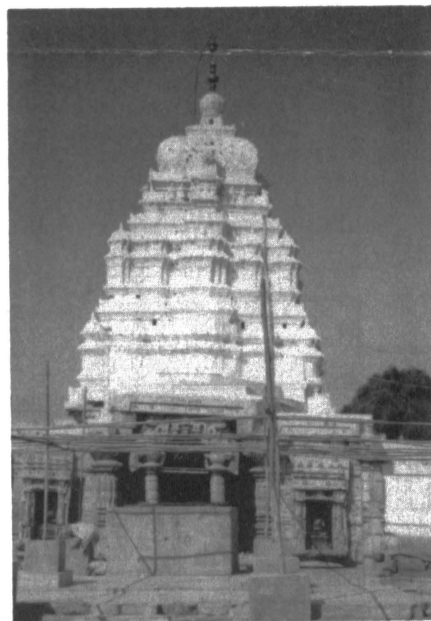
FIG.2 Front view of the temple

The differential settlement at the base and tilt towards north of the temple are noticeable (Fig.2) on viewing from east and west. The

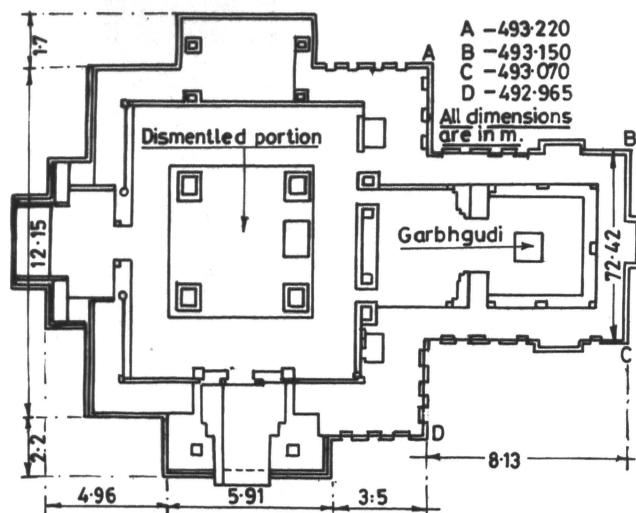
FIG.4 Temple plan

levels on the four corners of the existing structure taken in 1987 (Report, 1987) are shown in fig.4 and these showed no change during the period of three years upto 1990. The tilt of the back side between B and C towards north is 1 in 84 and between A and D is 1 in 51. The tilts show that there is tilt towards east also. The difference of levels between points B and C is 0.08m. As the temple is with massive walls with tapering top with a series of corbels, the entire structure may be considered to tilt by the same amount as its base. The overall tilt and general ground slope are in the same direction i.e. the north/north east.

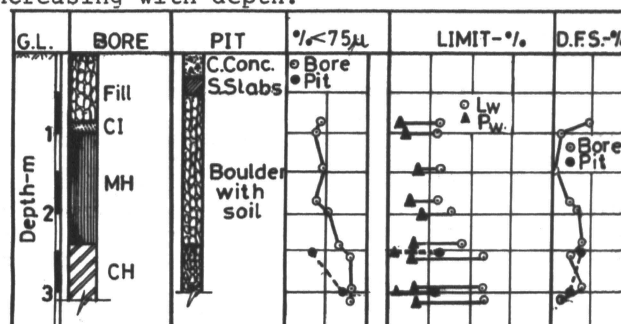
FIG.5 Bore log and pit data

The borehole made by augering and a pit dug at the site (Fig.1) showed strata as given in Fig.5. There is a trend of increasing finer fractions, higher liquid limits and swelling with depth. The lower strata soils in borehole and the soil in the interspaces of the boulders below the temple are of compressibility increasing with depth.

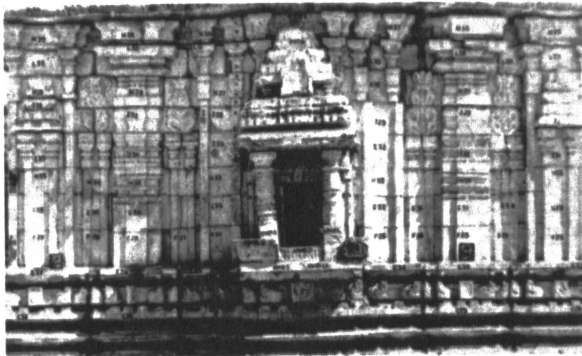
FIG.7 A view of back wall

The temple is several centuries old and no documented details except an original temple plan carved on a rock outcrop (Fig.6) at a place few kilometers away from the temple could be available. This plan is at the temple plinth level and if it is the complete layout, the original temple had only a smaller structure leading to the entrance of the sanctum sanctorum. Now dismantled front portion within a square of about 16m sides (Fig.4) must be a later addition. A part of the originally constructed front is still retained (Fig.2). The sanctum sanctorum structure at its base is within 7.5m x 7.5m (Fig.4) and with a total height of 16m upto temple top above the present floor level. The granite stone masonry with exquisite carvings Fig.7 has a wall thickness of about 1m and is 5.6m high. The remaining tapering top structure is plastered brick work with moulding (Fig.2 and Fig.3). The estimated weight of the superstructure is 1130t. The masonry on outside showed signs of weathering, obliteration of stone carvings, opening of joints and dislocation of stones (Fig.7). The brick top was also reported to have cracks in the past and repaired.
