# Foundations Failures of Bridges and Geotechnical Investigations

Proceedings: Third International Conference on Case Histories in Geotechnical Engineering, St. Louis, Missouri, June 1-4, 1993, Paper No. 1.26

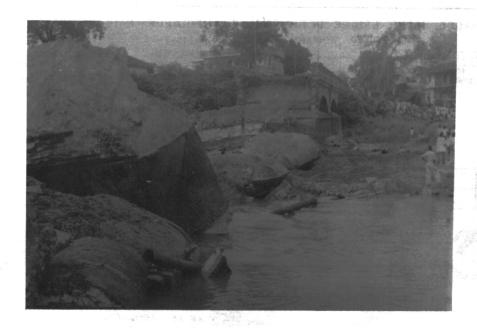
The wells were resting on yellow soil @3m below the lowest bed level. Concentration of flow is mainly in span Nos.3,4,5 & 6. During floods of 1989, there was heavy scouring at pier-3 which collapsed and the shallow well was uprooted (Photo-1). This brought down 5 spans i.e. spans 3 to 7 as there was no abutment pier. Two well foundations were uprooted. Cracks developed in other arches (Photo-2). There exists a Railway bridge @ 300m U/S on the same river has about 5.5m deep open foundation resting on similar type of foundation. No distress is observed on Railway bridge.

The investigation shows that heavy floods in this small river caused scour which extended gradually over years below founding level. The bridge did not collapse during high flood but on receding floods when a heavy tanker passed over the bridge. Pier p-3 which settled and gone way.

Photo 1 Pier No.3 from Piparia side of Palakmati Bridge.

Investigations have been done and it is found that good founding strata, yellow soil mixed with kankar is available at a depth 4m to 5m below the lowest bed level with S.B.C. of @ 30 T/Sq.m. Now a new bridge is proposed at the existing site with 5 spans of 19.2m c/c and the foundations are kept at R.L. 91.00 i.e. 5.5m below lowest bed level on yellow soil mixed with kankar.

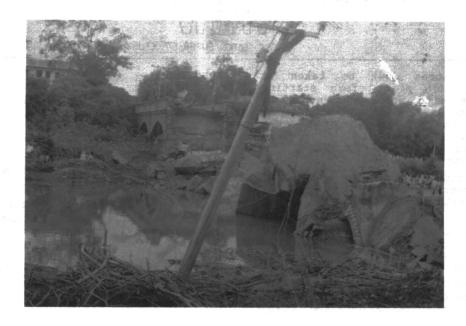
Photo 2. Showing 5 spans collapsed of Palakmati Bridge on Hoshangabad - Piparia Road.

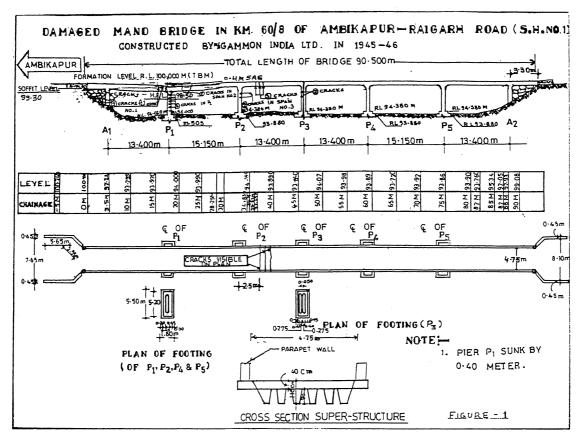
Details of Foundation and Founding Strata
The bridge has open foundation resting
on rock/hard strata. The superstructure
consist of two units of R.C.C. framed structure (3.3m cantilever + 13.40m + 15.15m
+ 13.40m). The details are shown in fig.1.
The foundations are resting at a depth
3.5m to 5m below the lowest bed level.

The river channel is flat with defined banks. The abutments are resting on high ground near banks. Pier P-1 is resting on gravel and below gravel it is only silt. The foundation of pier P-1 towards Ambikapur side sunk by about 0.4m in August 1991. Due to this abrupt settlement the abutment and all the three piers have developed through cracks below the supports. Similarly the slabs at 0.2 L. from support have developed severe cracks in all spans as shown in figure-1. The traffic on bridge has been stopped.

under pier P-1 and partly due to creation of cavity and voids in the silty strata due to flow of water with high velocity during rains. The bridge was standing due to arch action and when this arch action was broken due to unbalancing of the underlying strata, the settlement took place under pier P-1 and the failure of one unit of three spans occured.

is also not reliable, so it is under consideration to dismentle complete bridge and provide a new bridge with 2 lane carriage way i.e. 7.5m width.
