A Case History of the Collapse Accident of a Temporary Earth Support Structure

SYNOPSIS: This paper presents a case study on the collapse accident of a temporary earth support structure. The examination of the design plans and investigations of the construction site where the accident occurred has been carried out to throw light on the accident situations. Some causes of the accident occurrence which have been derived from these examinations and countermeasures for prevention of these types of accidents are discussed.

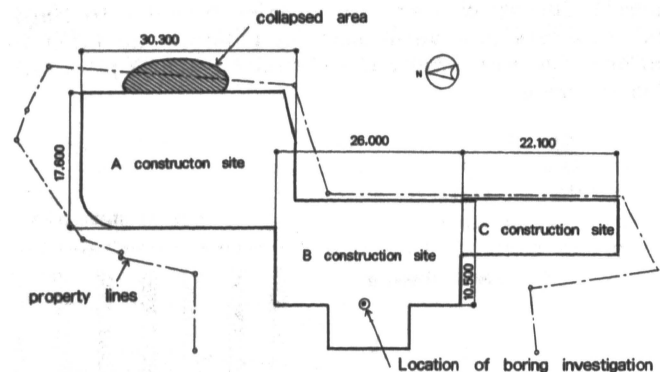
Fig. 1 The ground plan and the location of boring investigation

This accident occurred at the building construction site. The ground plan of the construction site is shown in Fig.1. The construction area was divided into three construction sites. The collapse occurred at A construction site which had an excavation area of 17.6 meters wide (north-south direction) and 30.3 meters long (west-east direction).

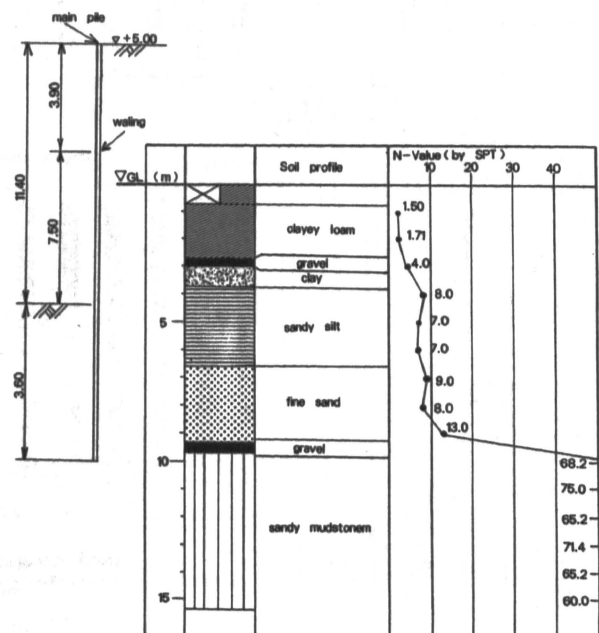
Fig. 2 Boring log of the construction site

Geological survey of A construction site was not performed. However, only one boring investigation had been conducted for the construction of the foundation piles. The location of the boring is shown in Fig. 1. Fig. 2 is the result of the boring investigation. According to this boring log, the ground consisted of cohesive soil (Kanto Loam) from ground level (GL) to -4 meters, sandy silt from -4 to -6.5 meters, fine sand from -6.5 to -9.5 meters and sandy mudstone below -10 meters. The N-value of the sandy mudstone was around 60 and other soil was less than 10. The ground water level was GL-1.5 meters.

According to the calculation sheet, the safety factor for overturning of the main piles was 1.2 and penetration depth of the main pile was 3.6 meters. The greatest part of the penetration portion was the fine sand and only 30 centimeters of the pile toe penetrated into the sandy mudstone (see Fig. 2). Resisting moment due to this 30 centimeters penetration portion covered about 40% of total resisting moment.

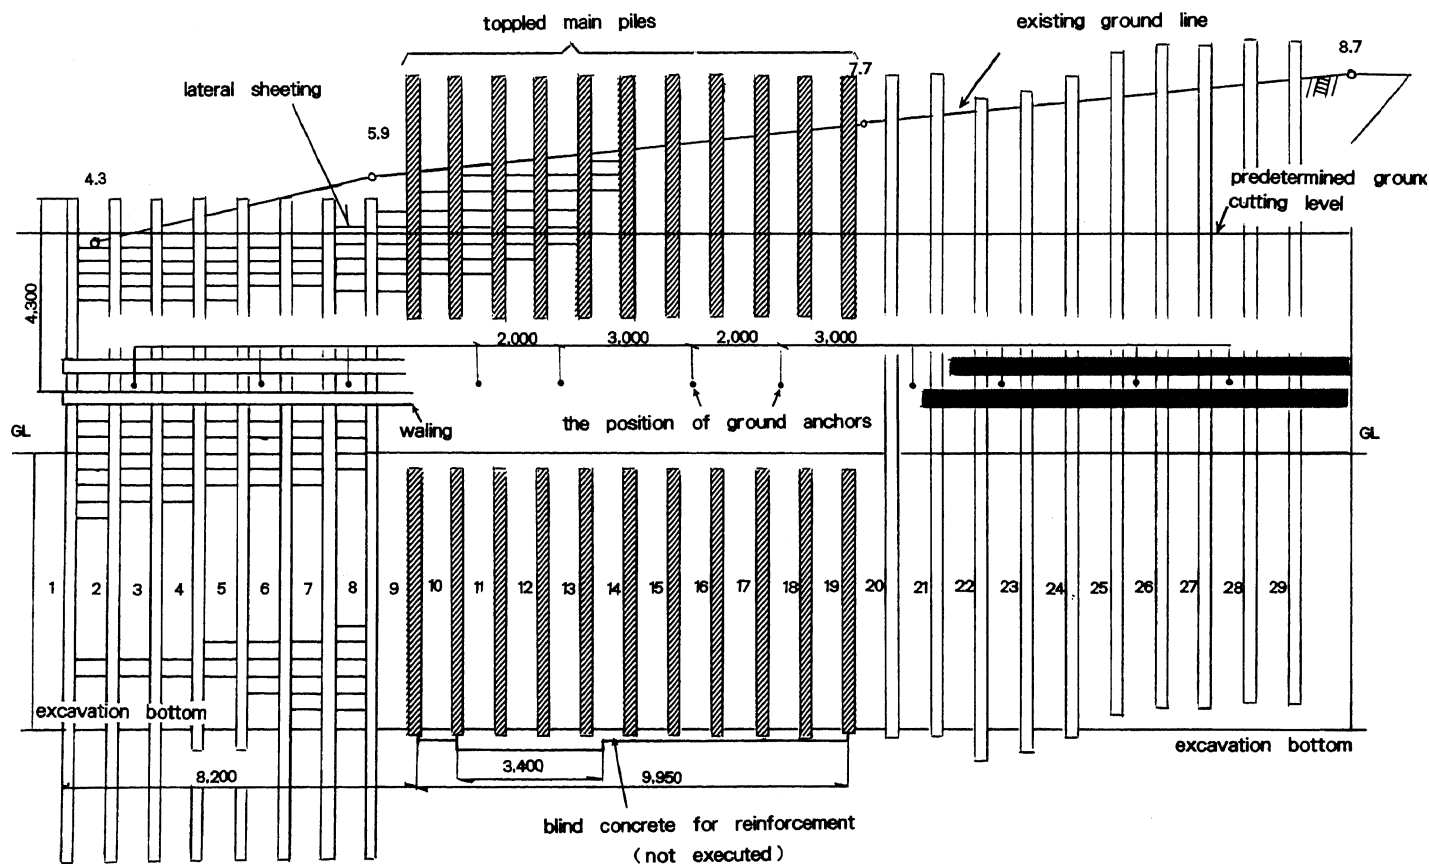
Fig. 3 The elevation of the collapsed earth support structure

At around 1:15 P.M., central 15 meters of the temporary earth support structure on the east side collapsed and 200 cubic meters of earth, 7 ~ 8 meters high and maximum thickness 4 meters, slid into the excavation area. Due to this collapse, 11 of the H-steel piles toppled. Four workers at the bottom of the excavation site were buried alive and three workers were struck by H-steel piles. As a result, five workers were killed and two others were injured. The elevation of the collapsed earth support structure is shown in Fig. 3.

The east side of the construction site where the collapse occurred was a hill shape of GL+5 ~ +10 meters (see Fig. 3). According to the construction plan, after this hill had been cut to GL+5 meters level, then 15 meters main piles would have penetrated the ground. However, the field engineer performed ground cutting without checking the excavated ground level with the assembly diagram, therefore the hill shaped ground was not cut to the designed ground level. In spite of the lack of ground cutting (GL+8 ~ +9 meters), the penetration work of the

main piles were carried out. As a consequence, it follows that 21 of the main piles had not penetrated to the predetermined ground level (except for 8 piles on the north side) as shown in Fig. 3.

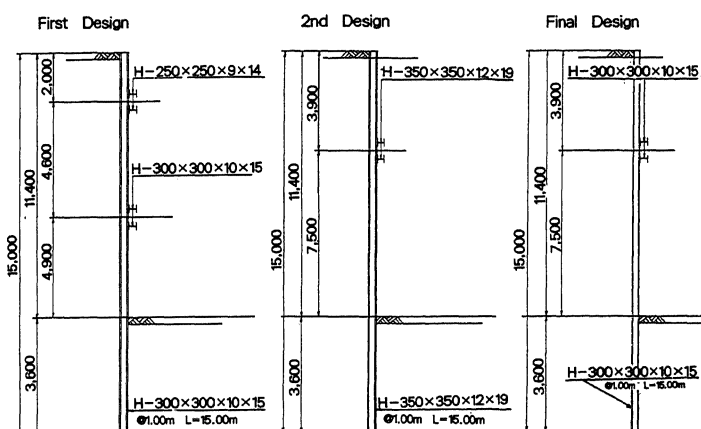
Fig. 4 Designs of main piles and ground anchors

meters and the 2-stage ground anchors were adopted. However, by the judgement of the field engineer, the design plan was changed to use a single-stage ground anchor and a 350*350 H-steel pile. Finally, 300*300 H-steel piles were used as the main pile (see Fig. 4).

In this construction, the temporary earth support structure was designed from the economical point of view or by the reason of material procurement at the site. For example, the 2-stage ground anchors were changed to single-stage anchors and the size of the H-steel piles were reduced (see Fig. 4).

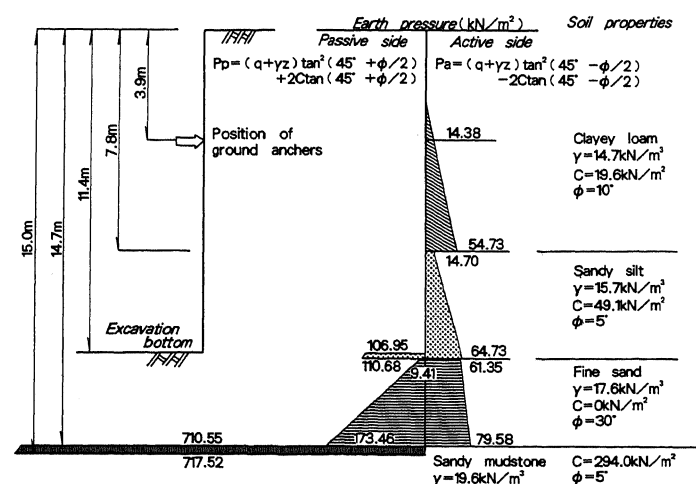
Fig. 5 The earth pressure distributions for the determination of the penetration length of main piles

Earth pressure distributions for determination of the penetration length of the main piles are shown in Fig. 5. If there was a lack of penetration of 30 centimeters, the safety factor for overturning was reduced to 0.7. Considering the accuracy of the penetration work of piles and the uncertainties of the ground conditions in this construction site, these design procedures, in which about 40 % of total resisting moment of the main piles was covered with the lowest 30 centimeters penetration portion, are undesirable.

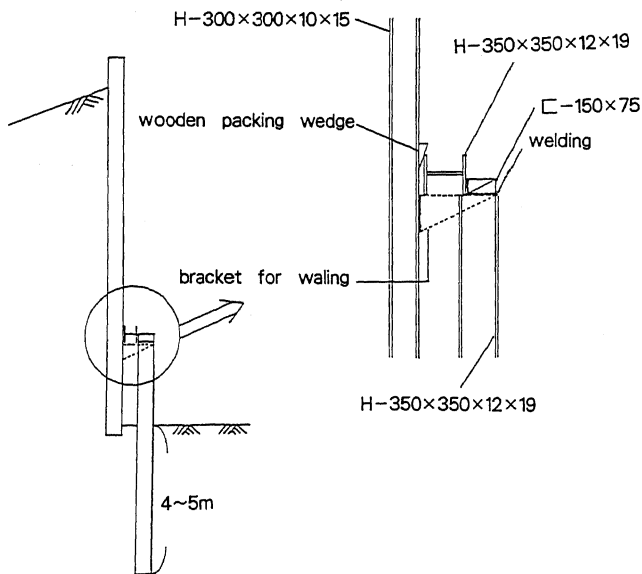
Fig. 6 The schematic diagram of remedial piles

In this construction site, insufficient penetration of the main piles on the east side was found just after the first excavation had finished and the remedial work had been done using H-steel piles available at the site. Additional remedial piles were driven in front of the main piles and the schematic diagram of remedial piles is shown in Fig. 6.

However, the strength of remedial piles had not been examined at all. In cases where such mistakes are recognized during construction, a detailed checking of such mistakes has to be made and effective remedial countermeasures should be taken immediately.
