International Conference on Case Histories in Geotechnical Engineering (1993) - Third International Conference on Case Histories in Geotechnical Engineering

Discussions and Replies Session 5

on
Failure of a Twenty-Foot High
Retaining Wall

Paper No. 5.31

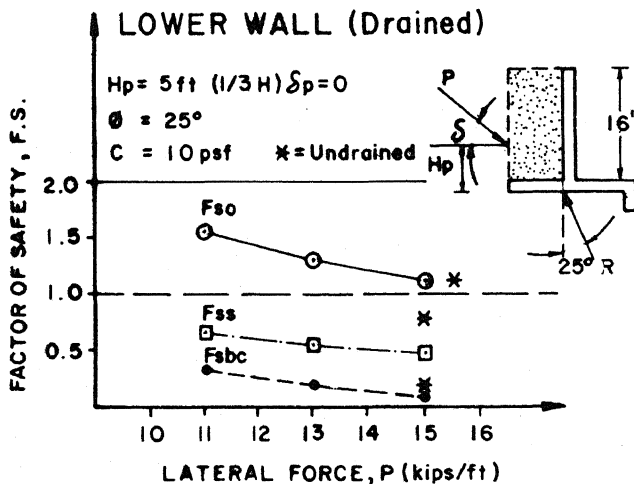
The work is valuable, well documented and comprehensive. A cross section of the site, however, showing the idealized soil profile after failure, obtained from the results of the site investigation would have been helpful. Figure 1 summarizes the results of the author's analysis in terms of safety factors for drained and undrained conditions. It is clear that the LW could not be stable from the bearing capacity and sliding points of view. It was founded on weak soil and supporting a load of about 15 kips/ft (22.4 ton/m).
