Failure of a Twenty-Foot High Retaining Wall

R. E. Olson
University of Texas, Austin, Texas

SYNOPSIS A cantilever retaining wall, designed in apparent accord with provisions in a civil engineering handbook, failed soon after construction. Analyses of the causes of the failure are presented.

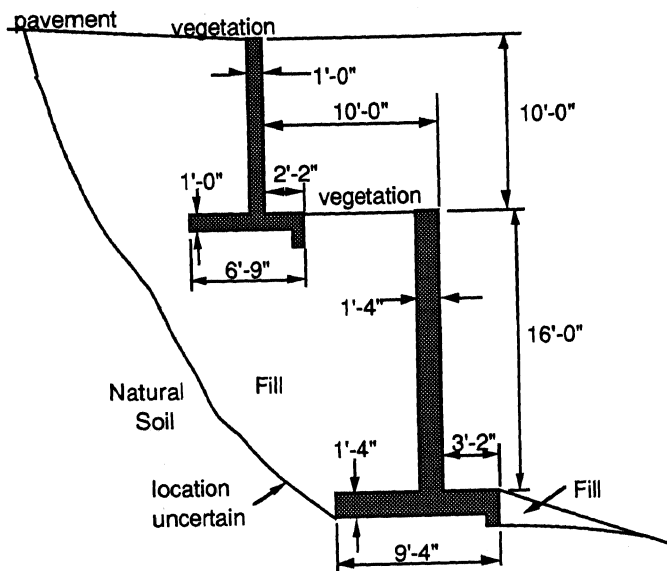
Fig. 1 Wall Configuration in the Area of the Failure

The estimated wall configuration in the area of the failure is shown in Fig. 1. The location of the contact between fill and natural soil is uncertain. The actual location of the bottom of the lower wall is unknown because design drawings indicated that the elevation of that base slab would be decided in the field. It is probable that the slab in the middle part of the failed zone was on natural soil because that was the apparent intent of the specifications, but it may also have been on fill.

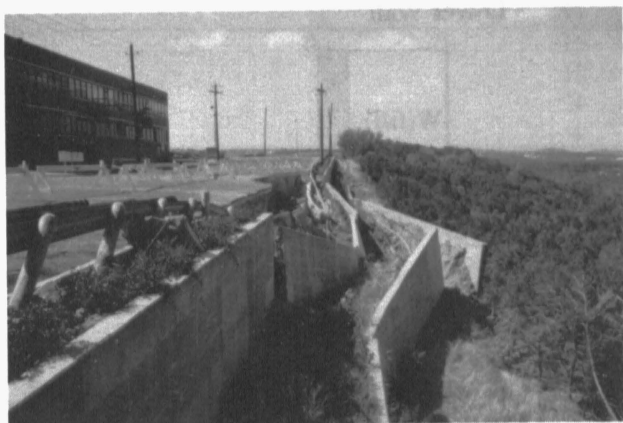
Fig. 2 View of the Failed Section of Wall

In late July, after a period of heavy rain, a section of the lower rear wall, with a length of about 135 feet (41 m), suddenly began to displace horizontally. My first site inspection was about seven hours after the failure apparently began and, at that point, the lower wall had displaced horizontally about fifteen feet (5 m) (Fig. 2). A substantial vertical scarp had formed in the fill because the upper wall had dropped into the void formed when the lower wall displaced. The lower wall continued to displace horizontally at a slow rate. Some months later, when the wall approached the property line, the damaged portion of the wall was removed.

The exposed fill was mostly limestone gravel but there were several layers of clay. Water was leaking out of the most pervious layers in the fill.

Vegetation in front of the lower wall was dry and dead but vegetation that had been between or above the walls was green. The soil directly in front of the wall, and the slumped fill, was soft. Broken irrigation pipes could be seen in the fill between and above the walls.

Based on the lack of stains, many of the weep holes had apparently not functioned. Attempts to drive rods through them often failed. It appeared that the fill side of some of the holes was blocked with concrete. Water was spurting out of the top part of one of the weep holes, in a stream

with a diameter about the size of a pencil. Apparently, the back side of the weep hole was blocked except for one small hole, and there must have been a substantial water head behind the wall.

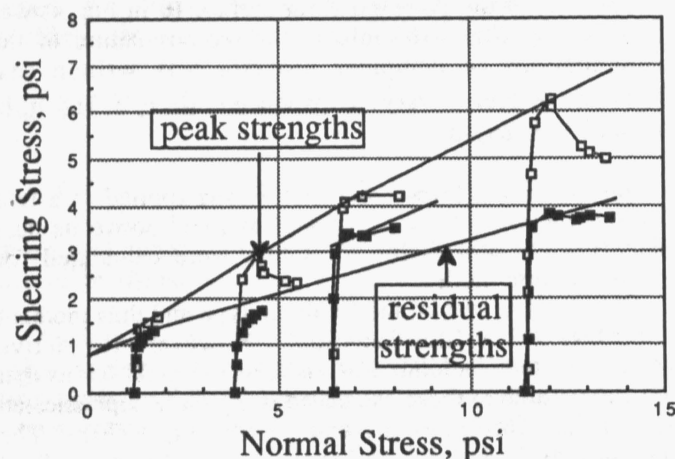
Fig. 3 Results of Direct Shear Tests on Natural Clay Shale

The "residual" friction angle was estimated simply by trimming a smooth failure surface in a direct shear sample and shearing the sample back and forth several times on that surface. Only the final stress path curves are shown in Fig. 3.

The estimated value of \bar{c} was 100 psf (4.8 kPa) for peak and residual, but $\bar{\phi}$ was about 25 deg. for peak and 16 deg. for residual conditions (Fig. 3). The measured shearing properties agreed well with a number of other shearing tests performed in our laboratory on samples from this formation, or from other similar formations in the area, except that the peak friction angle for the other tests was usually closer to 21 deg. and the residual friction angle generally was in the range of 12 to 15 degrees.

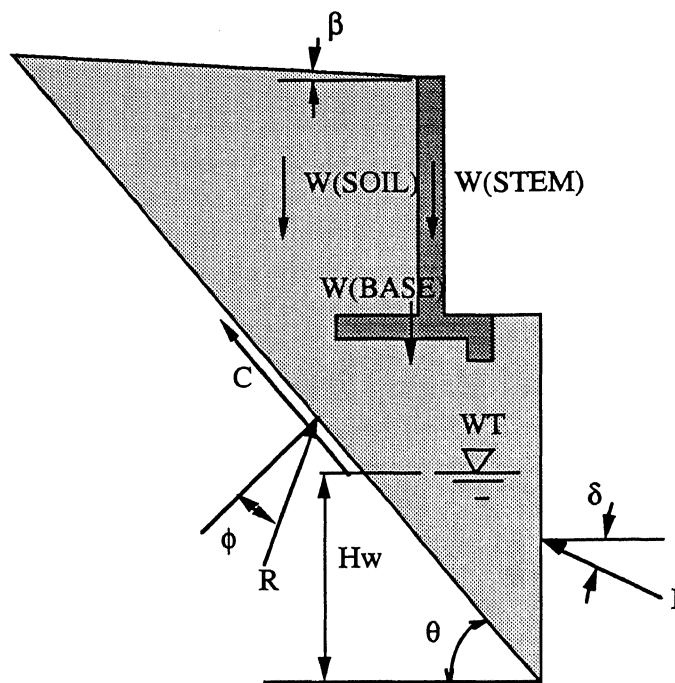
Fig. 4 Assumed Wedge of Soil Sliding Toward the Lower Wall

The analysis was performed in two phases. In the first, the upper wall and soil below it (Fig. 4) were taken out as a free body. Equations for force equilibrium in the vertical and horizontal direction make it possible to calculate the force P that this upper wall and associated soil applies to the vertical plane through the heel of the lower wall. The orientation of the potential shear surface (θ in Fig. 4) was obtained by trial. Because of the tedious nature of the computations, a computer program was written that allowed the user to vary the parameters (β , c , ϕ , H_w , q , δ , γ , and W) as required.

Analyses using $\delta=0$ (Fig. 4) indicated that P dropped from 39 kips/foot when $c=100$ psf (4.8 kPa), to 0 when $c=720$ psf (34 kPa). Measured undrained strengths were in excess of 720 psf (34 kPa) for the natural soils and

estimated undrained strengths for the exposed clay layers in the backfill also exceeded 720 psf (34 kPa). The analysis confirms the field observation that a substantial height of the clayey part of the fill would stand unsupported as long as it was undrained. The assumption of no drainage could not apply to the fill prior to failure, because of the gravel layers, but it may be relevant for the cohesive parts of the backfill immediately after failure.

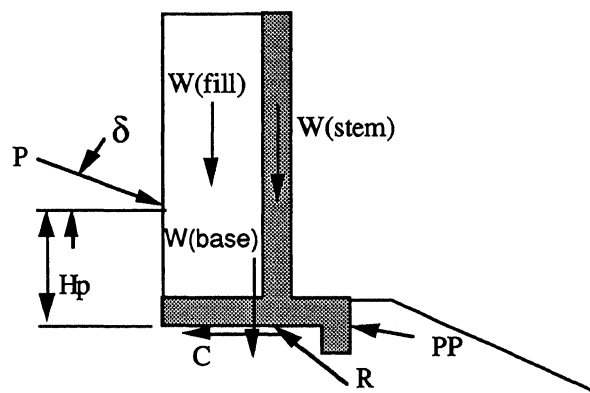
Fig. 5 Assumed Conditions for the Lower Wall Analyses to Obtain P

In the second phase, the force P was applied to a free body composed of the lower wall and soil above its heel slab (Fig. 5) and factors of safety were calculated for various failure modes.

Stability of the lower wall (Fig. 5) was analyzed for overturning, sliding, and bearing capacity. Equations for overturning and sliding are found in most books on foundation engineering and need not be repeated.
