Large Excavation Behavior at Petacalco, Mexico

SYNOPSIS: The pumping sump for the Petacalco, Gro. Power Plant required for its construction an excavation 100 x 87 m plan and 11 m depth. The calculated flow towards the excavation was 370 l/s. Two perimetral systems were proposed to control the inflow water: Cut-off wall or conventional pumping system. After a technical-economical analysis, the first one was selected. Due to construction delays of the cut-off wall and program construction demands, the excavation began simultaneously and advanced faster than the wall. The observed inflow water was ten times lesser than the predicted one, so that the construction of the wall was suspended. The excavation finished using a 6" diameter pump working continuously with a 35 l/s flow. During the excavation randomly thin layers and pockets of peat and organic clay were observed. These materials were not detected in the geotechnical exploration. The flow reduction is attributed to the presence of those materials.

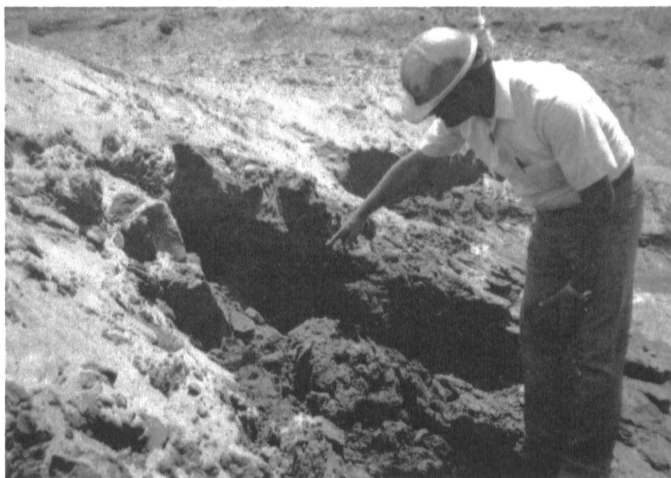
Fig.9 Detail of thin layers of peat and organic clay

Thin layers and pockets of peat and organic clay appeared during the excavation. These materials are located randomly and were not detected with the subsoil exploration. The location of those materials is shown in fig 8. Fig 9 shows a detail of the thin peak layers.

In spite of the previously geotechnical knowledge in the area and the verification soundings, thin layers and pockets of peat and organic clay were undetected. The water flow reduction to a one tenth of the expected one is attributed to the presence of those materials.

Geotechnical explorations in similar areas (randomly geological conditions) must be accomplished with the aid of tools like geophysics and the knowledge of the geological site conditions to prevent hazardous events. Nevertheless even with the execution of a complete program of exploration is possible to find unexpected situations in sites like this one.
