Failure of Highway Fill and Investigation into Its Causes

P. Jagannatha Rao

Central Road Research Institute, New Delhi, India

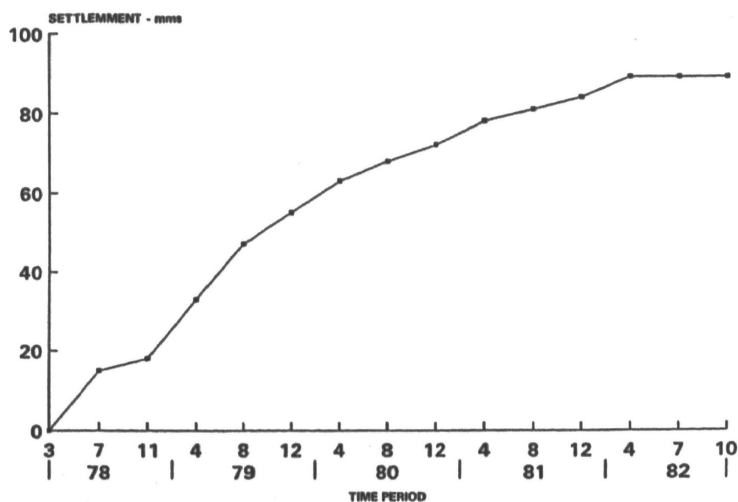
Fig.1 TIME VERSUS SETTLEMENT CURVE

Placement of fill started in march 1978. Stage construction, consisting of four stages at the site where the height of fill was about 12m was adopted. Full height of the embankment was attained in December 1980. The area was instrumented to monitor the settlements and performance of the embankment. Periodic observations were made and the data was analysed. Time versus settlement curve is shown in Fig.1. Upto October 1982, settlement of the order of 80cm was observed near the bridge approach where the height of embankment was about 12m. The rate of settlements due to consolidation was found to be low enough at this time leading to the assumption that distress in the pavement is unlikely to occur on this account.

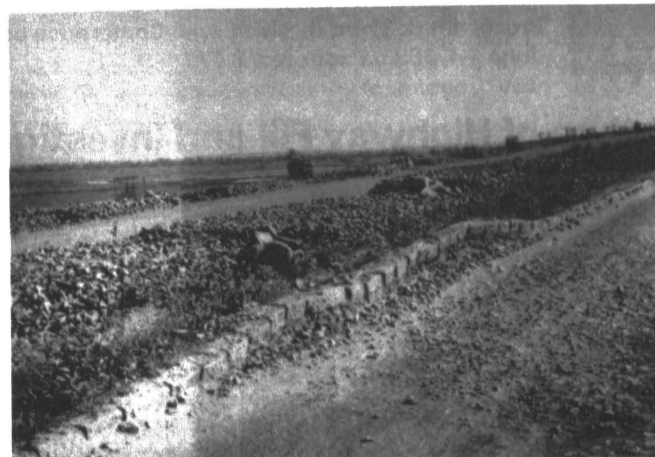
Fig.2 Typical transverse deformation

The stretch was opened to traffic in July 1982 and during the following three monsoon months, the pavement, especially the stretch over the approaches to the creek, experienced severe distress, which manifested itself in the shape of both longitudinal and transverse deformations, as well as formation of pot holes. Transverse deformations, longitudinal deformations and rutting had occurred where fill was upto 3m in height and the standing water was so high that little or no freeboard relative to the base of the pavement was available. A typical transverse deformation is shown in Fig. 2. Patch work on the damaged pavement can also be seen. Remedial measures such as filling of pot holes were adopted to maintain the road surface. Additional crust thickness was also provided. But the pavement continued to experience severe distress. Such an early failure of the pavement necessitated that the cause of such distress be identified. In this instance, the causes of the failure were not associated with the pavement thickness and thus detailed investigations were carried out to study the properties of fill material and the subsoil to find out the possible causes of distress. These investigations were essentially in the nature of getting first hand data regarding the fill material used, field densities achieved and the soaked CBR values of the subgrade.

The fill materials used fail to satisfy the prevalent norms for such materials as well as the densities required to be achieved. The distress experienced by the pavement can thus be attributed to the poor quality of the fill material as well as the low densities recorded.

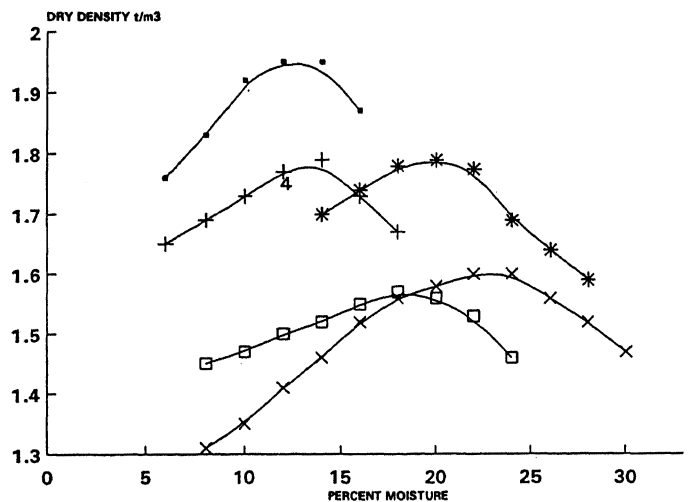
FIG.3 TYPICAL COMPACTION CHARACTERISTICS (MATERIALS SATISFACTORY AS FILL)

The maximum density as per standard Proctor compaction was high for this group of samples, and ranged from 1.8 to 1.9 t/m³. These materials were well graded, non-plastic or had a low plasticity index. Experience has shown that these are suitable as fills. In the present instance, pavements in the stretches located on such fill materials were performing satisfactorily. Typical compaction characteristics of satisfactory fill materials are shown in Fig.3.

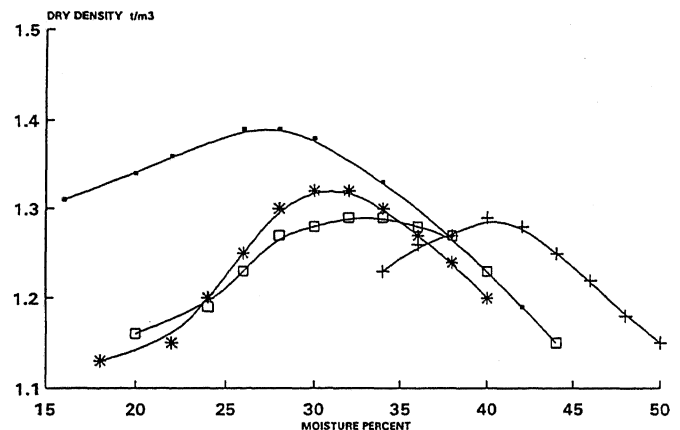
FIG. 4. COMPACTION CHARACTERISTICS (MATERIALS UNSATISFACTORY AS FILL)

The materials under this group represent fill materials having distinctly dissimilar properties to those from group A and group B. Typical compaction characteristics are shown in Fig. 4. It was found that all the materials in this group may be classified as inorganic silts or silty clays of medium to high compressibility i.e. ML to MH groups fig.5. These soils were found to be of non swelling nature and may be termed as inactive to normal, on the basis of Skempton's activity ratio. Standard Proctor density of these materials was found to be very low, of the order of 1.3 t/m³ only. Optimum moisture content ranged from 30% to 40% which is in the range of plastic limit of these soils. In the case study described earlier, major portion of the embankment on which the pavement was placed, was found to have been made up of materials of similar characteristics. In this embankment, it was

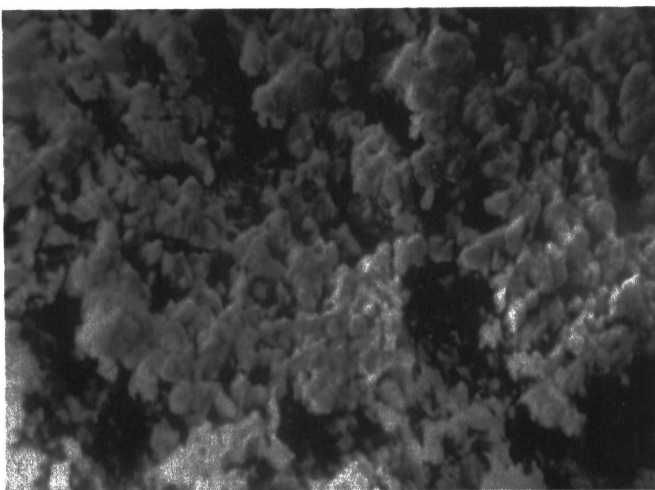
Fig.6 Limited Scanning Electron Micrograph of clay particles

found that even in the relatively dry season, insitu moisture content was high. Limited Scanning Electron Microscope (SEM) studies were carried out which indicated the likely presence of Allophane in the materials of this group. Fig.6 shows SEM of the clay particles magnified 10,000 times. Fill materials have low I_p combined with relatively high W_l and W_p . There is predominance of silt size particles in the soils. The materials are having low compacted density with high OMC. These materials were also found to retain significantly high water contents. Comparison of the properties of these materials with the properties of soils from other parts of the world show that these soil properties fit in very well with those of tropical residual soils derived from weathering of volcanic material, such as those found in Java (Wesley, 1973)
