Investigation of Collapse of an Apartment Building Due to Differential Filling

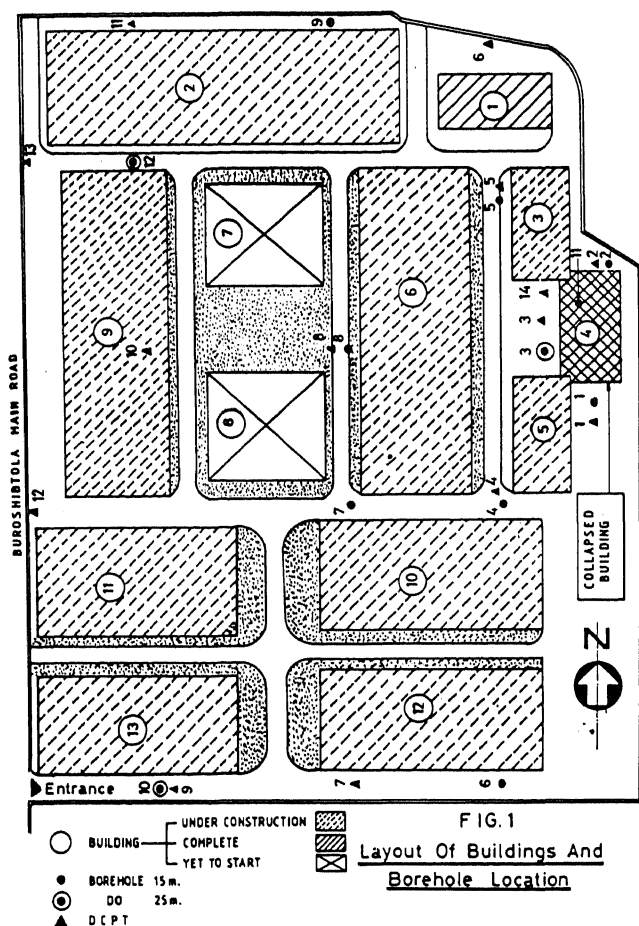
Fig. 1 shows the layout plan of the building complex at 5/7 Buroshibtala Main Road in south-west Calcutta. In all, there were thirteen buildings in various stages of construction, Table I.

The boreholes were done at locations indicated in Fig. 1 to determine the subsoil stratification at the building site and to collect disturbed/undisturbed samples for testing. The borehole locations were so chosen as to get sufficient

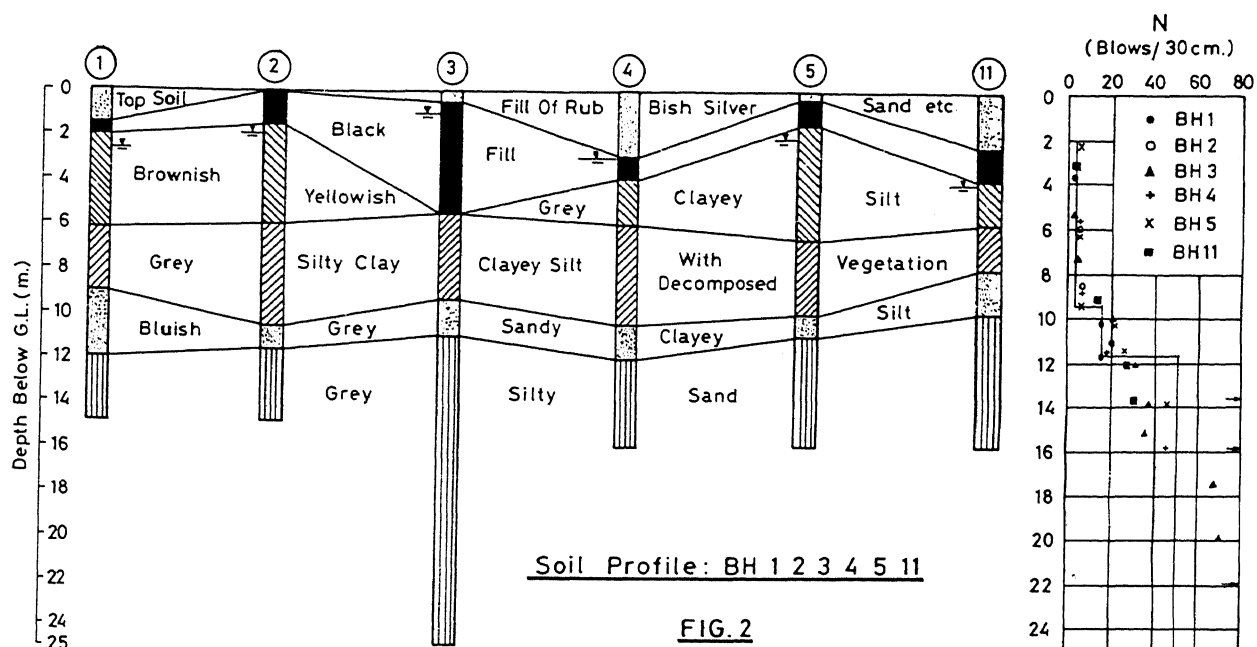
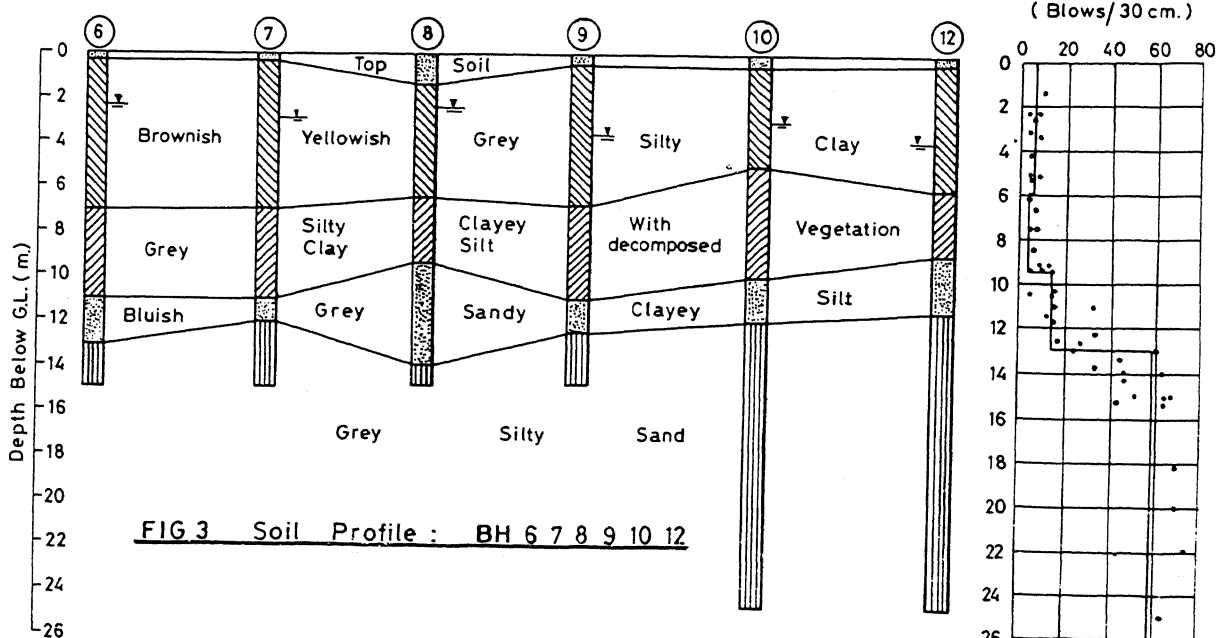
The soil profiles as revealed by the boreholes are shown in Figs. 2 and 3. Fig. 2 gives the soil profile in the area surrounding the collapsed building, while Fig. 3 gives the soil profile in the rest of the area. There appears to be some distinct difference in the soil profile in the vicinity of the collapsed building and in the rest of the area.

The subsoil in the collapsed building area, consisted of a heterogeneous fill of brickbats, rubbish, fine sand and a black/dark grey peat-like substance with high organic content. This was followed by successive layers of silty clay/clayey silt overlying medium to dense sand approx. 12 m below ground surface. The depth of fill at various locations near the collapsed building is shown in Table II. The fill was maximum near Borehole 3 (5.5 m) and gradually decreased on all sides.

The soil stratification in the rest of the area was fairly uniform with some variation in the thickness of individual stratum.

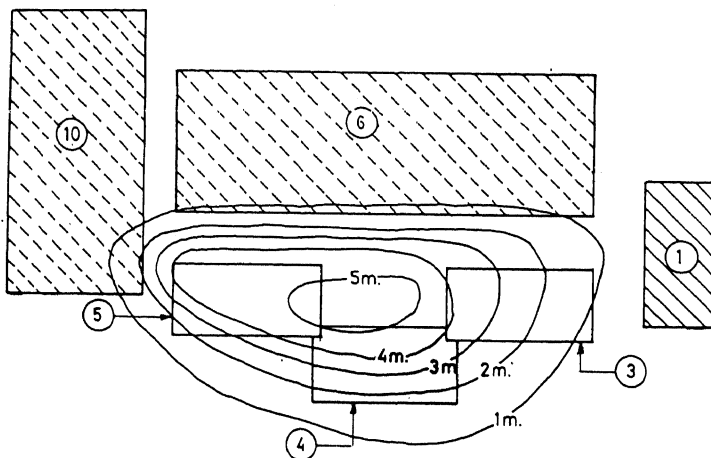
FIG. 4 Contour Plan Of Bottom Of Filled Up Soil

An attempt has been made to draw an approximate contour plan of the bottom of the fill in the collapsed building area - based on the field observations. The plan, thus obtained, is shown in Fig. 4. Although some interpolation had to be made to draw the contour plan it gives a fair representation of the depth of fill at different locations. It is apparent that the fill extended over most of the area covered by the three buildings in the collapsed zone. The maximum depth of fill, 5.5 m, was, however, found just west of the collapsed building. The depth of fill varied from 5 m to 2 m from west to east under the collapsed building.

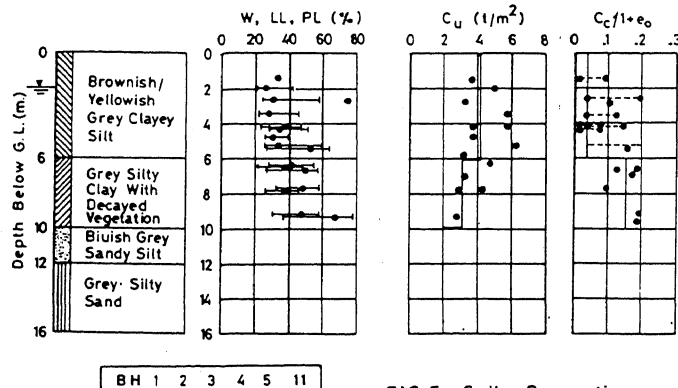
FIG. 5 Soil Properties

Fig. 5 shows the soil properties in the collapsed building area as obtained from laboratory tests. The ground water table, on average, was 2 m below G.L.

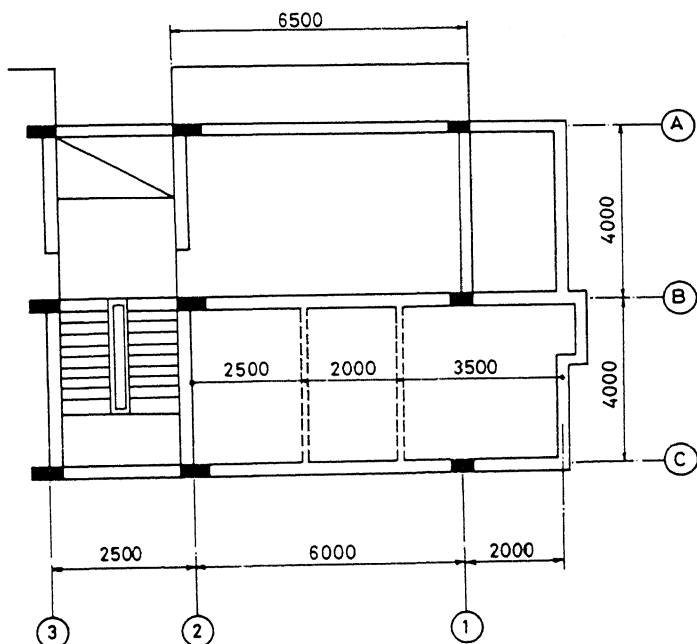
FIG. 6 Structural Plan: Building 4

The plan of the collapsed building is shown in Fig. 6. The building covered an area of 8mx18.5m having symmetry about the staircase block. There

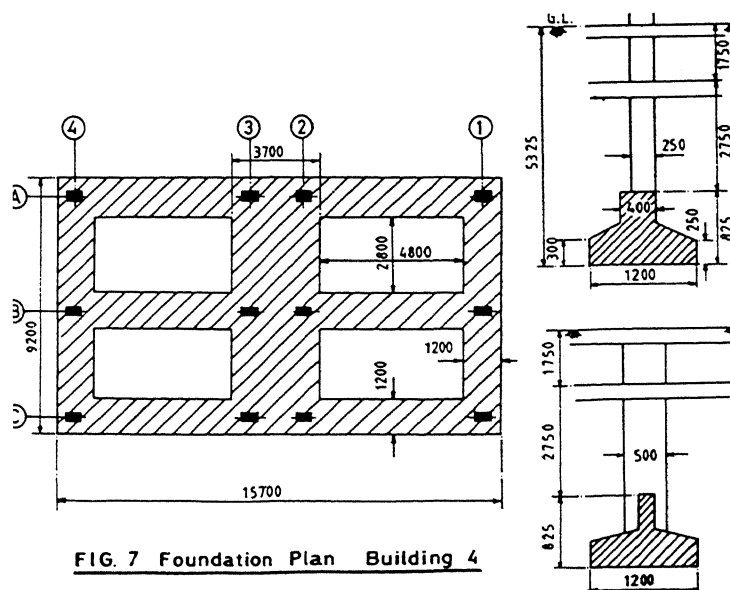
FIG. 7 Foundation Plan Building 4

were 12 columns in the building frame. The foundation details were obtained from excavation done at the site after the collapse, Fig. 7. The columns were supported on 1.2 m wide R.C.C. strips running east-west with interconnection in the N-S axis. The columns on either side of the staircase block were placed on a 6mx4 m grid (approx.) with a 2 m wide cantilever in the northern and southern faces. The vertical loads on the columns of the building frame as calculated from structural details are shown in Table IV.

It will be evident from the foundation details shown in Fig. 7, that - although the columns of the building frame were supported on two-way interconnected strips - the foundation as a whole would behave almost as a raft foundation placed 5.325 m below existing G.L. The equivalent raft covered a plan area of 9.2 m x 15.7 m with four

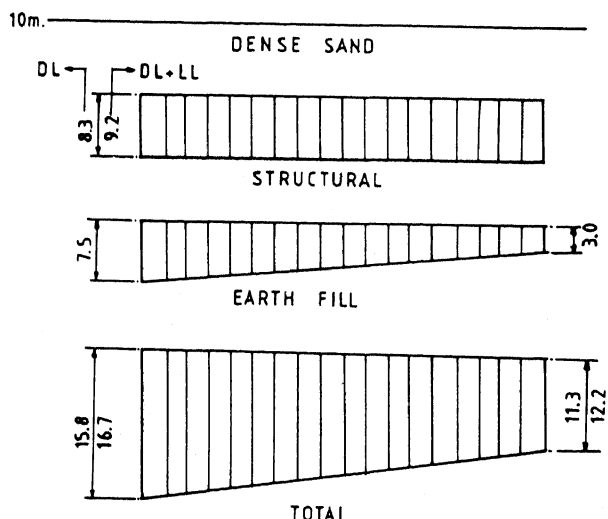
FIG. 8 Foundation Pressure Building 4 (t/m^2)

building area, Fig. 8. It would appear that the depth of the fill varied from 5 m on the western face to 2 m on the eastern face. The foundation raft was placed at 0.325 m below original G.L. at the western face of the building and excavation of varying depth - upto a maximum of 2 m at the eastern side - was made to build the foundation. The area was subsequently filled up with the factory waste to arrive at the finished ground level. With regard to the net foundation loading, therefore, a fill of varying depth - 5 m on the western side to 2 m on the eastern side - is to be considered on the foundation raft. This would give additional foundation pressure of 7.5 t/m² to 3 t/m² due to the overburden. The backfill upto the original ground profile was actually a replacement of the excavated soil and need not be considered as an additional load on the subsoil. The net foundation pressure below the raft may thus be obtained by considering the superstructure load and the backfill load separately. The data are shown diagrammatically in Fig. 8.

excavation was made across the building (E-W) from the then existing ground profile to locate the foundation at a depth of 5.325 m and the area was subsequently filled up. This resulted in differential filling on the foundation raft giving a non-uniform pressure of 16 t/m^2 on the western side and 11 t/m^2 on the eastern side of the foundation. The effect of differential filling was, perhaps, not taken into consideration in the foundation design.
