An Investigation of Rock Fall and Pore Water Pressure using LiDAR in Highway 63 Rock Cuts

Norbert H. Maerz

**NUTC
R364**

An Investigation of Rock Fall and Pore Water Pressure Using LIDAR in Highway 63 Rock Cuts

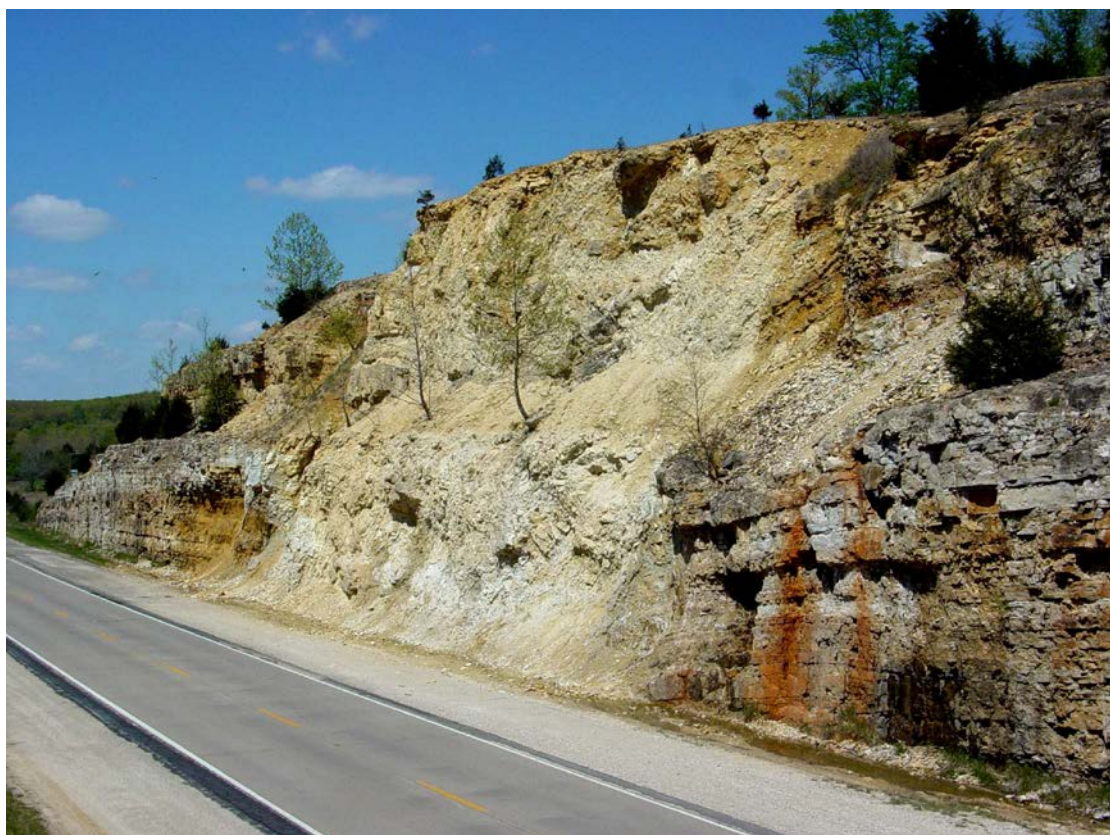
Two rock cuts were selected for this work along Highway 63 just north of Rolla (Figure 1). Site 1 (Figure 2) was located on a problematic rock cut that traverses across a filled sinkhole. This rock cut is constantly raveling and the ditches below this rock cut have been cleared of debris many times. Site 2 (Figure 3) was located just outside of a local operational quarry, where the seismic effects of blasting would contribute to rock fall. This location was chosen because there was evidence of both rock fall and groundwater leakage.

Figure 2: Site 1. This is a filled sinkhole that requires ongoing maintenance.

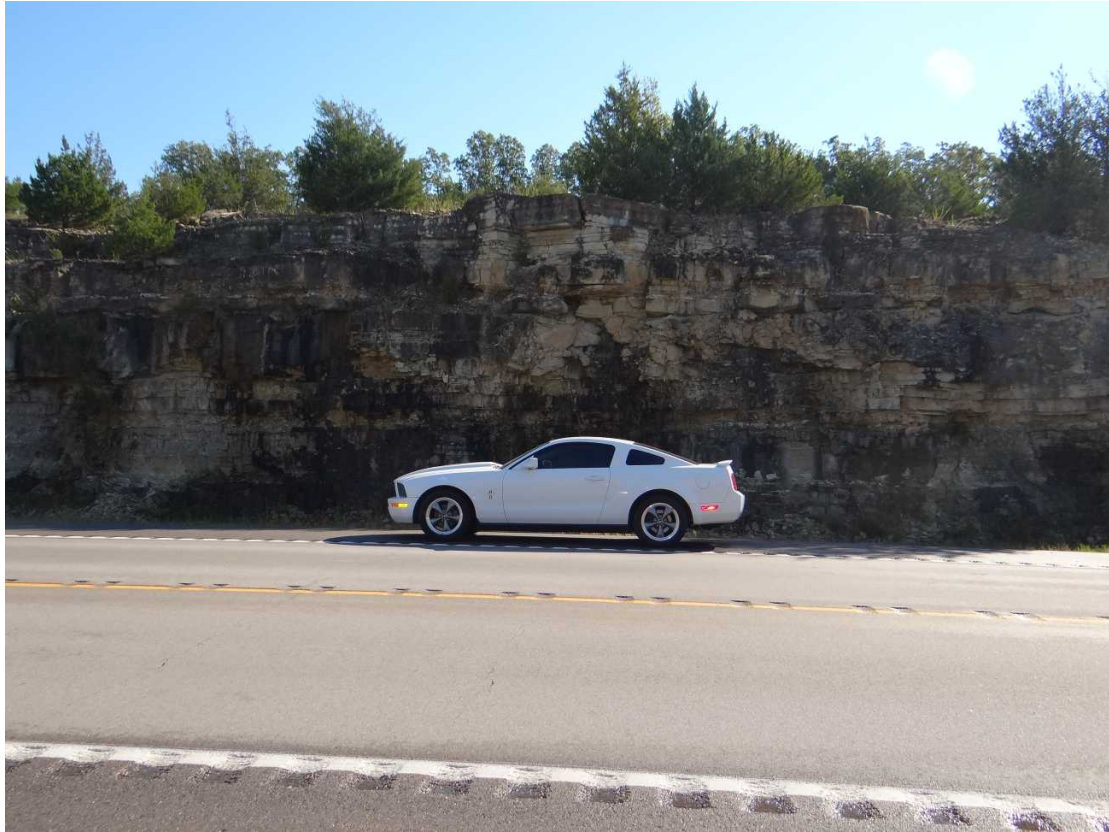
Figure 3: Site 2. Note the black stains on the rock indicating water flow.

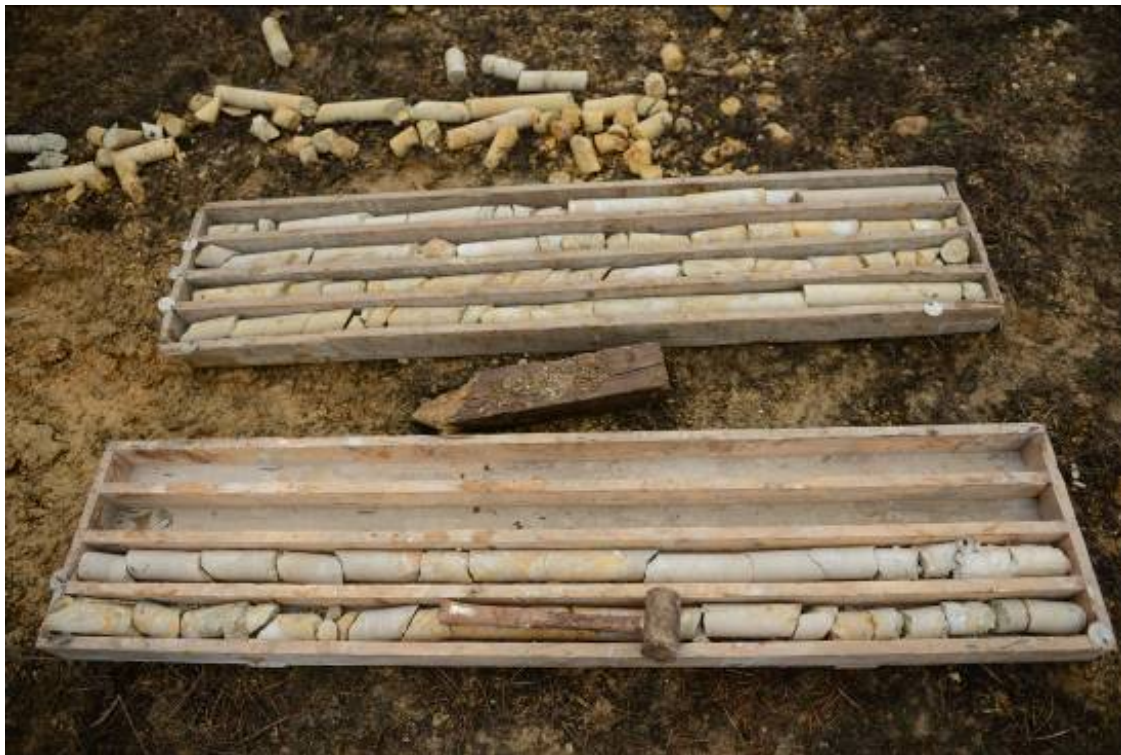
Figure 5: The rock core from Site 1.

0.4-5.4	13:55-14:05	5.0/5.0	0	46.78%	Main rock type is dolomitic. The color is from light grey to tan, highly weathered and highly fractured. There also some sandstone and clay seams. These sandstone seams and clay stone were found at depths of: 2ft, 5.5ft, 9ft, 11ft, 12.5ft, 15.4ft, 28ft, 31.5ft, 32.5ft, 33ft, 43ft, 48.5ft, 53ft, 58.5ft, 69ft.

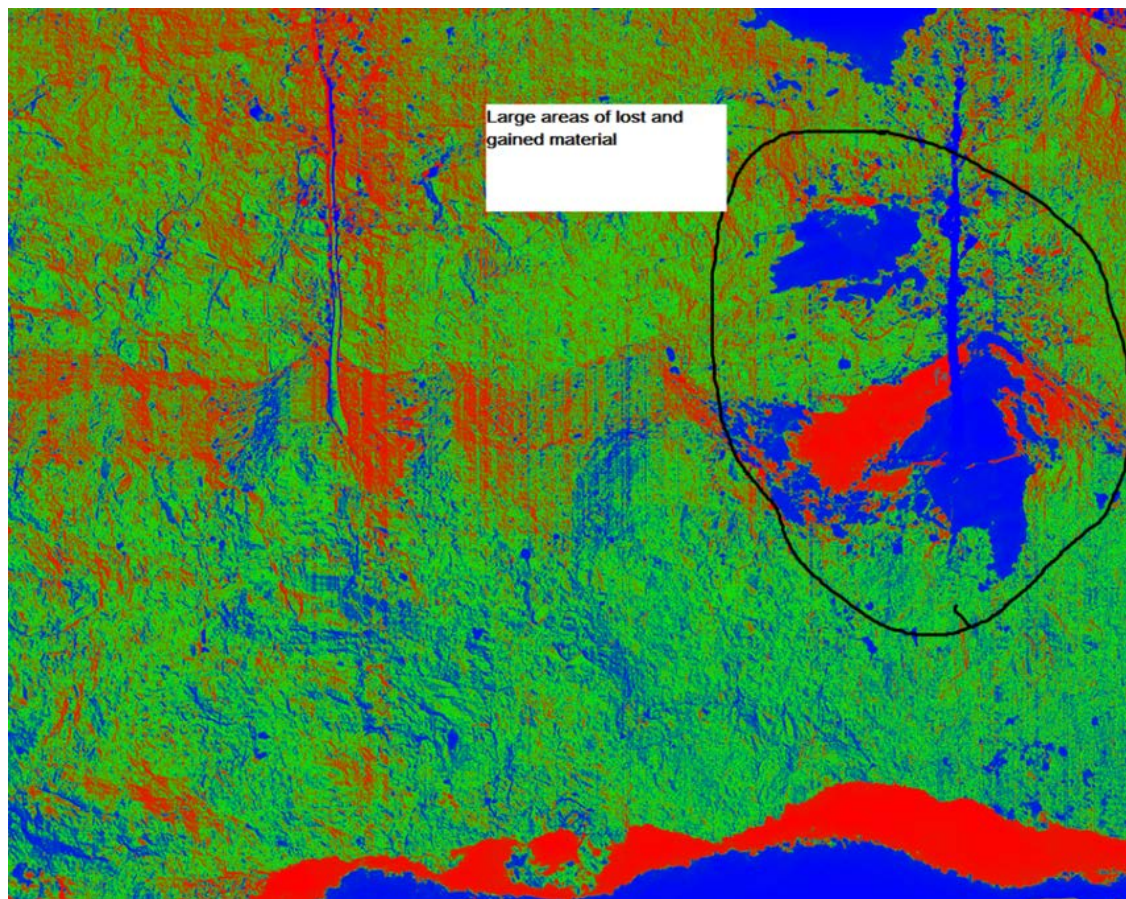
Figure 15 shows the raw results of the change detection algorithm, which nominally shows lost material in blue, gained material in red, and no change in green. The algorithm also has a vegetation removal aspect, however in Figure 15, the tree of Figure 14 (right hand true) is physically missing because it has either fallen down or been removed by the Missouri Department of Transportation personnel.

Figure 15: Initial results of change detection algorithm. Gained material is shown in red, and lost material is shown in blue. Note that tree in Figure 14 has been removed. The bottom of the image shows fallen rock.

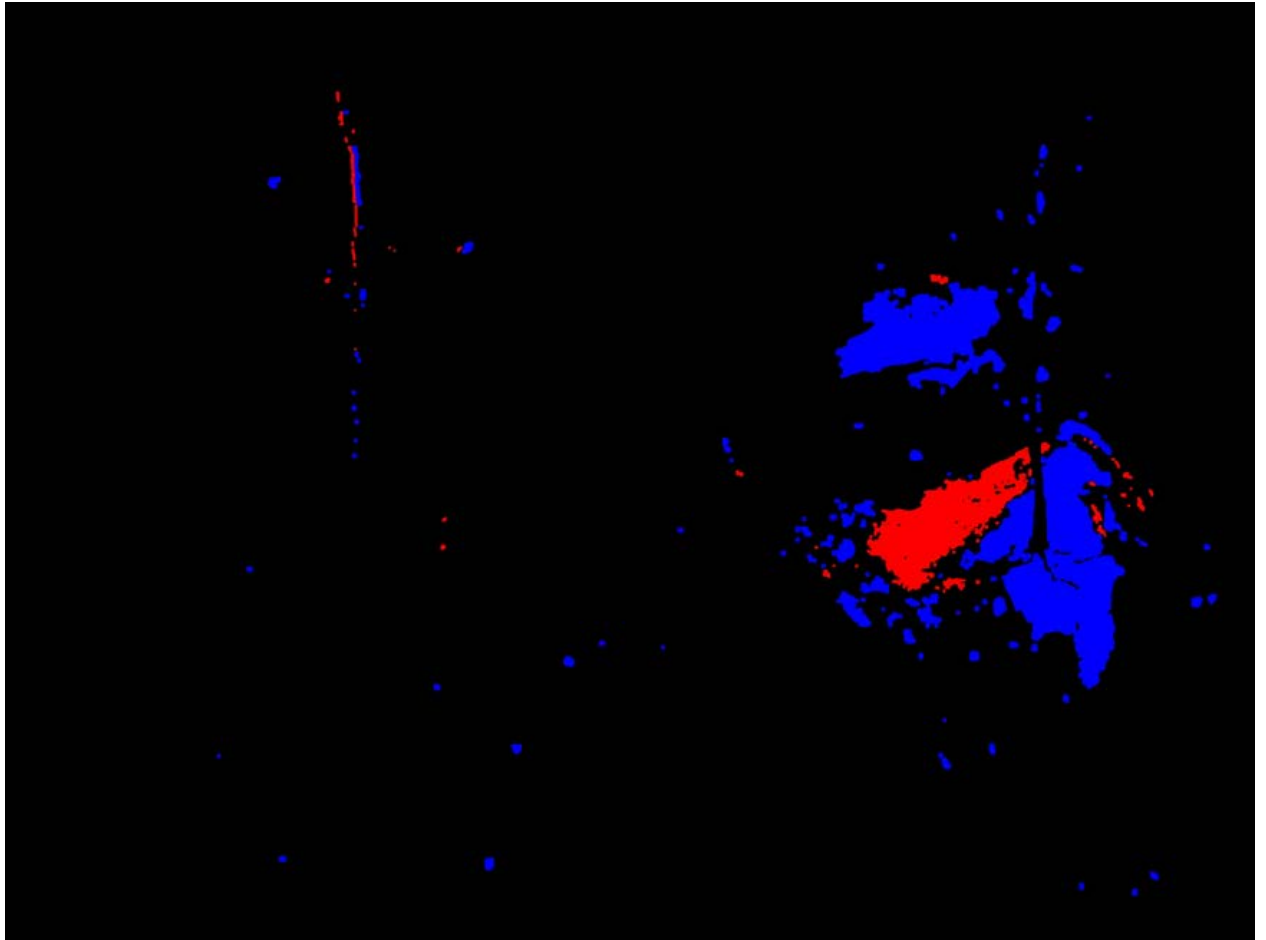
Figure 16 shows the final results of the change detection algorithm. Most of the fallen rock (blue) is as a result of the fallen/removed tree. Gained material (red) is typically the result of rock material that has fallen from higher up and has been left on the slope.

The statistics from this analysis show a lost rock volume of 8275.48 liters, and a gained rock volume of 2874.36 liters for a net loss of 5401.12 liters.

Figure 16: Final result of change detection algorithm by editing out the fallen rock at the bottom of the slope, and filtering the changes. Gained material is shown in red, and lost material is shown in blue.
