Interaction with Nearly Environment and Old Structure for a Deep Excavation. Case History in Bucharest

INTERACTION WITH NEARLY ENVIRONMENT AND OLD STRUCTURE FOR A DEEP EXCAVATION. CASE HISTORY IN BUCHAREST

The paper presents the influence of a deep excavation performed in Bucharest on the adjacent ground and on some old buildings around it; the damages and effects appeared during the excavation and the remedial measures are presented in detail, too. The excavation was designed to be 16.15 meters deep, sustained by a slurry wall enclosure of 60 cm thickness and pre-stressed anchors, and steel struts. Due to an accident that occurred to the trench walls, a thorough monitoring by instrumentation started. The results of this monitoring are shown.

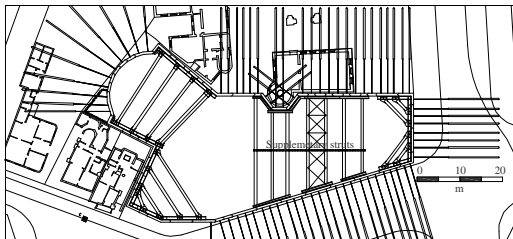
Fig. 3. Slurry walls enclosure, sustaining system, anchors and struts

The MBC structure will have 4 basements (for parking purposes), a ground floor and 18 stories for offices. The excavation for the execution of the 4 basements was designed to be 16.15 m deep, sustained by a slurry walls enclosure of 60 cm thickness, pre-stressed anchors, and steel struts. The slurry walls and the distribution of the anchors and struts are shown in the Fig. 3.

Considering the irregular form and the dimensions in cross section of the excavation (starting from 15.00m up to 28.00m) it was designed a retaining system using two solutions: five levels of pre stressed anchors 20.00 to 28.00m long, with bulbs of 8.00 and 12.00m and four levels of steel struts made of pipes 600 mm in diameter. The calculated force in the anchors was 540kN.

Analyzing the existing structure of the buildings in the close proximity of the site, it was decided to increase the safety of the old multi-storey building in Arcului 4 Street (Fig. 3), by a screen of tangent micropiles of 180mm diameter drilled 8.00m deep.

-The sustaining system of the slurry walls was supplemented in the D1 defect area with steel struts (at -10.00m level), using piles as intermediary supports (Figure3); in the defect area (with high hydraulic gradient) the 5th level of anchors (at -13.55m) was replaced by local supports - inclined steel struts;

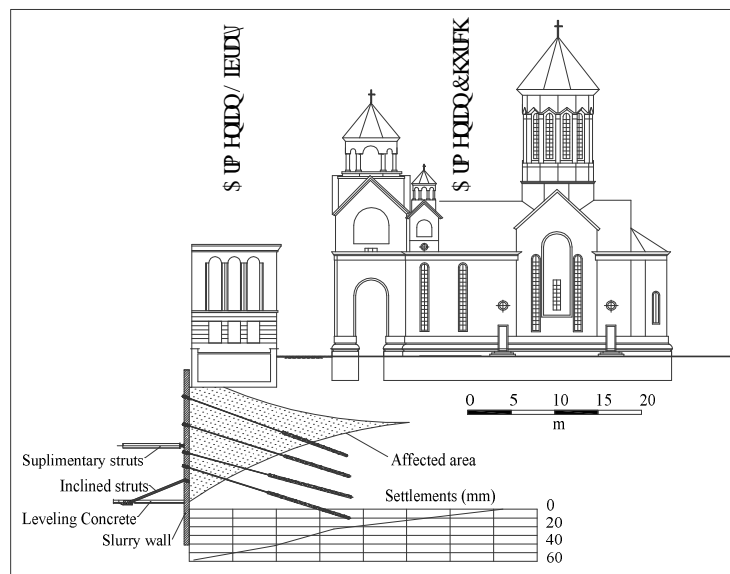
Fig. 9. Average settlements, influence of the defect D1, affected soil area

In the presented case, the major defects in the slurry walls, positioned unfortunately in the most sensitive area, lead to important loss of material and implicitly to settlements and damaging of the adjacent buildings; the influenced area was up to 20-25m from the excavation (Fig. 9).

- In order to restore the ground characteristics in the excavation surrounding area, a soil grouting program has been established, using a grid of vertical injectors from 6.00m to 8.00m deep; this program was based on the results of repeated dynamic penetration tests made on site, showing the most affected areas after the technical incidents (Fig. 9).
