Investigation of Structural Damage in a Corrosive Environment: A Case Study

Joanna L. Meldrum
Exponent Failure Analysis Associates, Inc., Menlo Park, CA

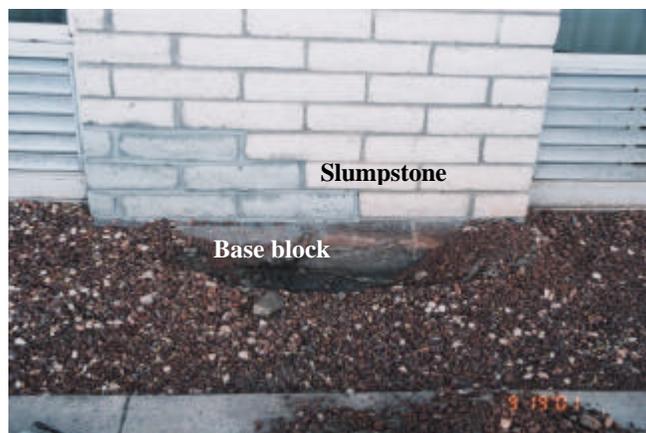
Of particular interest are the exterior shear walls along the east and west sides of the 4-story buildings. Figure 2 presents an overview of a typical exterior wall.

Fig. 2. Typical narrow exterior wall. Note that previous destructive testing had been performed on the left side of the wall.

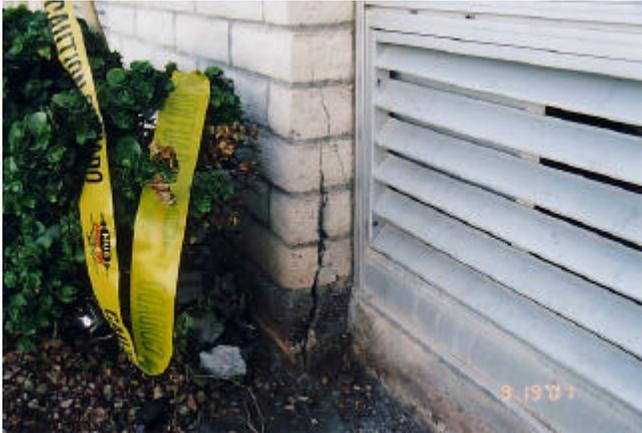
Damage to these walls in the form of vertical cracking (or

splitting) of the first few courses of block above the foundation level was reported subsequent to the October 16, 1999, Hector Mine Earthquake. The damage was noticed at the bottom, outboard ends of many of the walls, at or just above/below the soil line (Fig. 4).

Fig 4. Typical damage observed at base of slender CMU wall.

The cracks typically “daylight,” and are thus visually apparent, only at the wall ends (Fig. 4) and along the lowest mortar joint typically below grade and not visible without excavation.

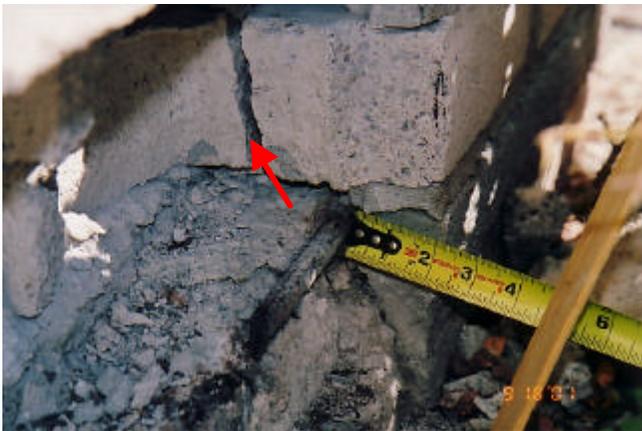
Further inspection revealed that the blocks were spalling (splitting) along a vertical plane parallel to and behind the front face of the wall (Fig. 5).

Fig. 5. Example showing existence of vertical crack in the central portion of a wall. The arrow points to the outer face of the block wall.

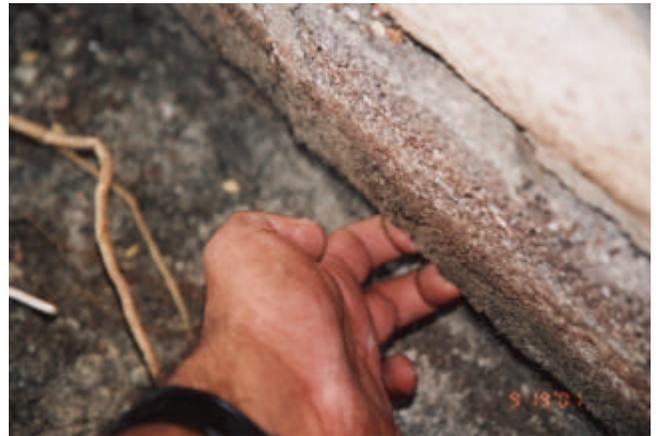
During the site investigation, the soil adjacent to the walls was excavated (depth ranging from less than a foot to 2-feet) to expose the base block in more than twenty locations around the perimeter of the buildings. It was noted that the cracking extended along the entire length of the wall in all areas where a source of water (sprinkler, spigot, drain, etc.) was identified in the immediate vicinity of the wall. The cracking was also observed along the non-slender north and south walls of the buildings. Figure 6 shows typical cracking noted in the base

Fig. 6. Typical cracking of base block. This condition was observed around the entire perimeter.

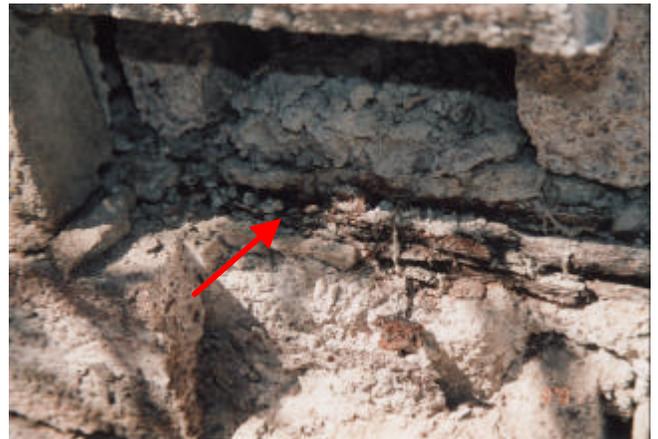
In all cases, the cracks and spalling of the CMU shells occurred at locations that exhibited significant corrosion of the reinforcing horizontal steel (Fig. 7).

Fig. 7. Example of severe corrosion of reinforcement in concrete. The arrow points to corrosion product as the original steel was completely corroded.

1. Splitting of the concrete block in all cases was associated with corrosion of the reinforcing steel. The volume of the corrosion product that is formed as the reinforcement corrodes is several times that of the original (uncorroded) steel. As the corrosion product expands, it stresses the surrounding concrete, eventually leading to cracking of the concrete block. In some locations the steel reinforcement was observed to be entirely corroded.

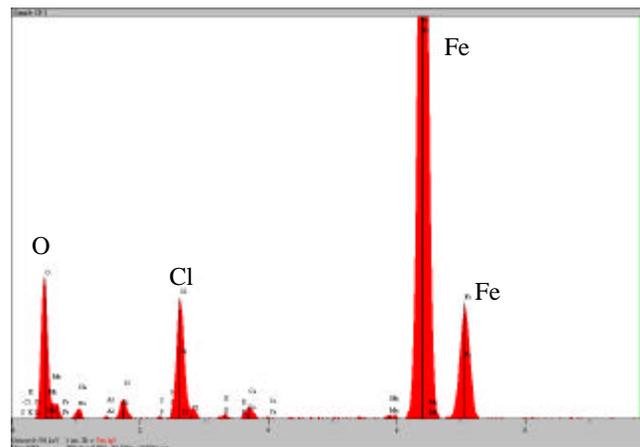
Scanning Electron Microscope (SEM) and Energy-Dispersive Spectroscopy (EDS) on three reinforcement and corrosion product samples was carried out to determine the elemental composition of the corrosion products. The results of the EDS analysis detected chloride ions on the corroded reinforcement samples and in the corrosion product (Fig. 12).

Fig. 12. Example of Electron Dispersion Spectroscopy (EDS) result for corroded reinforcement specimen

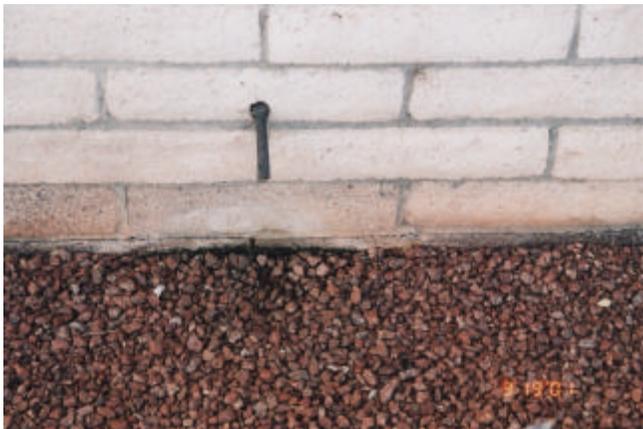
Sulfate ions in contact with concrete can cause the cement component of concrete to degrade, resulting in a more porous concrete (Fig. 13). This facilitates ingress of water, oxygen, and aggressive ions. The moderate levels of sulfates in the irrigation water are sufficient to cause mild sulfate attack. (ACI, 1992). Some evidence of sulfate attack was also noted in the petrographic analysis of the concrete samples.

Fig. 13. Example of deteriorated concrete located next to a source of water.
