Foundation Reinforcement of the Ipanema Beach Offshore Sewage Pipeline

FOUNDATION REINFORCEMENT OF THE IPANEMA BEACH OFFSHORE SEWAGE PIPELINE

The Ipanema Beach offshore sewage pipeline was installed thirty years ago in water depths up to 31m, in Rio de Janeiro, Brazil. It has a unique design, because steel piles were driven every 41 to 50m at joint along its length, in order to support it, keeping a constant gradient flow. These piles maintain the pipeline above mudline. After only a few years a first of these pile supports collapsed, allowing the pipeline to drop on the seabed, because of the occurrence of micro-cracks triggered by corrosion and environmental loads. Similar failures took place again before corrective measures could be taken. The main challenge faced at the end of 1999 was to solve the problem, thus avoiding any major consequence to the environment in the vicinity of the City of Rio de Janeiro, without having to interrupt the sewage pumping. This challenge was met by designing a non-conventional foundation reinforcement. In December 2001 the final support was reinforced. It is estimated that the entire life of the structure was increased by at least 30 years.

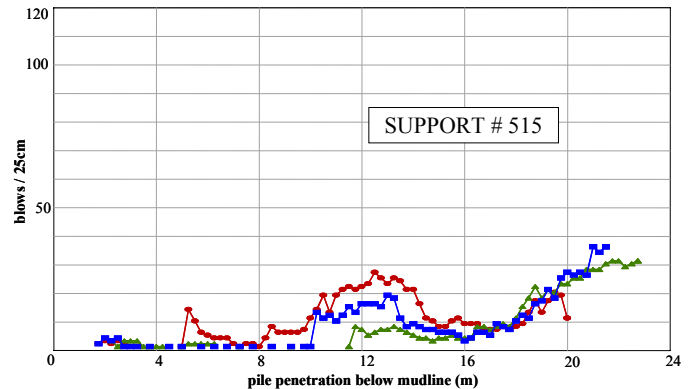
Fig. 8b - Typical Blowcount Records of Area 2

- Area 2, at 26m water depth, is approximately 1,200m away from the beach. The piles were driven up to 20-22m penetration below the seabed reaching 20 to 40 blows per 25cm. They penetrated practically due to self-weight for up to 10m (possibly in very soft to soft clay soils). From 10 to 14m a compact sand deposit was found. According to the geophysics, as the distance from the shore increases the rock deepens and along a 300m extension the second interface even vanishes from the records (the first interface varies between 3 to 10m);

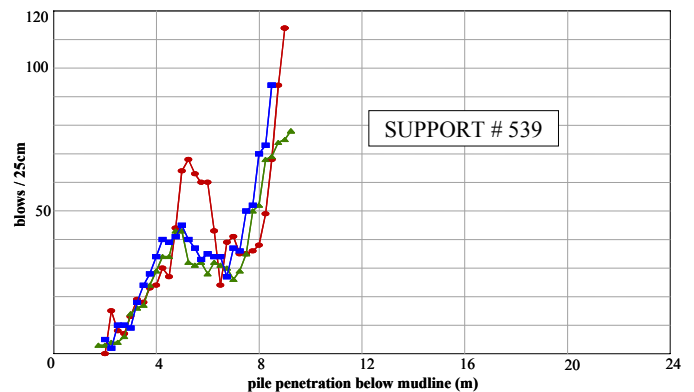
Fig. 8c - Typical Blowcount Records of Area 3

- Area 3, around 29m water depth, approximately 2,200m from the shore. In that location the piles were shorter than in the other parts. After a 2m self-weight penetration, between 4 to 8m penetration the blowcounts remained constant at around 30-40 blows per 25cm. Suddenly they increased to approximately 80 to 110 blows per 25cm at 8-9m penetration below the seabed. The soil profile below 2m seems to be a compact to very dense sand. The seismic survey identifies three interfaces, at 5m, 10m and below 20m (this deeper interface possibly represents the same rock identified in Area 1);

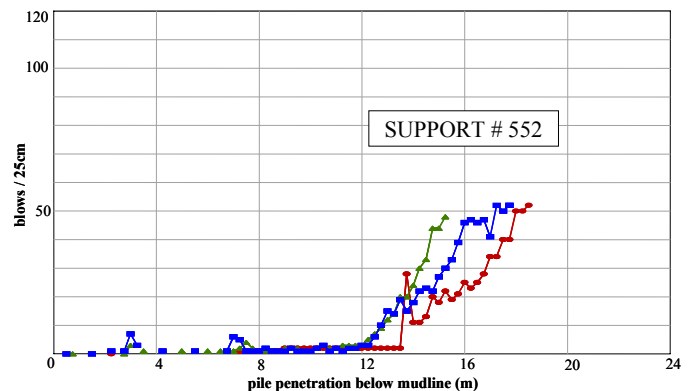
Fig. 8d - Typical Blowcount Records of Area 4

- Area 4, around 29m water depth too, approximately 2,800m away from the beach. This is the area where the presence of soft clay deposits becomes more intense. Self-weight penetrations of up to 12-13m were observed. After that the blowcounts increased to as much as 50 blows per 25cm at 15-18m penetration below the mudline (possibly in compact to dense sand). The geophysics showed just the third interface, varying between 12-25m (the two shallower interfaces disappeared along a length of 200-400m);

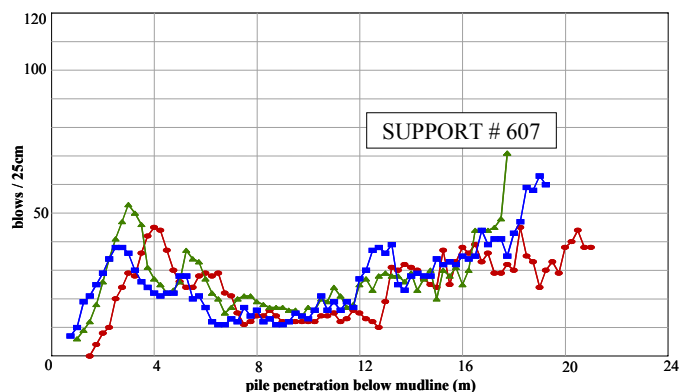
Fig. 8e - Typical Blowcount Records of Area 5

- Area 5 is the pipeline diffuser zone. This is the most distant area from the shore, at 31m water depth. Pile penetrations varied from 18 to 21m below the seabed. No self-weight penetration was verified. The driving possibly happened entirely through sandy layers. In the superficial layer the blowcount reached 50 blows per 25cm (dense to very dense deposit), but at 6-7m it decreased to the level of 10-20 blows per 25cm (medium compact to compact granular deposit). As penetration increased so did also the blowcount reaching 40-70 blows per 25cm at final penetration. The seismic survey identified the three interfaces at 5m, 10m and between 15 and 25m.
