Landslide Monitoring and Remediation – A Case History

LANDSLIDE MONITORING AND REMEDIATION – A CASE HISTORY

Located in the Catskill region of New York State, Bleheim-Gilboa Pump Storage Power Project has a generating capacity of approximately 1,000 MW. The Project was constructed in 1973, and consists of two reservoirs connected by penstocks and a pumping-generating hydro-power plant.

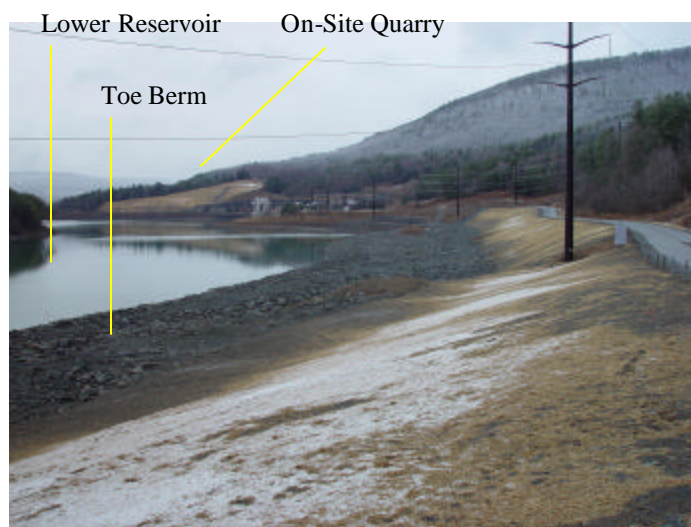
Figure 2. Completed Rock-filled Berm at the Toe of the Landslide

The remediation construction began in July and was largely completed by the end of 2001. A total of over 200,000 cubic yards of rock material was placed to complete the construction of the toe berm. Figure 2 shows a photo taken in February 2002 of the completed toe berm.

The buttressing remediation mainly involved the construction of a rock-filled berm along the toe of the landslide. Another key component of the remediation is the construction of drainage channels to systematically divert surface run-off away and off the landslide area.

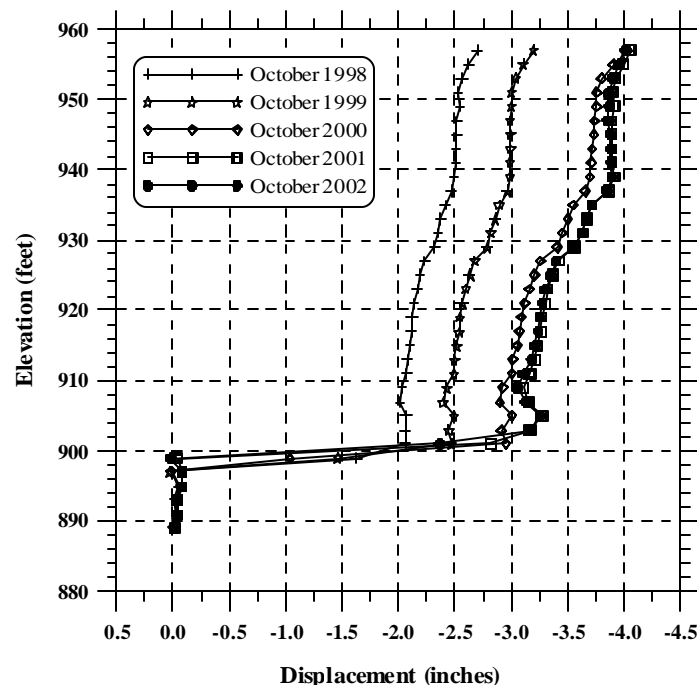
Figure 3. Measured Profile at IC-1

The inclinometer field readings have been taken on a monthly basis. The historical displacements measured at one of the downslope inclinometers (IC-1) are shown in Figure 3. For presentation clarity purpose, Figure 3 shows one set of inclinometer data for each year. A distinct shear zone of about 8 feet thick located at a depth of approximately 60 feet below the ground surface can be observed in Figure 3. It can also be noticed that the landslide movement has slowed down since the October 2001 measurement.

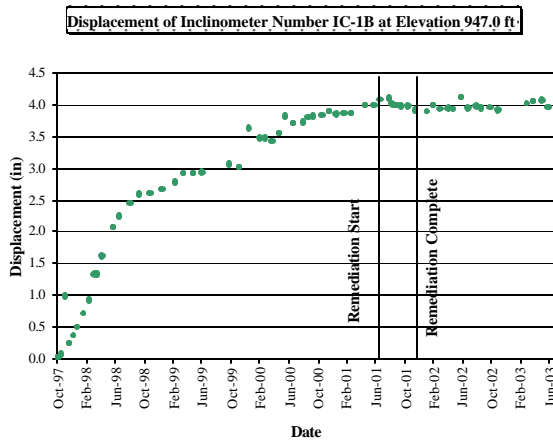
Figure 4. Historical Near-Surface Movement at IC-1

More monitoring data measured at IC-1 location are shown in Figure 4 which plots the historical movement measured at about 8 feet below the ground surface and in the general east-west direction.

Figure 4 indicates that the ground movement at IC-1 location averaged at about 3 inches per year during the first year of the measurement, and then decreased to an average of

approximately 0.53 inch/year in the following three years of period until the time of the remediation construction. Shortly after the commencement of the toe berm and surface water drainage system construction, movement at IC-1 has virtually been steady as indicated in Figure 4.

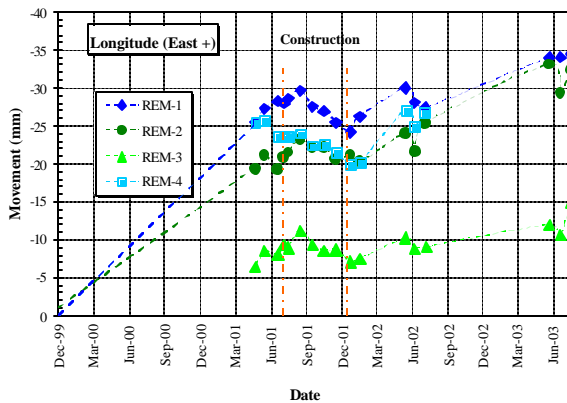
Figure 5. Landslide Movements Measured by GPS

The GPS measured landslide movements in the longitude direction are summarized in Figure 5. GPS measurements are generally consistent with those measured by the inclinometers. Based on our experience at this project, it is believed that the GPS is relatively more accurate than the inclinometers. However, GPS seems to demand more advanced maintenance and trouble shootings.

Thus far, even only one and a half years of monitoring data are available since the completion of the remediation construction, it seems that the movement of the landslide has decreased noticeably. The observed stabilization trend of the landslide is believed to attribute to both the toe berm and the surface water diverting system.
