International Conference on Case Histories in Geotechnical Engineering (2004) - Fifth International Conference on Case Histories in Geotechnical Engineering

## An Unstable Deep Canal Cut in Fat Clay – A Case History of Slope Failures on the McClusky Canal, North Dakota

Mark C. Gemperline

*U.S. Department of the Interior, Bureau of Reclamation, Denver, Colorado*

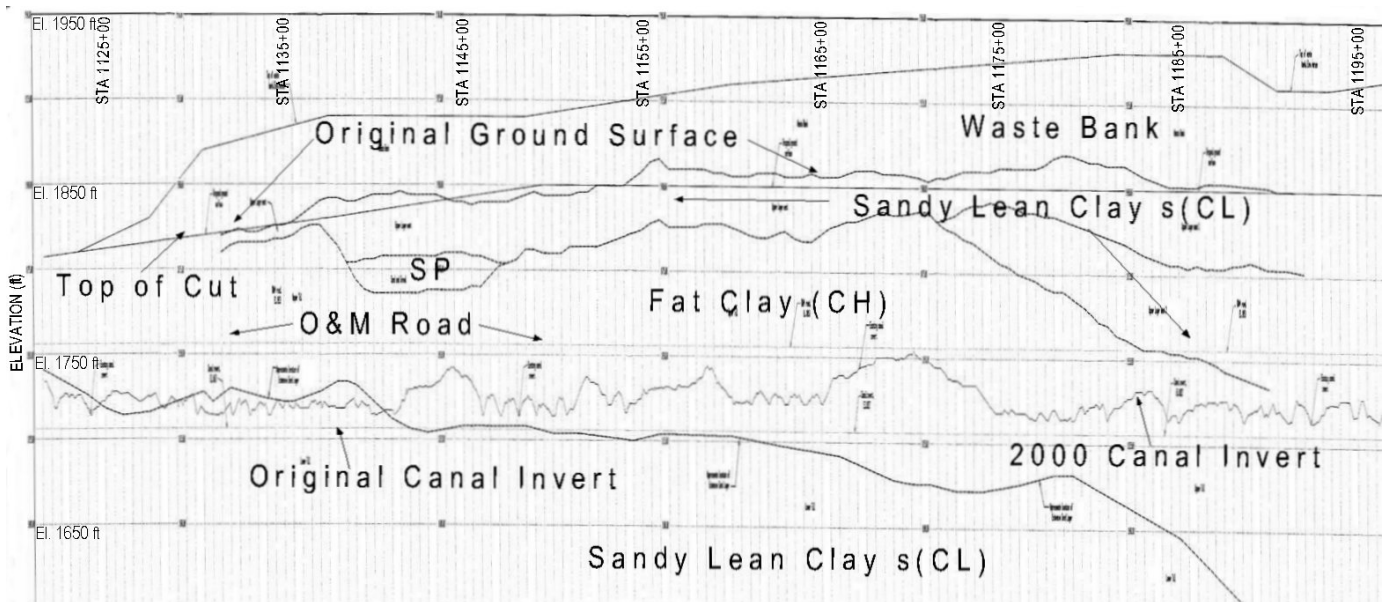
Figure 2 portrays a centerline profile of Reach 2A showing the waste bank, original ground surface elevation, top of cut after construction, canal invert information. The stratigraphy shown in this figure will be discussed later.

Fig. 2. Canal Centerline Profile and Stratigraphy

Local soil strata are approximately planer and dip to the south at about 1 degree. The canal is directed east through the first half of Reach 2 and then turns slightly to the south near the midpoint as seen on Fig. 3. Consequently, soil layers observed on the cut face of the canal appear horizontal through the first half of Reach 2, and appear to dip in the later half. Figure 2 portrays the general stratigraphy along the Reach 2A canal alignment using an exaggerated vertical scale.

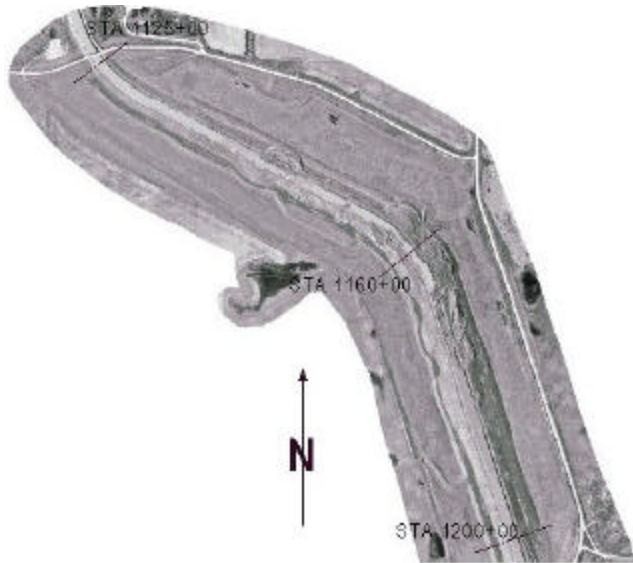
Numerous slope failures have occurred in Reach 2A throughout its approximate 30 year history. Some slides occurred during and shortly after construction, however, most occurred later. Often the latter slides occurred during periods of rapid snowmelt or after large precipitation events. Longitudinal tension cracks along the crest of the slope or in the waste bank were often observed for months and/or years preceding slides. In the winter these cracks would fill with ice. Perched water seeps into the canal cuts at several locations. Figure 3 presents an aerial photograph taken in May 1999. Many existing slides are apparent. Continued landslides and slope modifications have altered the shape of the canal since the photograph was taken.

Fig. 3. 1999 Aerial Photograph of Reach 1

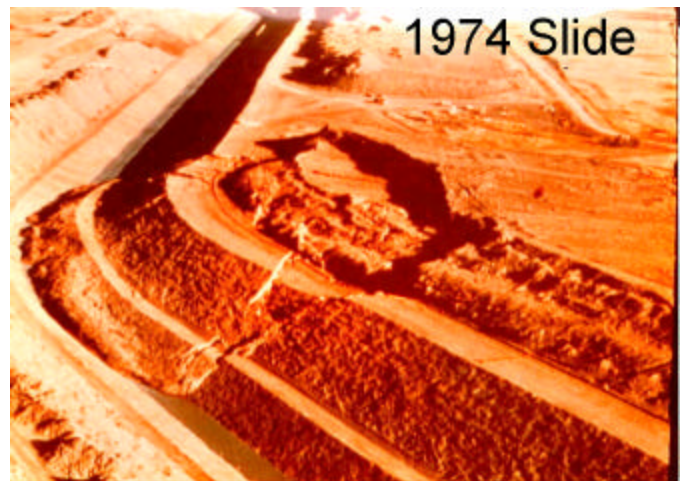
Major slope failures were noted between stations 1661+30 and 1673+50 shortly after excavation in the fall of 1973. In the fall of 1974, a large slide occurred on the left side of the canal prism between stations 1206+61 and 1216+40; a short distance beyond the southern end of Reach 2A. A photograph of this latter slide is provided on Fig. 4. An ensuing investigation, summarized in a 1977 report, concluded “The results of the analysis indicates that canal slopes should be cut back to either a 3:1 or 4:1 slope” (USBR 1977). In addition it was recommended that the Waste bank be moved farther from the canal. The study used the Spencer Method for slope stability analyses. Pore water pressures for effective stress analyses were estimated using Ru values (Ru is the ratio of

Fig. 4. 1974 Slide Located Beyond the South End of Reach 2A. Reach 2A is visible in the background.

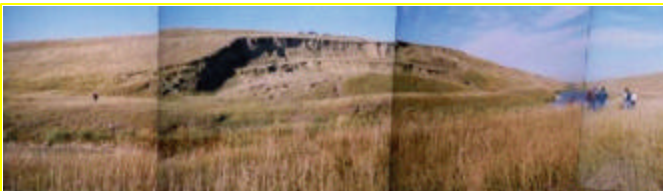
It was noted by operation and maintenance personnel that slide activity was correlated to precipitation events. The Bureau of Reclamation annual 1998 Operation and Maintenance Review makes the following statement regarding recent slides; “Most of the (more recent) slides along the McClusky Canal occurred in 1993, after a very large rainfall event, which local landowners estimated to be 12 to 14 inches of rain within a 24 hour period.” Aerial photographs, taken a day after the storm, show large pools of standing water in farmland located adjacent to the canal. Figure 5 shows a recent 90 ft high slide near the center of Reach 2A at Station 1160+00.

Fig. 5. Recent Slide on Right Side of Reach 2A Near Station 1160+00.

Operation and maintenance personnel have noted a frequent occurrence of slide remobilization. This is due, in part, to the practice of excavating the toe of slides to eliminate canal blockage.

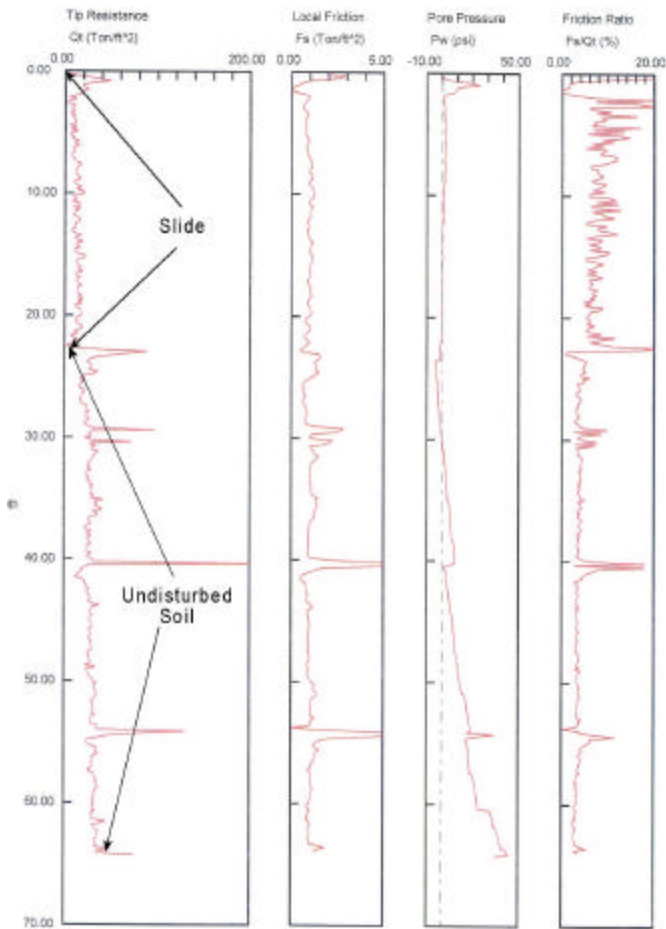
Seventy-three cone penetrometer holes were pushed to depths of 50 to 100 ft to characterize soil type, soil strength, stratigraphy, and ground water conditions in Reach 2A. A typical cone log is provided on Fig. 6

This log represents a location where a cone was pushed through the center of a slide. In this instance the disturbed slide material is readily distinguished from the underlying, stiffer, undisturbed soil. This type of information was very helpful in establishing slide geometries.

Fig. 6. Example Cone Penetrometer Log

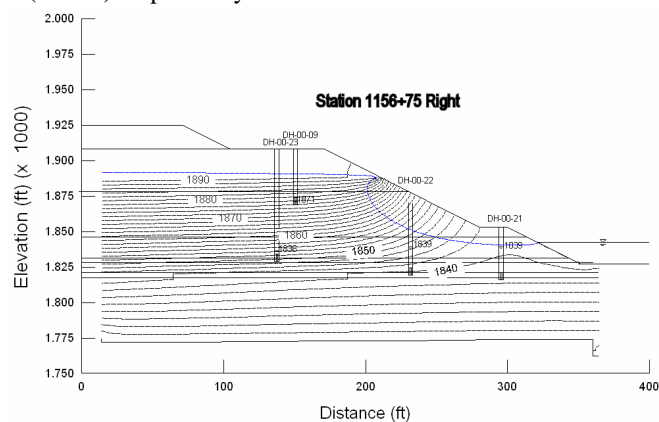
A typical groundwater model for Reach 2A, characterized by equipotential lines, is shown on Fig. 9. Models were created using the computer program SEEP/W<sup>TM</sup> (SEEP/W 1999). Figure 9 represents expected groundwater flow in a Reach 2A canal slope section during periods of normal periods of rainfall. Several models representing different cross-sections of Reach 2A were created. Similar models were made to represent periods of extended precipitation. Pore pressures for effective stress slope stability analyses were obtained directly from these groundwater models.

Fig. 9. Equipotential Lines and Groundwater Elevations Representing Hypothesized and Measured Groundwater Conditions Respectively.
