## LANDSLIDE STABILIZATION AT MISSOURI ROUTE K BRIDGE OVER BLACKWATER RIVER

### ABSTRACT

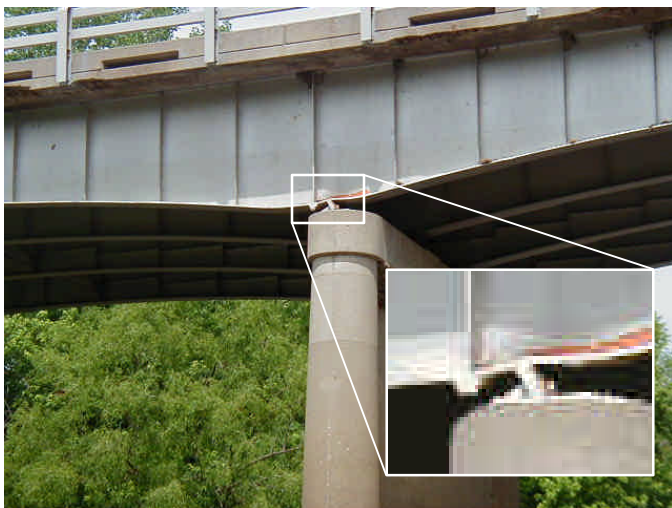
In May 2002 during a flood event on the Blackwater River, a landslide occurred on the south riverbank. The landslide caused bridge Pier 4 to move approximately 12 to 15 inches horizontally toward the river and 1 to 1.5 inches vertically upward. The pier movement caused the bridge girders to drop off the rocker bearings. The damage caused by the slide resulted in the Missouri Department of Transportation (MoDOT) closing the bridge to vehicular traffic.

In late May 2002, local residents of Blackwater and the surrounding area noticed a sag in the Route K bridge deck and railing. The residents alerted MoDOT. On May 29, 2002, MoDOT emergency personnel observed that the rockers supporting the main span girders had “rolled over” at all the bearings at Pier 4 of the bridge (see Fig. 3). MoDOT personnel suspected that a landslide had occurred and closed the bridge to vehicular traffic. MoDOT retained URS Corporation to investigate the landslide and recommend stabilization options.

Fig. 3. Damage to Rockers at Pier 4.

As a result of the landslide-induced damage to Pier 4, it was necessary to replace the existing pier. To achieve a redundant design, MoDOT decided to design the foundation for the replacement pier to withstand the lateral soil pressures resulting from the landslide assuming that no slide stabilization was constructed. We estimated that the lateral soil load on the shafts would be uniformly distributed with a magnitude of 10.8 ksf. This value corresponds to  $12s_u$ , where the design undrained shear strength,  $s_u$ , was taken as 900 psf.

To withstand these lateral pressures, two 9-ft diameter drilled shafts were required for the Pier 4 replacement foundation. The shafts required 8.5-ft diameter sockets drilled 17 ft into limestone bedrock. Because of an accelerated construction schedule, construction of the shafts was to be done concurrently with slide stabilization work.

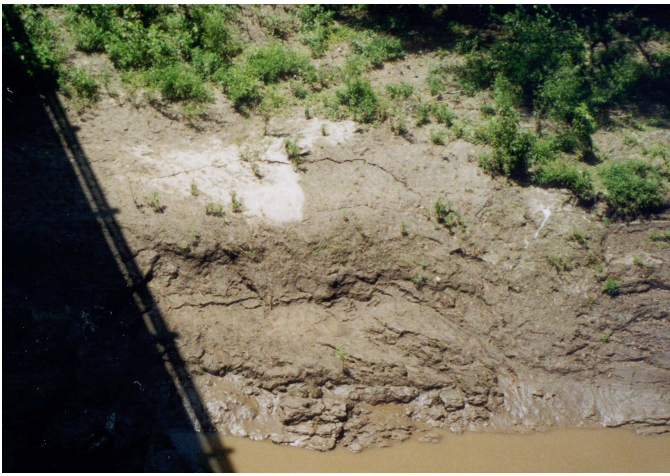
On June 7, 2002, we observed a number of scarps striking roughly parallel to the river extending from the riverbank to approximately 10 feet north of Pier 3, as shown in Figs. 4 and 5. Lateral movements at the scarps were about 1 to 2 inches and some showed vertical displacement of up to 12 inches. By July 1, 2002 many of the scarps were more visible as a result of dry weather. We observed another major scarp (originally obscured by vegetation) that was located approximately 40 feet north of Pier 3 and extended approximately 300 ft to the west to a concrete boat ramp (see Fig. 5). The scarp appeared to be pre-existing and showed lateral and vertical displacements of about 3 inches and 3 ft, respectively.

Fig. 4. Northern Portion of "Shallow" Landslide.

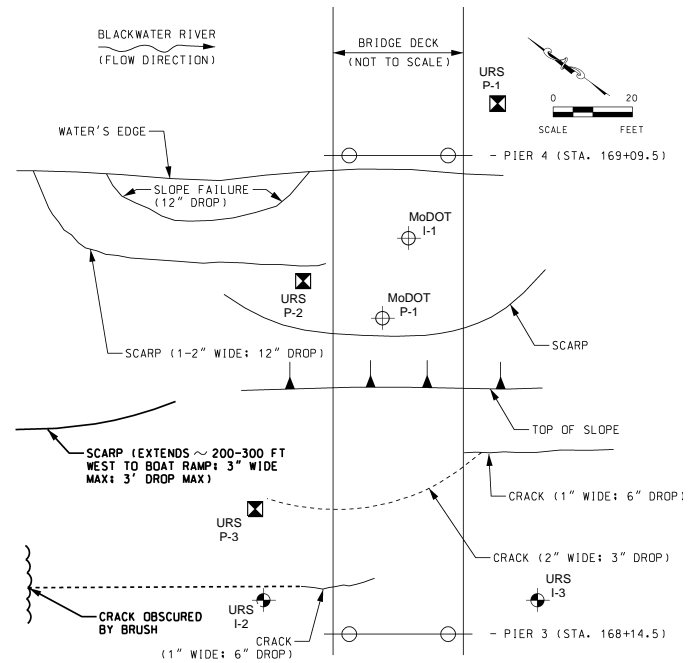
In early July 2002, URS drilled four borings at the site as shown in Fig. 5. URS installed inclinometers (socketed into bedrock) in two borings to evaluate the extent of the existing slide and monitor slope movements during stabilization work at the bridge. URS also installed vibrating wire piezometers at three locations. One piezometer was installed to monitor groundwater conditions in the gravel layer overlying bedrock, and another was installed to monitor the surficial clayey and silty soils. URS installed the third piezometer in a 30-ft long steel casing that was lowered from the top of the bridge into the river to monitor river levels. One end of the casing was laid on the south riverbank while the other end extends about 25 feet into the river. All recent (2002) borings were drilled using rotary wash techniques. Samples were obtained using a split spoon sampler in accordance with the standard penetration test (SPT; ASTM D-1586) or a 3-inch O.D. thin-walled Shelby tube (ASTM D-1587).

Fig. 5. 2002 Boring Location Plan and Site Observations.  
(Note observations in bold made July 1, 2002.)

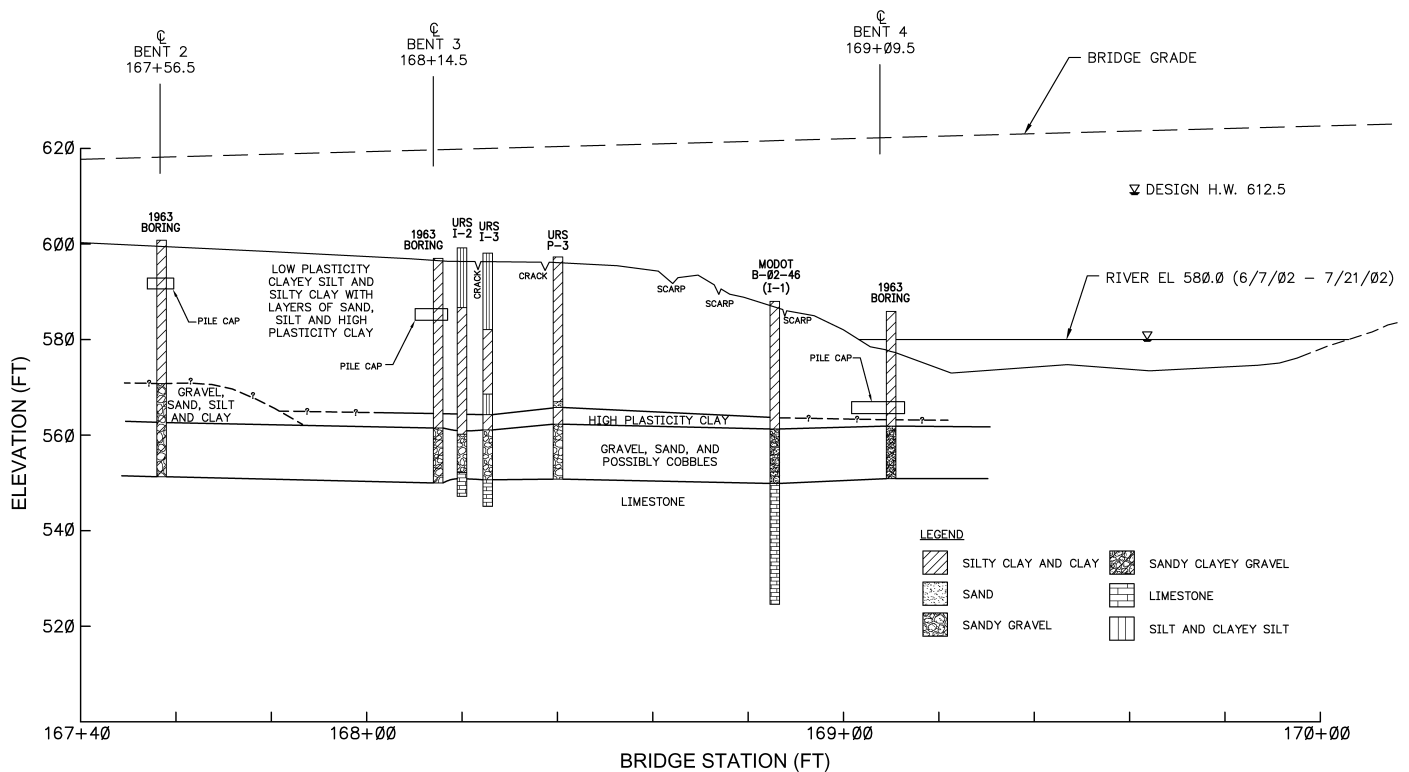
Four primary subsurface strata are present at the site: (1) interbedded silts and clays; (2) high plasticity clay; (3) gravel and sand; and (4) limestone bedrock. Figure 6 presents the subsurface profile and Fig. 7 summarizes the index and engineering properties of the materials.

Fig. 6. Subsurface Profile.

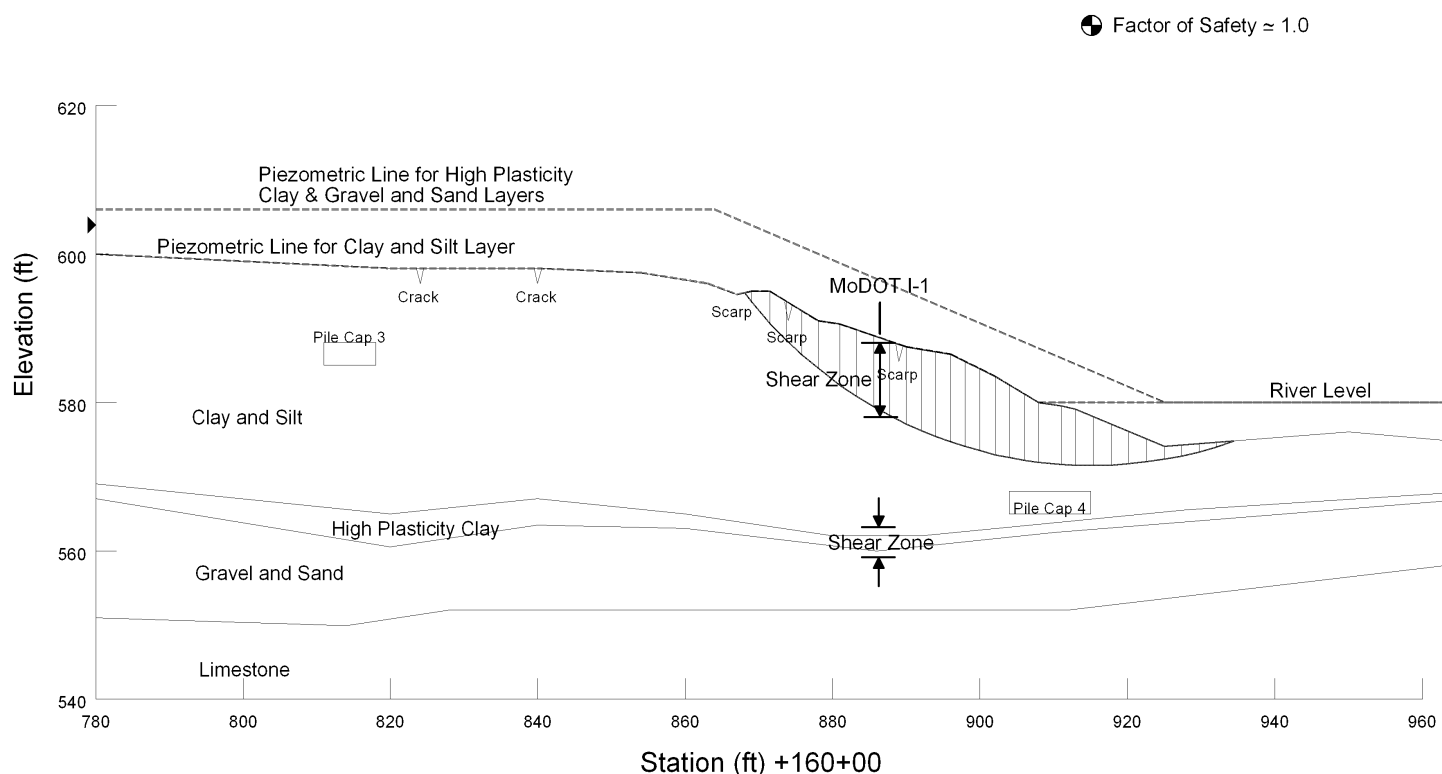
Based on the field investigation, we anticipated that two separate slides occurred at the site – a “shallow” and a “deep” slide. The shallow slide likely was triggered by rapid drawdown of the river, i.e., high water pressure in the silt and clay attempting to exit the slope with no equalizing water pressure from the river against the slope. This slide presumably occurred after the deep slide as the Blackwater River receded. This type of slide occurs regularly along the Blackwater and evidence of rapid drawdown slides is visible at numerous locations upstream and downstream of the bridge.

**Shallow Slide.** Figure 8 presents the back-analysis results for the shallow, rapid drawdown failure. As indicated in the figure, the head of the critical slip surface corresponds to the large scarp at the edge of the bank. Furthermore, the depth of the critical slip surface corresponds to the upper zone of movement measured in MoDOT I-1. We believe that this slide occurred after the deep failure as the floodwaters had receded, and that this slide did not influence the movement of Pier 4.

The analyses indicated that the shallow slide was marginally stable, with a factor of safety (FS) of about 1.1. This FS is consistent with the minor creep movements observed in MoDOT I-1. As such, the drained friction angle of 28° assumed for the clay and silt layer appeared reasonable.

Fig. 8. Back-analysis of "Shallow" Slide.

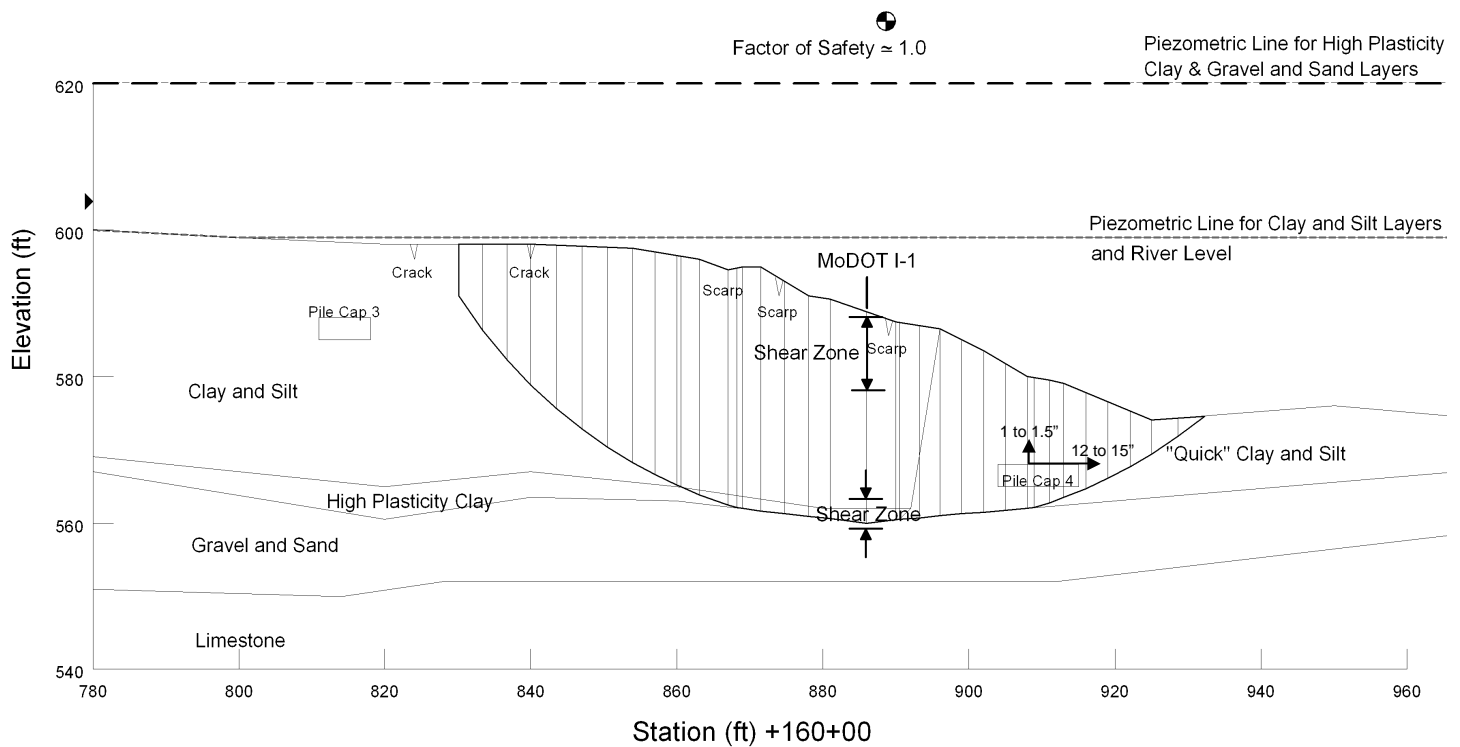
We suspected that artesian water pressures in the gravel layer triggered the deep slide. Based on observations of limestone outcrops along the northern bank, it seems likely that the gravel layer is hydraulically connected to the river via jointing in the limestone bedrock (and possibly local scour of the riverbed). While the floodwaters started to recede, we believe sufficient artesian head was present in the gravel layer to cause a quick condition below the streambed. This caused the clayey streambed soils (and toe of the slope) to fracture and “blowout.” When the toe of the slope was lost, a slide occurred within the high plasticity clay near the interface with the gravel layer or along the upper surface of the gravel and sand layer. These circumstances are rather unique because similar failures did not occur during major floods in 1993 and 1995. In this case, we presume that the floodwaters receded more quickly than the artesian pressure dissipated due to the

**Deep Slide.** Figure 9 presents the back-analysis results for the deep failure related to artesian pressures. As indicated in the figure, an artesian water level in the gravel layer of El. 620 is required to yield a factor of safety of about unity. This implies that the flood levels were higher than El. 612.5 and/or joints in the limestone charged the artesian pressures. This artesian head triggered quick conditions over a wide zone in the gravel layer. The soil labeled "quick" clay and silt indicates the extent of quick conditions in the gravel layer. In addition, a tension crack to the depth of the more permanent watertable (about El. 590) was added to reduce tensile forces in the slices. Figure 9 indicates that the head of the critical slip surface falls between the cracks observed just north of Pier 3 and the bottom of the critical slip surface corresponds to the lower zone of movement measured in the inclinometer.

Because the stability analyses provided factors of safety close to unity, these conditions (i.e., an approximate head difference of about 20 feet between the river and gravel layer) were

The analyses also indicated that the deep slide had stabilized, with a FS of about 1.3. This FS was consistent with the inclinometer data in MoDOT I-1 and survey measurements of Pier 4 that indicated essentially no continuing movement of the deep slide or Pier 4.

Fig. 9. Back-analysis of "Deep" Slide. Note that Pile Cap 4 was Moved 12 to 15 inches Laterally and 1 to 1.5 inches Vertically.

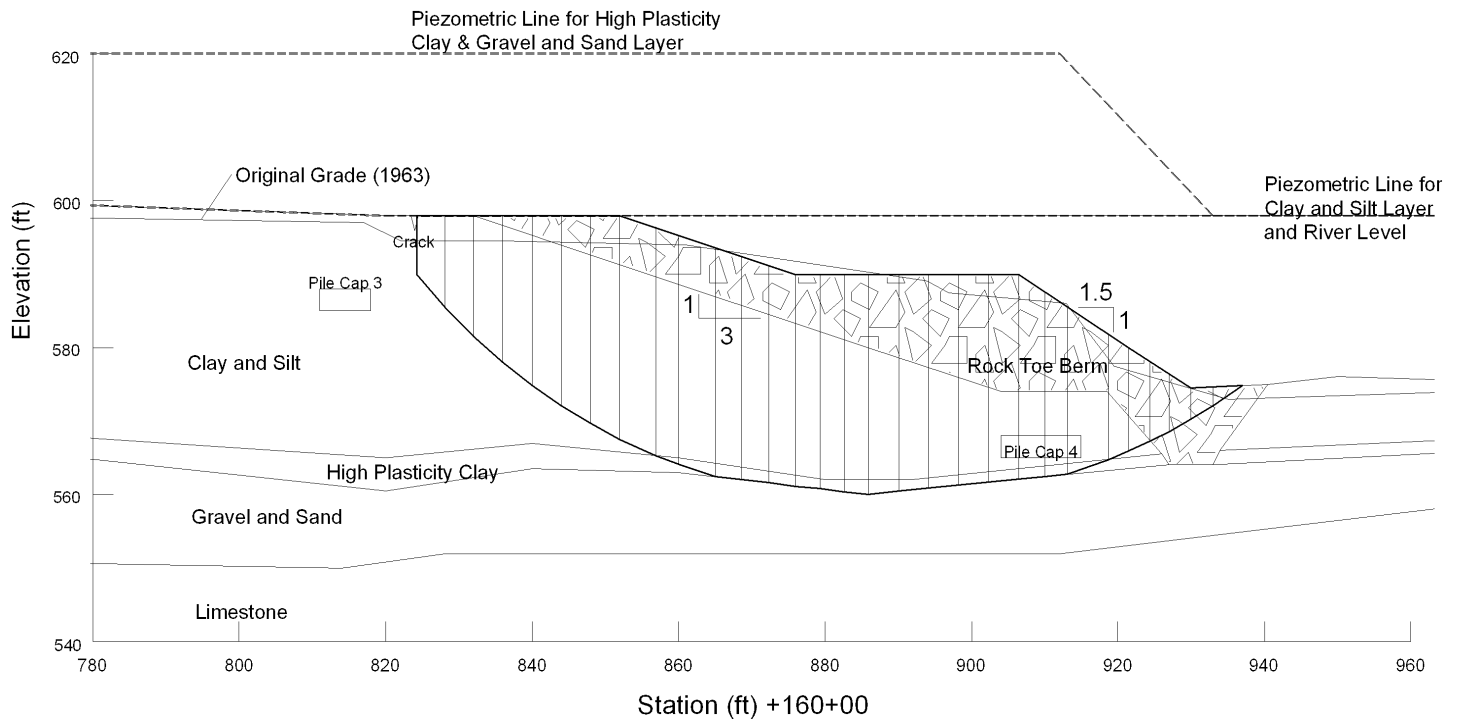
Fig. 10. Rock Toe Berm Design Section and Example Trial Sliding Surface.

Figure 10 shows the design configuration of the rock toe berm. The only restriction for the toe berm was that the final berm configuration was limited to the geometric limits of the riverbank at the time of bridge construction in 1963. The final slope of the toe berm is 1.5H:1V and the top of the berm is at El. 590. This configuration was developed to provide a factor of safety against slope failure of at least 1.3 throughout construction and during a repeat of the water conditions that caused the failure in Spring 2002 (i.e., river level at El. 599, artesian head at El. 620). To prevent scour and erosion of the toe berm material, it was decided to utilize MoDOT Type 2 Rock Blanket material (about 3-ft diameter rock).

The rock toe trench provides a drainage path for artesian pressures during flood events. This element of the repair will prevent a quick condition from developing in the gravel layer and prevent a "blowout" near the berm toe. Furthermore, the

toe trench protects the berm from being undercut by local erosion or scour of streambed soils at the toe of the berm. Lastly, the weight of the berm prevents a shallow rapid drawdown failure of the riverbank clays and silts.
