Geotechnical Investigation of the Hollóháza Landslide Case

GEOTECHNICAL INVESTIGATION OF THE HOLLÓHÁZA LANDSLIDE CASE

Hollóháza is a little mountain village in North-East Hungary. Following a long wet period in 1999 the largest mass-wasting event of the 20th century occurred. The total volume of mobilized earth material was over 1.5 million m³. One major concern of problem management was that the value of the damaged infrastructure was less than the total costs of restoration and stabilization, while the natural potential of the settlement is outstanding. After investigating the causes of the landslide the cheapest effective solution had to be found. Hollóháza is surrounded with the residuals of a 4-6 km diameter volcanic caldera. The settlement was established in the natural depression of the caldera where the bottom andesite is covered with varying depth of rhyolite-tuff and clayey marine deposits with the tilt of 10-25 degree toward the valley. The rhyolite-tuff that is originally fallen into seawater has a high bentonite content, montmorillonite content is close to 60%. The covering clay layers has almost 40% illite-montmorillonite content. Water from precipitation moves towa

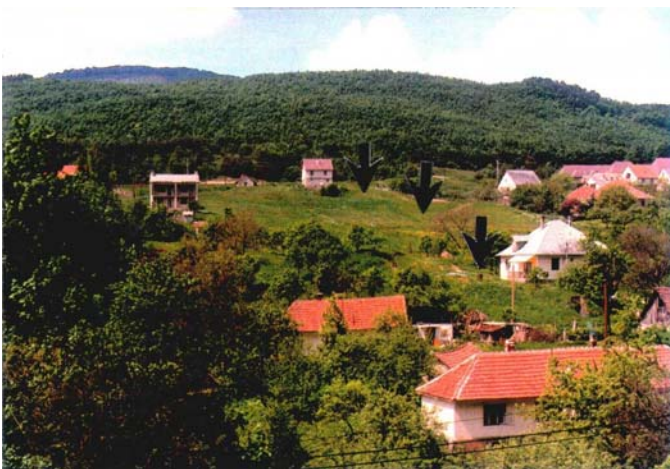
Slide 1. Transverse ridgers caused by earlier slides

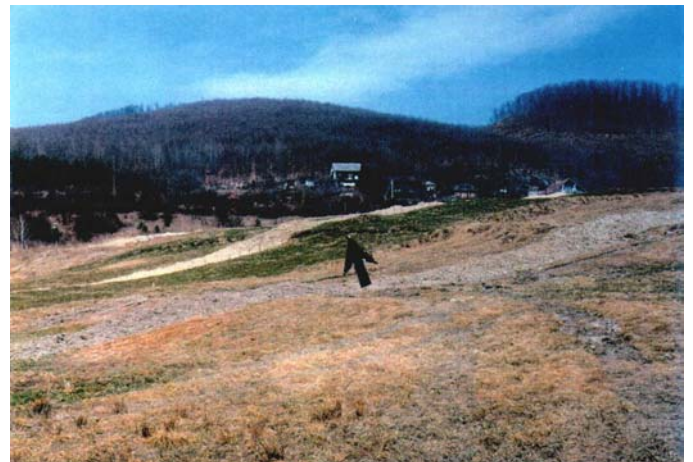
Slide 2. Toe of the slide surface

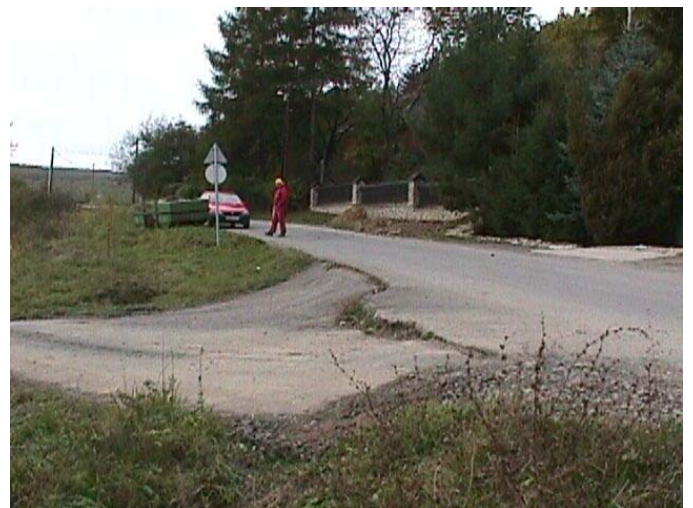
Slide 3. Transverse crack by the top of sliding surface

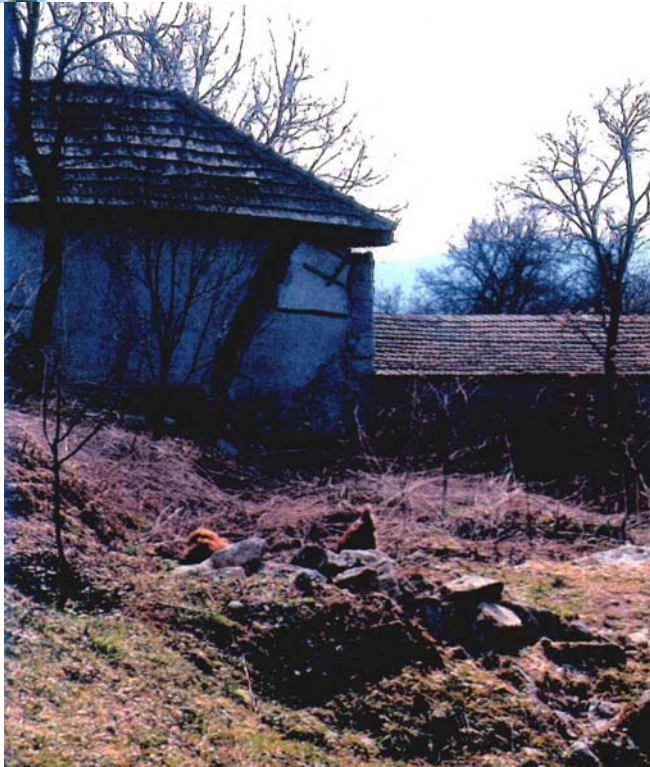
Slide 4. Cracked and damaged building on the sliding area

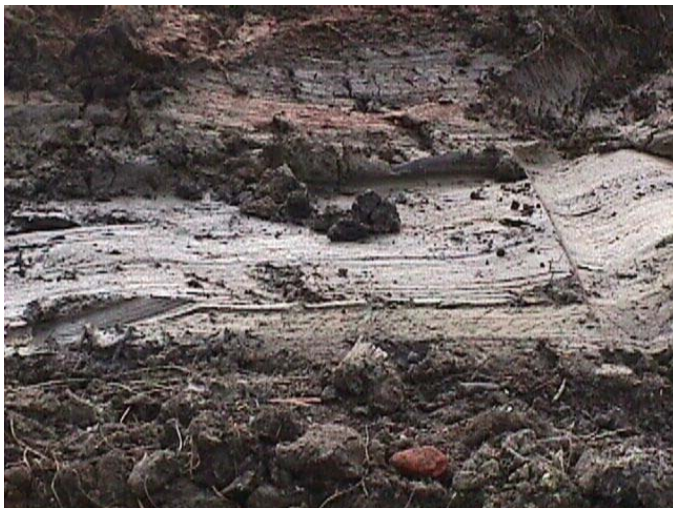
Slide 5. Monmorillonite clay on the sliding surface

This depression is cut across by a NW-SE tectonic valley, which accommodates the channel of the Török creek. The rhyolite-tuff and clayey marine deposits lay with the tilt of 10-25 degree toward the valley. At the hill foot the rhyolite tuff is covered by massive dacite and andesite lava and their clayey weathered residuals. The rhyolite tuff mixed with seawater deposits has increased bentonite content (60% montmorillonite) and the covering and bottom sea deposits have also high (40%) illit-montmorillonite content. These deposits tend to expand when contacted by water.

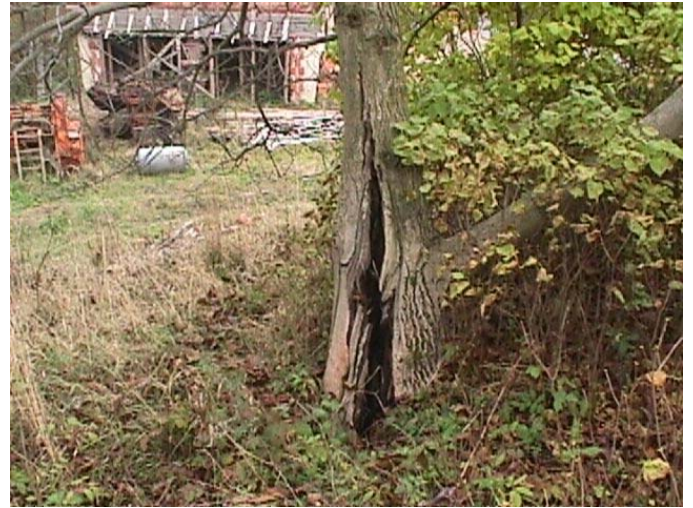
Slide 6. A tree splitted of by a transverse crack

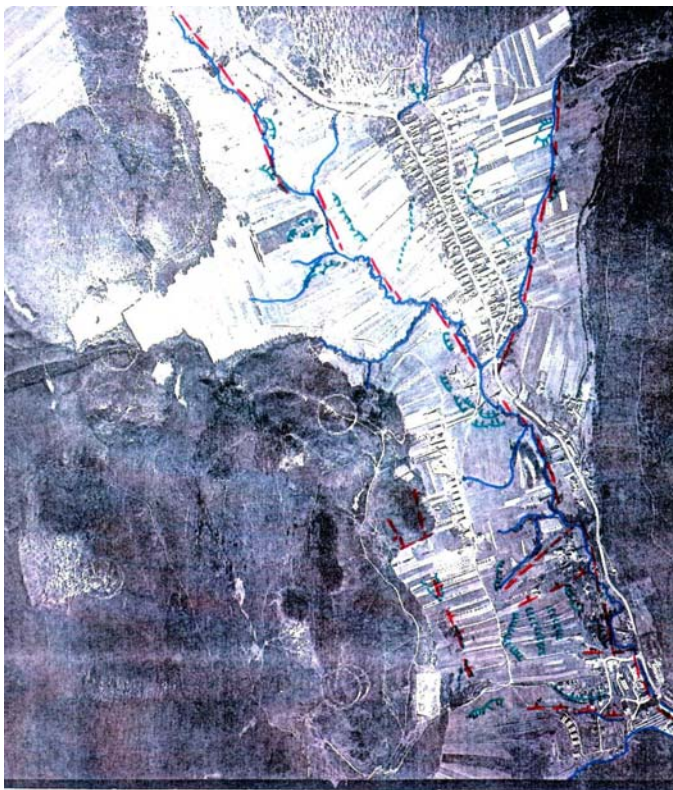
Topographic maps and aerial photographs of the site (Figure 2.) show the bending shaped foreheads of mass movements, creeps and series of bigger scale, flocs and sinks on the areas covered by clay or rhyolite tuff material. At other locations, where rhyolite tuff and clay layers are covered by hard lava flow these formations do not exist.

Figure 2. Traces of mass movements on the Hollóháza aerial photograph

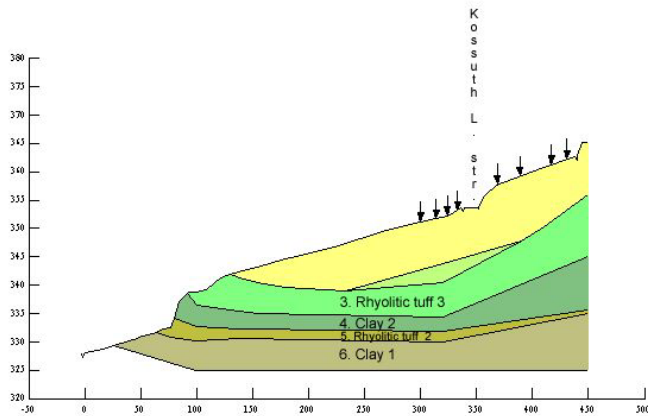
Figure 4. Typical geological cross section of the Northern area

The figures show that the geological setting of the Northern and church sites are rather simple, the sliding surface is always the boundary between the clay and rhyolite layers. The difference is that while on the church site only one sliding surface is predicted on the Northern site at least four sliding surfaces are probable. The volume of the mobilized earth material is around 1,5 million m³, and 0,2 million m³ at the church site.

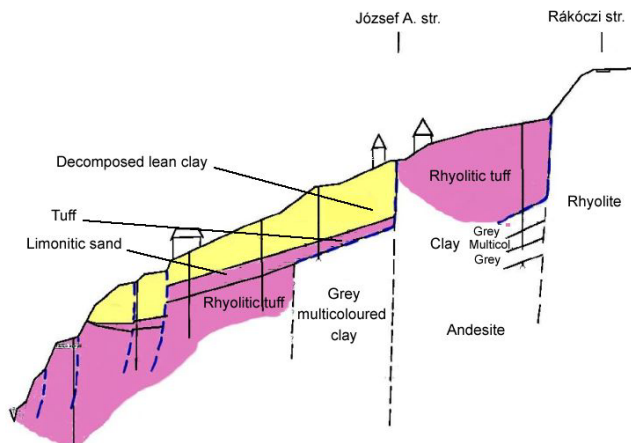
Figure 6. Typical geological cross section of the site near the kindergarten

The movements near the kindergarten are somewhat different from that of the Northern site. The hillside has a multi-layered terrace structure at this location (Figure 6.). The surface of the 3-5 steps in the topography are leveled or slightly dip backward. These are for sure the residuals of former slides occurred in several steps. Due to the more complicated geological structure geoelectric investigation supported the traditional borehole logging. Figures 7-8. show 2 longitudinal and 2 perpendicular geophysical cross-sections.

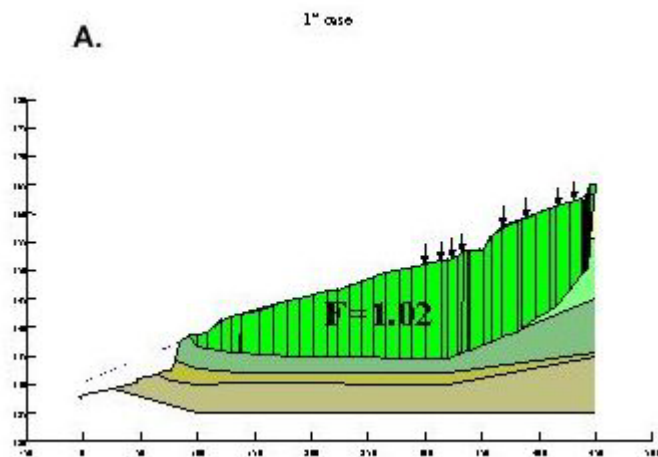
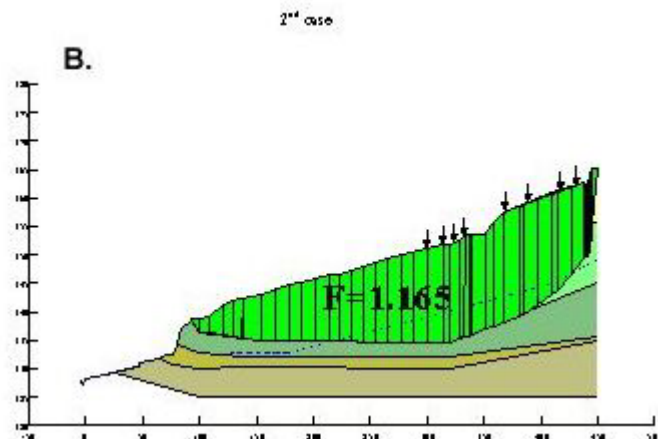
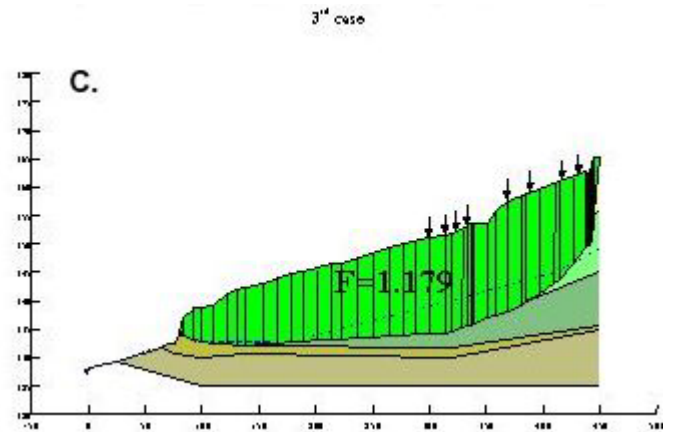
Out of 15 stability assessments 3 typical cross sections are indicated on Figure 10. On Figure 10a. the sliding surface is that of case 1., with groundwater level on the surface. On Figure 10b. the same case with groundwater level 16m below surface. Figure 10c. shows Case 3 with groundwater level 16m below surface.

It was concluded during the slope stability analysis that 12-16m lowering of groundwater is necessary in order to achieve the minimum level of safety of stability, which is the partial protection of the site allowing smaller scale instabilities.

Stability - considering cost-benefit aspect as well - can be achieved by lowering the groundwater level according to our calculations. This way $SF=1.2$ level can be achieved. Installations needed for lowering groundwater level are the following:

- On residential areas dewatering arms starting from vertical shafts. In the initial phase the existing dugged domestic wells can increase efficiency, however their average depth of 6,0-10,0 m; is not sufficient.
- Installation of retaining walls at the tongue of mobilized earth materials. Traditional drainage ditch may cause further instability due to the unfavorable soil characteristics. It is recommended to install geo-drains or flat-drains because only minor leakage is anticipated.
- It would be necessary to install a boundary drain system outside the mobilized area. It is aimed to eliminate potential inflow to the area.

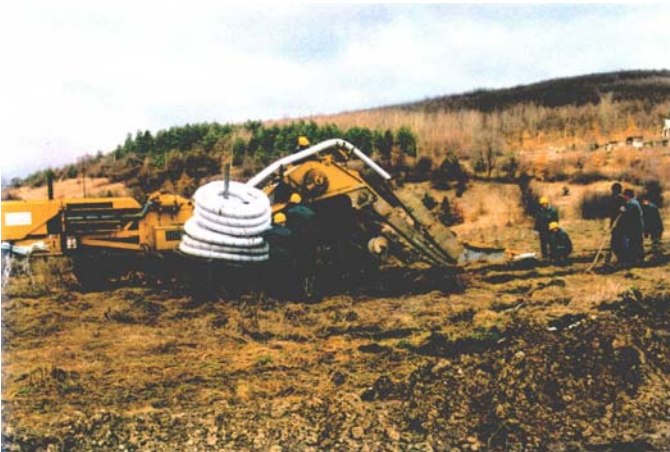
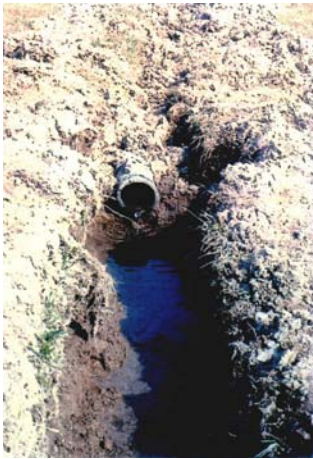
The temporary testing of the proposed methods have already started while the assessment of the site was conducted. The interventions caused couple of meters decrease in groundwater level in existing wells and the installation of 6 geodrains at the front of the mobilized locations. This resulted that the intensity of the daily movements decreased from the scale of cm-s to a few millimeters. The discharge of the 30-40m long drains was not more than 10-30l/min/drain (see Slides 7-8.).

Slide 7. Construction of geodrains

Slide 8. Outcoming water from geodrains
