Drake Lake Dam – A Performance Case History

DRAKE LAKE DAM - A PERFORMANCE CASE HISTORY

Drake Lake Dam was constructed during the summer of 2000 as part of the development of the Jim Edgar/Panther Creek State Fish and Wildlife Area in Cass County, Illinois. The earthen dam on a natural soil foundation has a length of 450 feet and a height of 45 feet with 3H:1V upstream and downstream slopes. The dam has a principal spillway structure consisting of a cast-in-place concrete drop inlet tower, a 36-inch reinforced concrete pipe (RCP) outlet pipe, and an impact-basin-type energy dissipater/outlet structure. Construction of the earthen embankment began in July 2000 and ended in September 2000. During the latter stages of construction, observed and measurable distress of the dam was detected in the inlet tower and RCP outlet pipe. The movement measured in the principal spillway intake tower and the 36-inch RCP was the result of lateral spreading and vertical cracks in the embankment dam, both in the downstream and upstream direction, due to rapid embankment filling over the soft, silty clay foundation soils. Redesign of the dam structure was required to account for these unexpected site

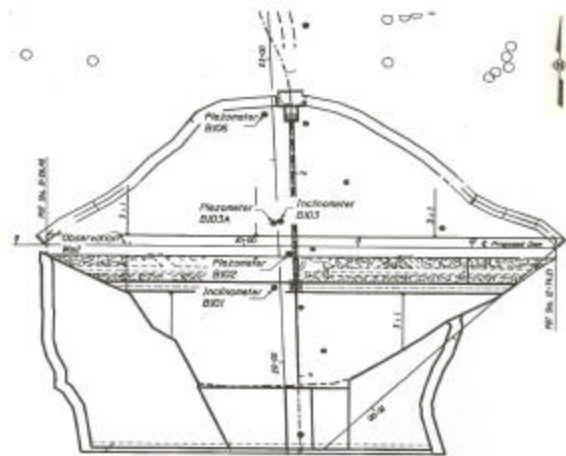
Fig. 1. Drake lake Dam – Plan View

This earthen dam was constructed from July to September 2000 and experienced observable and measurable distress during the latter periods of the construction. Upstream tilting of the principal inlet structure tower was observed. The upstream tilt was measured in the range of 9 inches from the current top of the spillway structure to the top of the pile cap. In addition, the segmental, 36-inch-diameter RCP beneath the embankment elongated horizontally and settled a maximum of 10.2 inches at the joint, 20 feet downstream of the spillway

intake tower, with lesser amounts of settlement at pipe joints near the toe. The pipe joints had total joint separation in the range of 13 inches (8 inches downstream of the intake structure and 5 inches upstream of intake structure at the base of the spillway intake tower) measured from the original intake to energy dissipater. The RCP had radial cracks internally near the separated joints at some locations. While drilling a

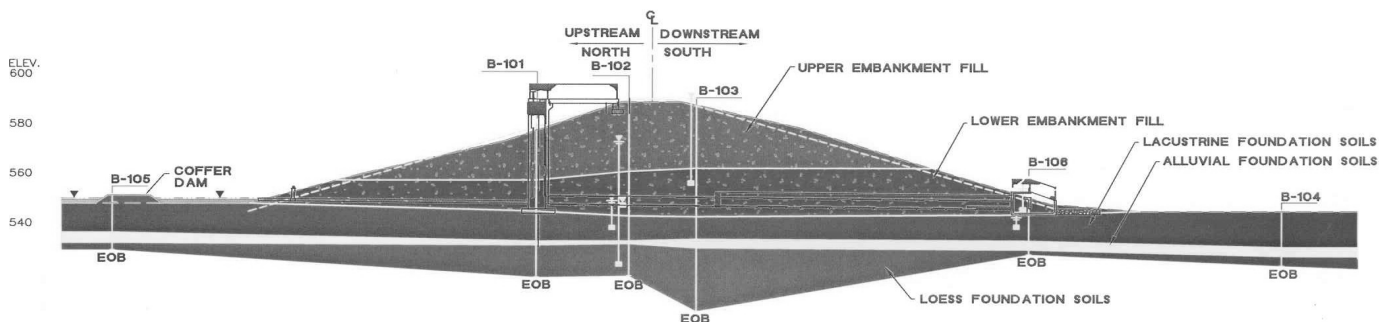
Fig. 2. Drake Lake - Cross Section

A cross-section depicting the subsurface conditions with the spillway structure super-imposed on the section as shown on Figure 2.

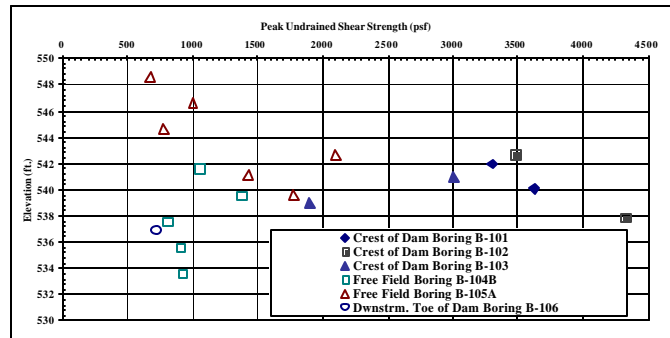
Fig. 3. Vane Shear Results

In-situ vane shear test results indicated that the undrained shear strength immediately below the embankment had increased to a range of 1,980 to 4,300 pounds per square foot (psf). A plot of the vane shear results is presented in Figure 3.

Field vane shear tests indicate that the foundation soils below the dam gained substantial strength (e.g., S_u equals 1,980 to 4,300 psf), due to consolidation under the weight of the dam. Peak vane strengths beyond the toe of the dam were considerably less (S_u equals from 675 to 1,775 psf). These

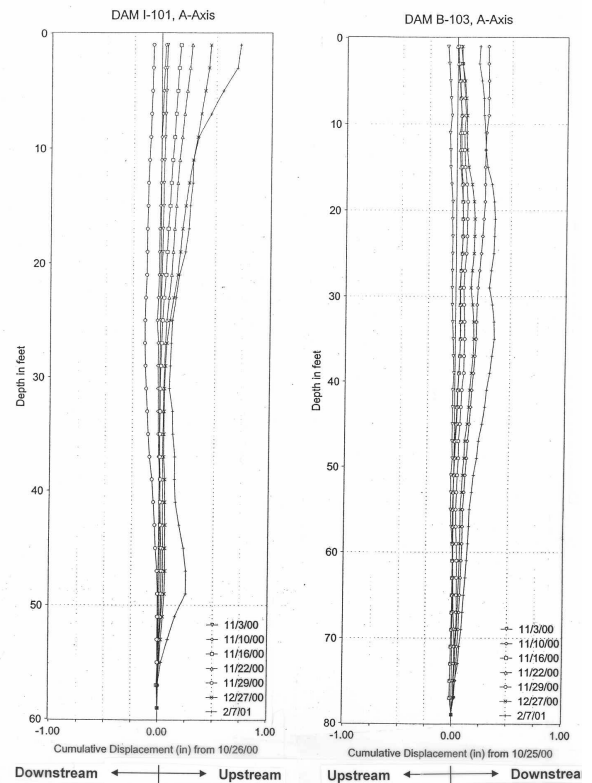
Fig. 4. Inclinometer Readings

Inclinometer casings were installed within two borings to monitor lateral movements of the dam and foundation soils. The readings at the inclinometer casing installed on the upstream slope of the embankment indicated some steady movement of up to 0.8 inch in the south (upstream) direction and 0.5 inch in the east direction. The inclinometer casing installed on the dam crest and downstream of the dam centerline had movement of 0.25 to 0.5 inch to the north (downstream) between the reading taken on October 26, 2000, and February 7, 2001. However, between December 27, 2000, and February 7, 2001, there appears to be about 0.5-inch movement. Results of the inclinometer readings are included in Figure 4.

In general, the readings were somewhat erratic. The readings appear to indicate some movement had occurred within and just beneath the dam embankment. If the dam embankment and foundation had moved the magnitude indicated by the inclinometer readings, there would be some concern that the embankment had not yet stabilized. However, the other instrumentation, such as the vibrating wire transducers and measurements of the outlet pipe joints, did not support these inclinometer observations. The apparent movement was attributed to instrumentation or system error since two different sets of inclinometer reading equipment was utilized.

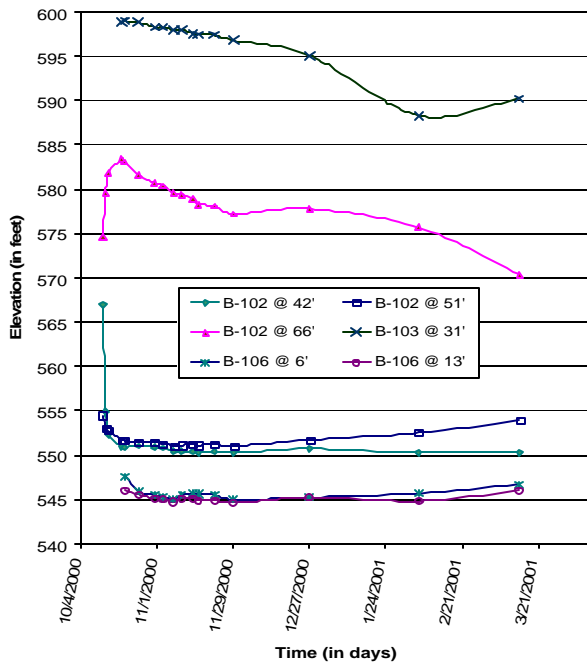
Fig. 5. Piezometer Readings

pressure within the dam and foundation soils. The locations of the transducers are shown on Figure 2. With the exception of several readings affected by trapped drill water, since the beginning of November 2000 readings have shown only slight fluctuations in the range of 0.2 to 0.8 foot.

The steady pore water pressure readings indicate that the construction-induced increase in pore water pressure had dissipated and the primary settlement of the lacustrine clay foundation soils is complete. Results of the vibrating wire piezometer monitoring program are shown on Figure 5.

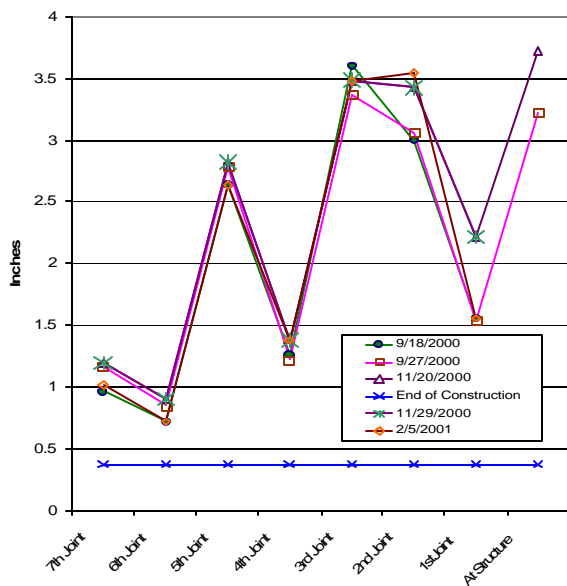
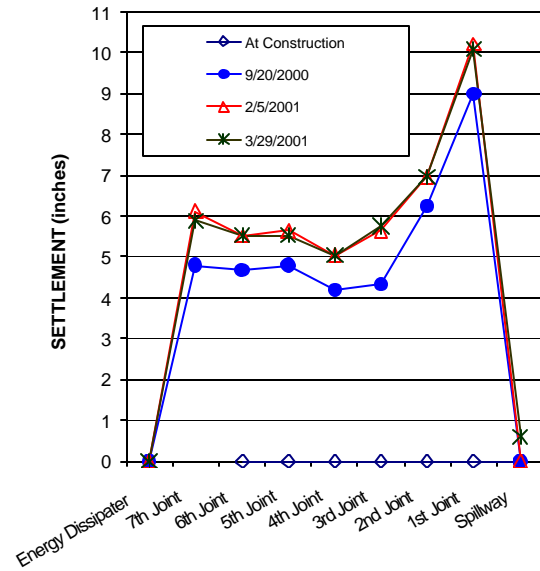
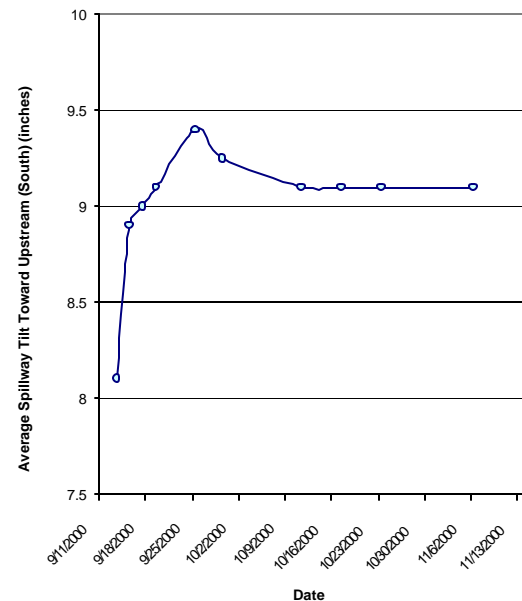
Measurements of the movement of the seven joints between the 20-foot RCP sections were also taken. The pipe joints were originally placed with minimal separation between the joints. The soils movement resulted in the separation of the joints. The joint separation readings indicated that the joint separation ranged from 0.72 to 3.54 inches. The greatest amount of movement occurred within Joint No. 2, located 40 feet downstream of the inlet structure.

Readings were taken of the joint separation along the outlet pipe, settlement measured at joints along the outlet pipe, and the amount of tilting that has occurred to the inlet structure. Results of these measurements are included on Figure 6A, 6B,

and 6C. Readings were also obtained to record the amount of tilting of the inlet structure in the south (upstream) direction. Assuming that the inlet structure was constructed level, the measurements indicate that the spillway tilted approximately 9.06 to 9.12 inches toward the upstream (south).

Horizontal movement measured in the principal spillway intake tower and the 36-inch RCP was apparently caused by lateral spreading of the embankment dam in both a downstream and upstream direction due to compressible and lower strength lacustrine foundation soils. We believe that rapid filling over the compressible lacustrine soil layer created a short time period of low shear strength in the relatively soft foundation soil due to excess positive pore water pressure. As a result, the soft foundation soil was overloaded, developed high positive pore pressures and essentially experienced plastic yielding or horizontal shear failure. Since the low strength foundation soils were restrained above by the embankment and below by the dense underlying till, the low strength silt crept laterally due to sustained driving shear stresses greater than the resisting stresses. Since the embankment dam was resting on a compressible silt layer, the dam and embedded structures moved horizontally and settled vertically in response to foundation soil movement. We believe that the principal spillway and horizontal pipe movements were caused by lateral spreading and vertical consolidation of the compressible lacustrine silt. The shear strength of the softer foundation soils material was considerably lower than anticipated, and the soft foundation soils could not consolidate fast enough under fill loading rates to limit lateral movement. Loss of drilling fluid in our mud rotary cased borings indicates that there were vertical cracks parallel to the dam alignment across the center portions of the recently completed dam with no pool. The ratio of settlement to horizontal movement that was measured in this dam (e.g., dh/ds equaled 0.7) should have caused cracking in the embankment. The maximum recommended dh/ds ratio for stable fills on compressible foundations should not exceed 0.4 per Ladd (1991).

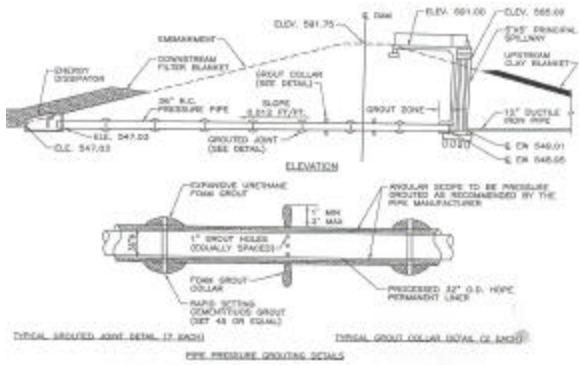
Fig. 8. Outlet Pipe Repairs NTS

The 36-inch RCP had joint separations up to 3.54 inches wide. Also, some sections had cracks along the pipe crown. The pipe was considered unsuitable to convey water through the embankment. The open joints and cracks could allow water to enter the dam embankment, which could result in a piping failure of the dam. Also, if the pipe was subjected to high flows, the openings in the pipe may act as a siphon, which would suction embankment material into the outlet pipe, resulting in voids at the openings. Due to these factors, the pipe was lined. A synthetic felt material, impregnated with heat-activated resin and HDPE liner systems, were evaluated for this project. The 30-inch diameter HDPE liner was selected since it is more ductile and able to accommodate future lateral and horizontal strains anticipated during the life of the structure. The HDPE liner pipe selected was a 1,000 Series PE 3408, Driscopipe with a 50 psi pressure rating.

Prior to installation of the liner system, the existing RCP joint cracks were grouted as an additional preventive measure against water seepage from the pipe into the surrounding subgrade. This grouting was performed from within the pipe at each joint using an expansive urethane foam grout. Figure 8 shows the HDPE liner system and the joint grouting detail.

Two cement grouted "dough-nuts" or anti-seepage collars were installed along the pipe between Joints 1 and 2 and between Joints 2 and 3. These collars were created with a pressure-grouted zone extending 1 to 2 feet outside the pipe. Figure 8 shows the grout collar concept.

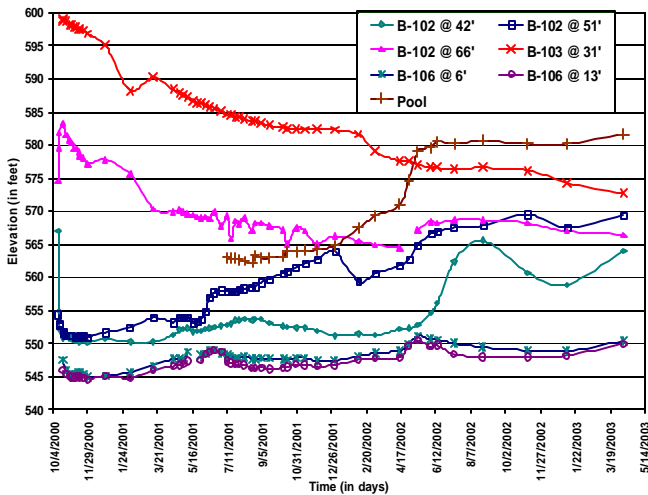
Fig. 9. Piezometer Results as of April 2003

As of May 2002, the lake level had risen to within 6 feet of the normal pool level. Instrumentation monitoring has continued to evaluate the dam performance as the reservoir fills. As indicated by the inclinometer and piezometer readings, the structure appears to be performing satisfactorily. Pore water pressure within the lower fill continues to dissipate as shown on Figure 9. There has been some continued settlement of the dam and its foundation as noted by inclinometer casing movement towards the centerline of the dam, shown on Figure 10. It is anticipated that some settlement of the crest of the dam will continue as the grout within the embankment
