A Study on the Performance of a Reinforced Dike Section With Geogrid During the Tottori-Ken Seibu Earthquake

A STUDY ON THE PERFORMANCE OF A REINFORCED DIKE SECTION WITH GEOGRID DURING THE TOTTORI-KEN SEIBU EARTHQUAKE

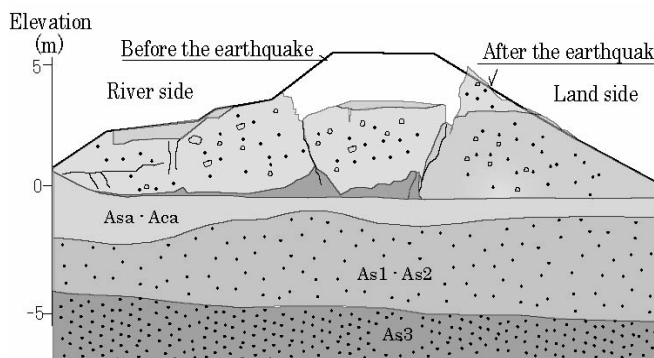
Past cases of embankment failure tells us that embankment body was split as shown in Fig. 5 (Sasaki et al., 1997) by stretching effect (Terzaghi, Peck and Mesri, 1996), caused by lost of shearing resistance between the embankment bottom and the foundation ground due to raised pore water pressure when liquefaction took place at shallow depth like this site.

Fig. 5. Shiribeshi-toshibetsu river dike

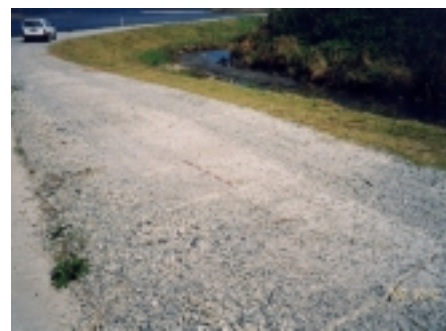
Fig. 12. Transverse cracks observed at the crest

The length of the severely damaged section was about 120 m, located on the curved part of the dike axis continuing to the river dike of the Ii-nashi River as illustrated in Fig. 3. Many transverse cracks as shown in Fig. 12, and the discrepancy at the joint of concrete facing as shown in Fig. 13 were observed at this section, resulting 1 m subsidence of the dike crest. Beside these deformation to embankment, up-heaving of the bottom of the side ditch as shown in Fig. 14 and traces of sand boiling at surrounding ground surface near the toe of the embankment were observed. A fisherman told his fear to one of the authors as he watched the sand and water boiling from the lake bed after he felt the shaking when he was catching corbicula in the lake.

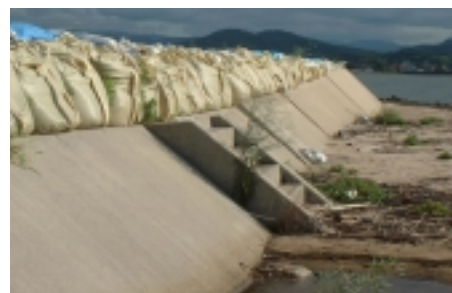
Fig. 13. Discrepancy of concrete facing joint

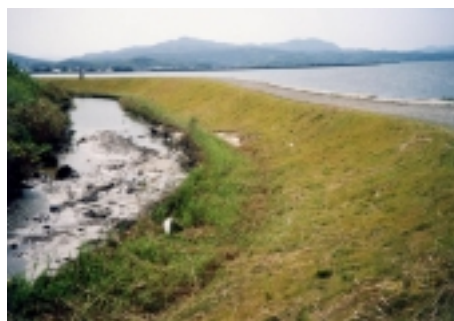
Fig. 14. Up-heave of the ditch bottom

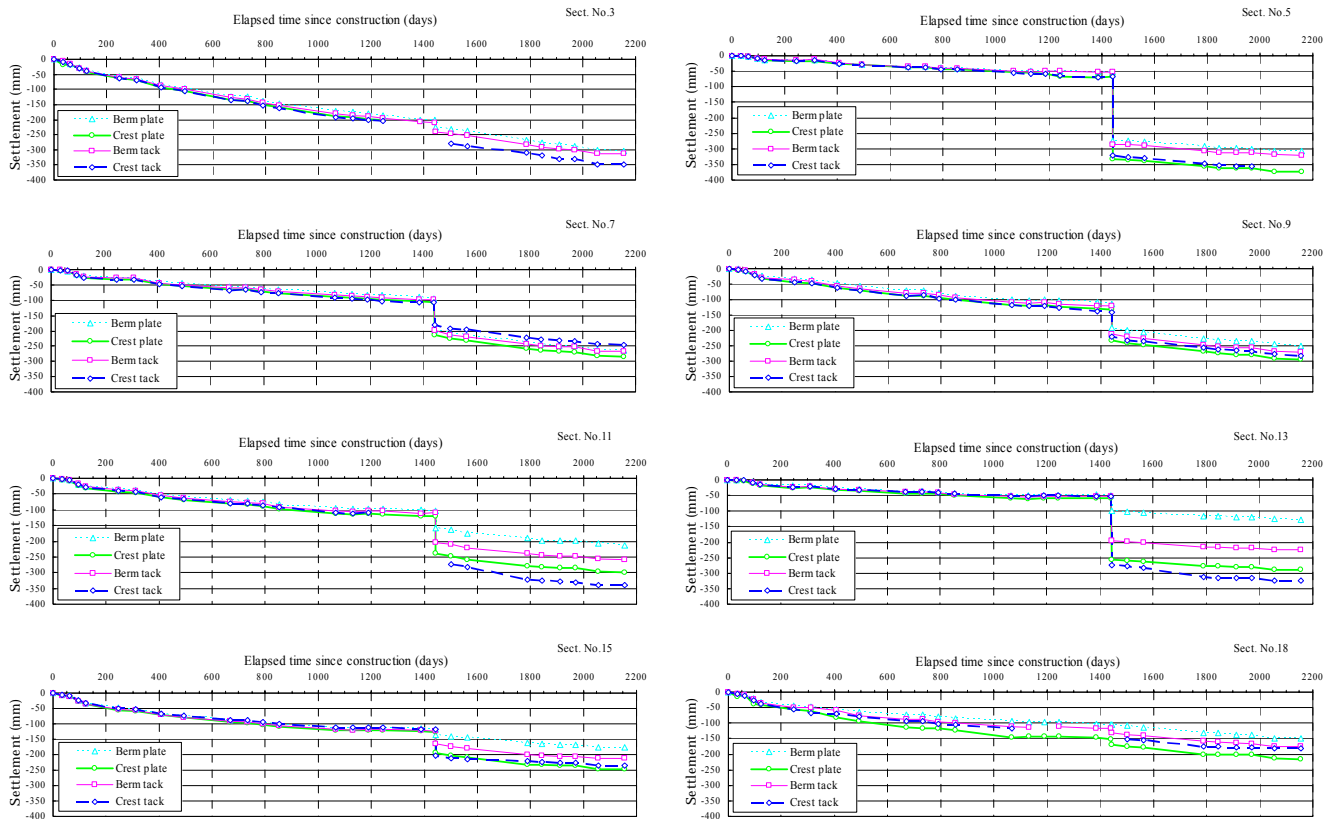
Figure 15 shows the time histories of the settlement observed at crest, shoulder, and berm of the embankment at 8 cross sections since the completion of the embankment construction. Figure 16 shows the comparison of the crest elevations along

Fig. 15. Time histories of the settlement

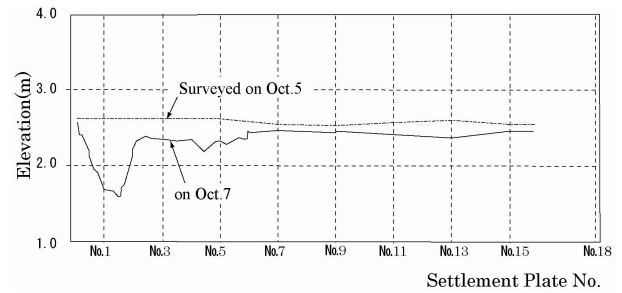
From these figures, it is known that the section which seemed to be sound experienced settlement by about 5-20cm even though no cracks on the embankment crest nor on concrete facing were observed by eye inspection. This is thought to be owing to an effect of geogrid against stretching of the embankment, and it did help to avoid the emergency treatment to the shaken dike even though the settlement was caused for about 20 cm.

Fig.16. Comparison of the crest elevations

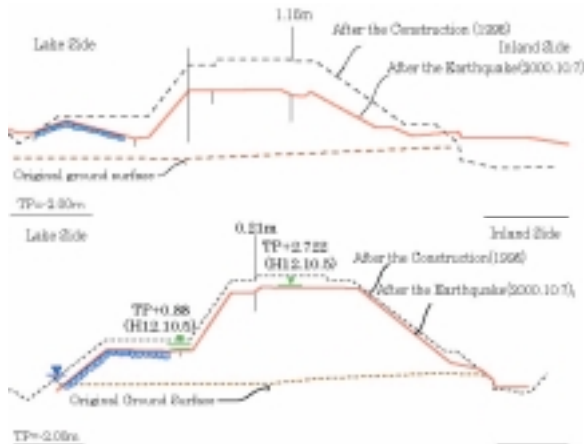
settlement point) surveyed just after the earthquake. It should be noted that there was no longitudinal crack though the settlement amount of the embankment crest reached to about 1 m at the Section No.1+16.

The reason why this portion of the Arashima dike section was caused the severe subsidence is not yet clarified, however it could be pointed out that this portion is situated on the ground where liquefiable sand layer is comparatively thicker, and that

Fig. 17. Comparison of the cross section at No.1+16 and No.7

this portion is located on the curved part of the dike axis. Curved part of the dike axis may cause comparatively larger cyclic stress to the liquefiable sand layer due to the three dimensional response of the dike. The ratio of the observed settlement to the thickness of liquefiable soil layer is not uniform as shown in Fig. 18. Mean value of this ratio was 2.3%.

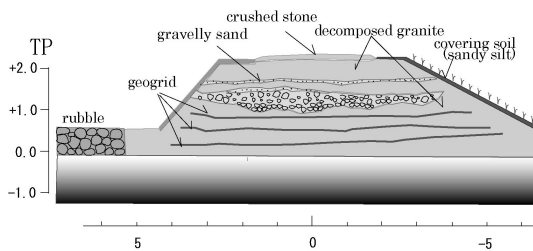
It was found that the geogrid at the Section No.3 was still horizontal as shown in Fig. 19 even though the crest settlement of about 20 cm was recorded at this section. This fact was in harmony with the aforementioned observation that no deformation took place to the embankment at this section except for the uniform settlement. Contrary to this, the geogrid at the Section No.1+16 was found to have been bent downwards as shown in Fig. 20 and was also found that the interval distance between the lowest sheet of geogrid and the middle one was slightly decreased. It is considered that not only the foundation ground but the bottom part of the embankment at this section became also to be liquefied so that the sand between these sheets of geogrid could be squeezed out.

Fig. 19. Geogrid after earthquake at No.3

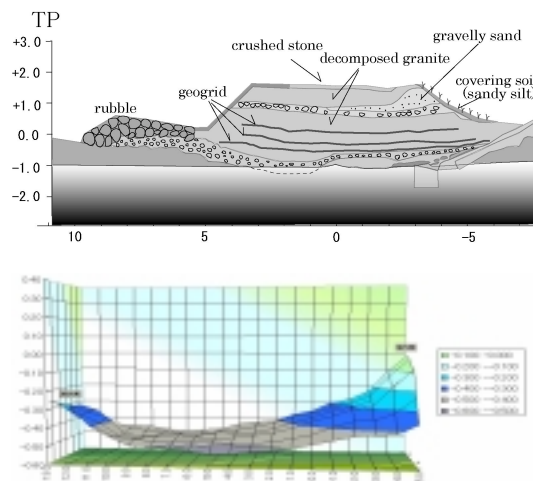
Fig. 20. Geogrid after earthquake at No.1+16

decrease of anti-stretching effect of geogrid due to the lost of friction by immersing water. If this is the case, interval distance between the lowest and middle sheets of geogrid becomes shorter as seen in Fig.20.
