## **DUTCH DIKE BREACH, WILNIS 2003**

**S. Van Baars**

University of Technology Delft  
Delft, The Netherlands

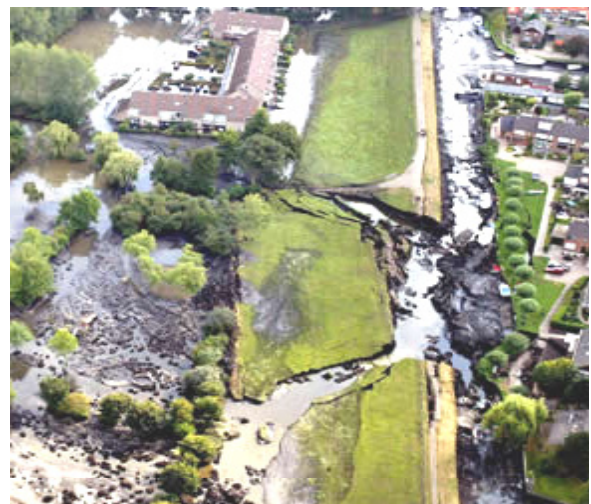
Therefore the Dutch were very much surprised at August 26th 2003, after the warmest and driest summer in fifty years, that a dike along a canal failed. Figure 1. shows the empty canal on the left and the dike on the right. Figure 2. shows the dike after failure. About 50 meter of dike was shifted towards the north (left of the picture), leaving two breaches through which the water from the canal streamed into a lower quarter of the village Wilnis, 30 km Southeast of Amsterdam.

*Fig. 2. Shifted part of a canal dike*
