International Conference on Case Histories in Geotechnical Engineering (2004) - Fifth International Conference on Case Histories in Geotechnical Engineering

## Behavior of Reinforced Wall System During the 1999 Kocaeli (Izmit), Turkey, Earthquake

## BEHAVIOR OF REINFORCED WALL SYSTEM DURING THE 1999 KOCAELI (IZMIT), TURKEY, EARTHQUAKE

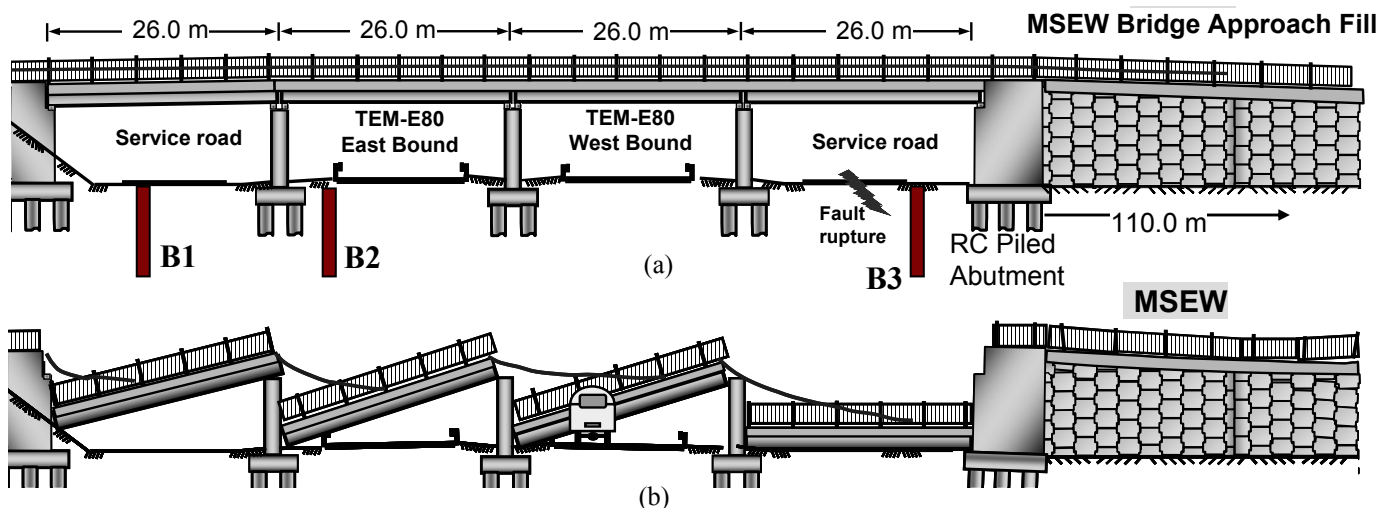
During the earthquake, the majority of the highway facilities performed well, except that the bridge overpass in Arifiye (Fig.2), located less than 50 km eastward of the epicenter, collapsed due to tectonic movement along the fault zone. The surface fault rupture passed beneath the northernmost span of the overpass while causing substantial surface deformations. The collapsed bridge blocked the TEM and caused serious delays in transporting immediate disaster-caused emergency needs in the epicentral area. Moreover, nearly a dozen people died when a passenger bus crashed into a collapsed deck while passing under the overpass.

the earthquake. Major damage to the walls was not from seismic design, but a combination of adverse effects by the nearby fault movement and, possibly, bearing capacity problems associated with underlying foundation soil. Figure 2 depicts the overpass and the reinforced walls before and after the damage, respectively.

Fig. 2. The bridge overpass at Arifiye and mechanical stabilized bridge approach fill walls (a) before, and (b) after the earthquake.

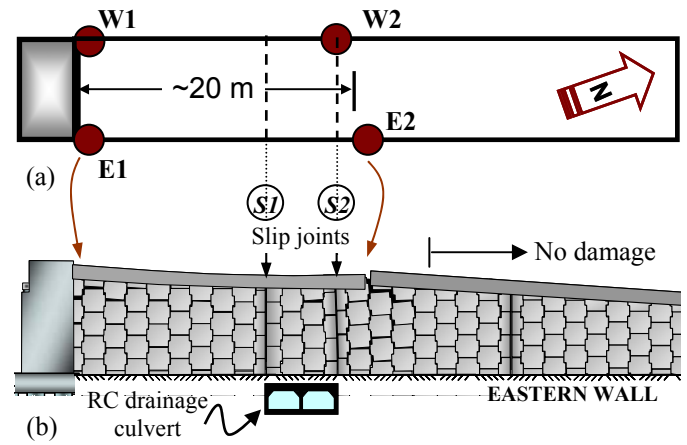
A reinforced concrete culvert was designed beneath the approach ramp possibly to facilitate storm or flood water discharge in approach ramp area (Fig. 5b). However, the culvert was not useful as it appeared inactive due to road fill at both sides of the approach ramp. Two slip joints (S1 and S2, Fig. 5) were also designed on each wall face on top of the rigid culvert to protect the walls damaged from differential settlement.

Fig 5. MSE bridge approach (a) plan view of approach fill with damage-concentration; (b) schematics of eastern wall after the earthquake.

Only a limited section of the MSEW approach ramp was damaged to a great extent in between the bridge abutment and RC culvert. This section constituted approximately 20% of the entire length of the reinforced earth structure. The most damage-affected locations within this section along the eastern and western wall faces are highlighted in Fig. 5a as E1 and E2, and W1 and W2, respectively, whilst their detailed views are presented in Figs. 6 and 7.

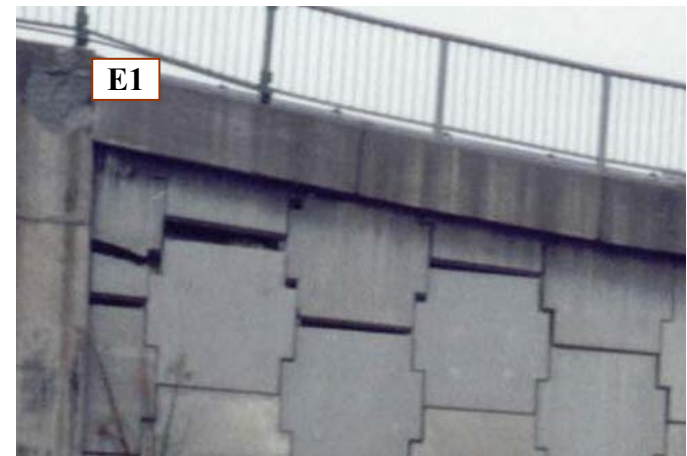
Fig 6. Damage details for (a) E1 and (b) E2 on eastern MSEW face (photos after Ozbakir).

both locations were also different. At E1, the vertical ground deformation was so large that the flexible wall face was forced to be displaced both vertically and longitudinally. However, the movement in the longitudinal direction was greatly prevented by the rigid abutment. This caused large panel separations and cracks at the higher levels (Fig. 6a), but no damage observed at lower wall elevations.

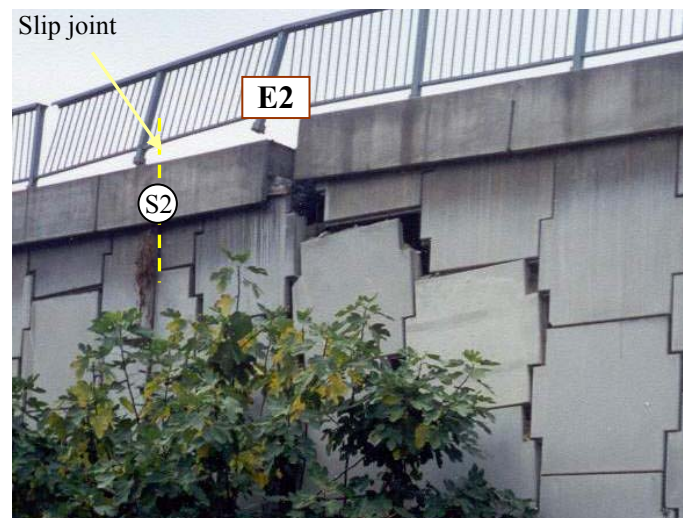
(b)

The tilting in the cross section resulted in different damage states above the culvert at E2 and W2 such that the western wall buckled in the vicinity of W2 (Fig. 7a), whereas the eastern wall face were stretched outward (Fig. 6). The buckled side increased compression on the facing panels at W2, whilst crashing and forcing the panels displaced (Fig. 7b). On the other hand, the largest damage in the reinforced walls was observed at E2 as shown Fig. 6b. At this location, the wall displaced both vertically and horizontally for about 25-30 cm. The displacements at this locality was so large that they exceeded the allowable design limitations for an independent panel movement. Thus, the panels could not accommodate the ground deformation, and finally, large panel separations and cracks (especially at lower elevations of the wall) occurred. However, the facing panel connections with the metallic reinforcements did not fail, and their flexible joints allowed large displacements and differential settlements.

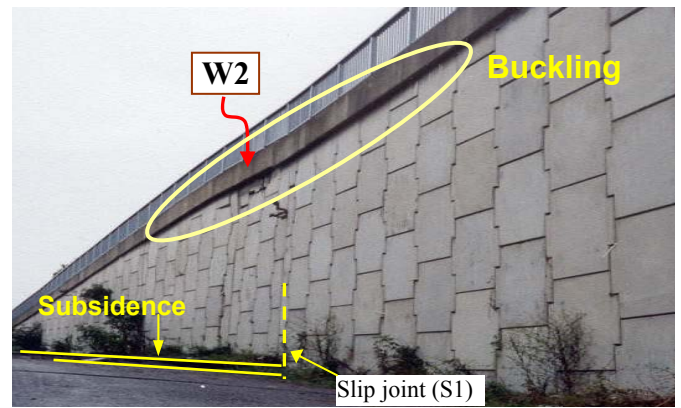
Fig 7. Western MSEW face: (a) buckled wall, looking from south to north; (b) damage details at W1 and W2, looking from north to south (photos after Ozbakir).

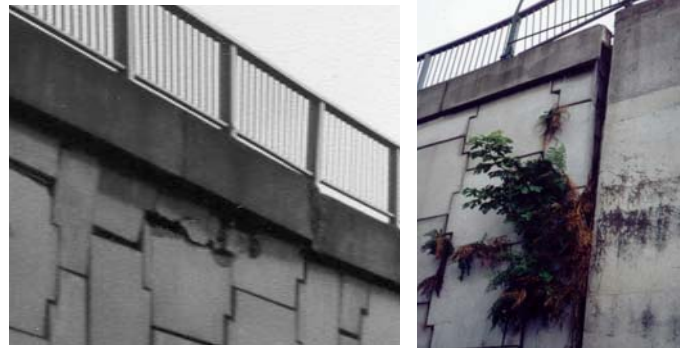
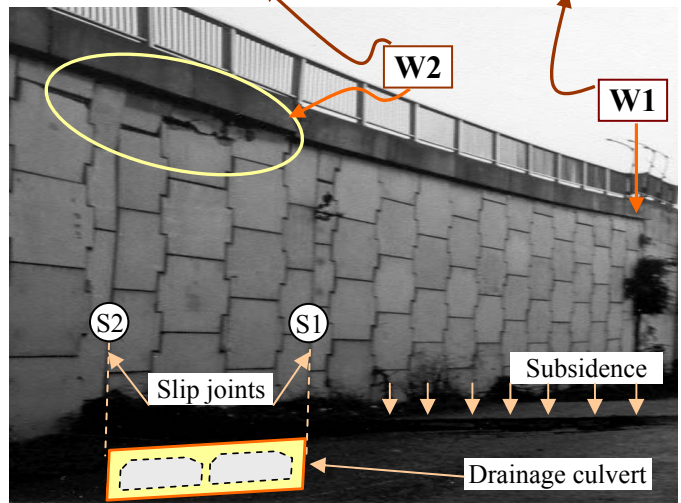
(b)

large compared to E1. On the other hand, a gap of about 10 cm occurred between the panels and the abutment as shown in Fig. 7b. This gap appeared to be resulted from the buckling in the same wall face in vicinity of W2 (Fig. 7a). That is, once the wall buckled at W2, the wall face was pulled longitudinally (northwardly) as a whole. This behavior along the western side of the approach ramp did not cause any damage in the facing panels between W1 and W2. This was an interesting observation indicating that the reinforced wall system was very flexible.
