Case Histories of Soil Behaviour and Investigations for Seismically Distressed Earthen Dams of Kachchh Region in Gujarat, India

CASE HISTORIES OF SOIL BEHAVIOUR AND INVESTIGATIONS FOR SEISMICALLY DISTRESSED EARTHEN DAMS OF KACHCHH REGION IN GUJARAT, INDIA

In the morning of January 26, 2001, a devastating earthquake of magnitude M_w 7.7 rocked the Gujarat State of India. The disastrous earthquake claimed thousands of human lives besides widespread destruction of the properties including damages to water resources projects of Kachchh region. This worst ever natural calamity of recent time posed challenging and daunting task of restoration and reconstruction works. A committee of experts was constituted by Government of Gujarat with a view to assess the damages occurred to the dams & other appurtenant structures and to recommend restoration and reconstruction works. Consequent to the event, dams of Kachchh region situated within radius of 200 km from the epicenter were inspected as per the guidelines of International Commission On Large Dams (ICOLD). Integrated geotechnical investigation program comprising soil exploration and laboratory testing was chalked out to determine the prop

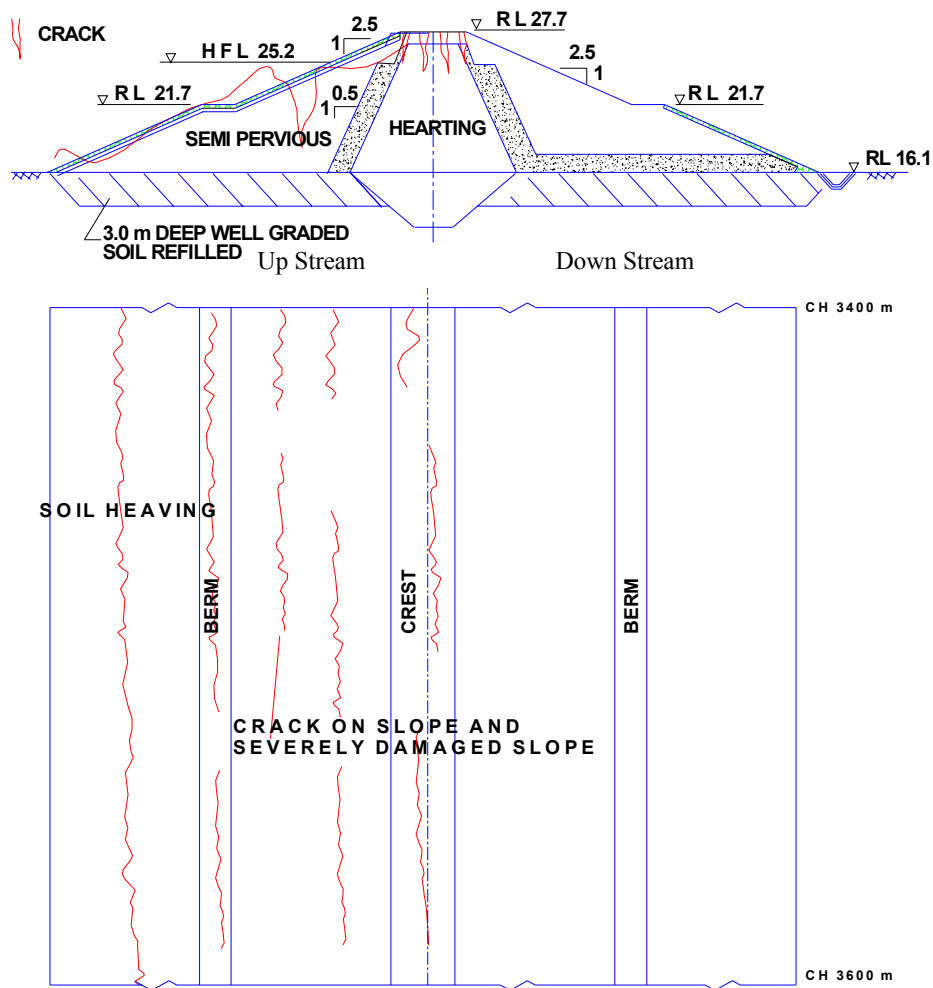
After the event of earthquake, the dam was inspected by the Panel of Experts. The distressed features observed are shown in fig. 2 and described below:

- ◆ Prominent longitudinal cracks on the crest and upstream slope.
- ◆ Most prominent was the deep crack near the center of the crest extending about 10m in one stretch, between ch. 3550 m and ch. 3700m (deep river channel portion). This crack had been measured up to 1.4 m depth and about 40 cm wide at the crest.
- ◆ Noticeable longitudinal crack at the center of the crest at ch. 3700m, measuring up to 3m depth.
- ◆ Prominent and noticeable slips of the upstream edge of earth dam in the deep river portion, showing acute slump of the slope and scrap up to 5m depth. Sand blows in the down stream portion. These are clear indication of liquefaction.
- ◆ Few transverse cracks with differential settlements near the junction of spillway and earth dam.

Fig. 2 Earthquake damages and restoration works of Fategadh dam.

The stability analysis of existing earth dam revealed that upstream slope could be unsafe against earthquake loading. Therefore, additional rock zone was provided and the values of final factor of safety worked out are given in Table 2.

Values of SPT were taken into consideration while finalizing the section of the earth dam. In accordance with clause 3.3.3 of Indian Standard (IS) No. 1893-1984, for the depth up to which the SPT values did not meet the requirements of the code (10.45 m in this case), the existing soil was excavated and replaced by compacted soil to achieve the desired SPT values.

At Ch. 3600m, down to 5.95 m depth from ground level SPT values were ranging from 3 to 14. The loose layer of this zone was therefore compacted by driving timber piles in a area of radius of 10 m around the location of the specific bore hole.

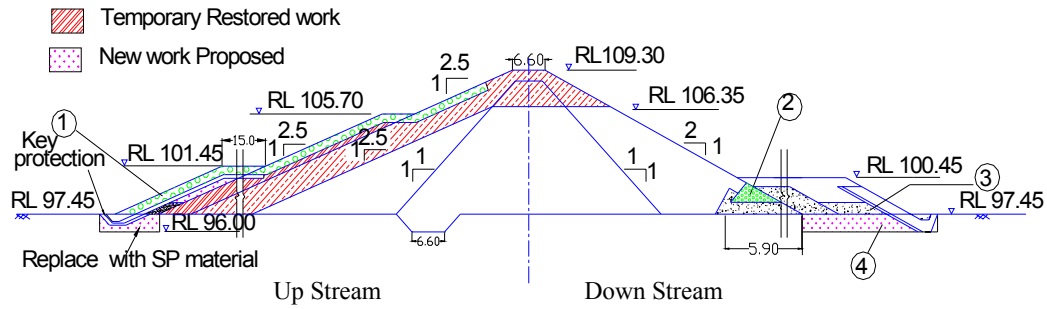
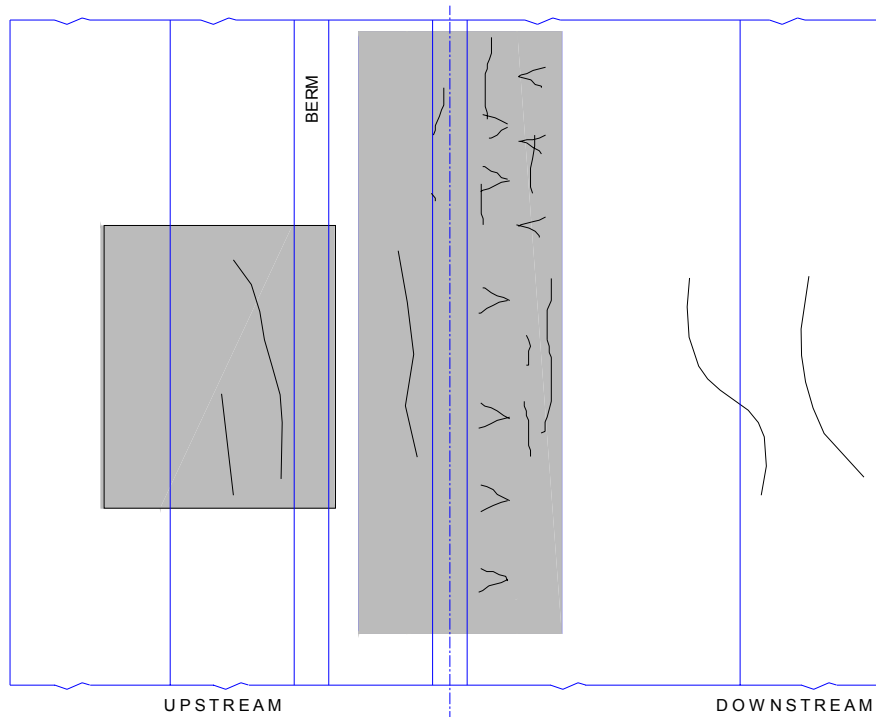
Fig. 3 Earthquake damages and restoration works of Adhoi - II dam.

After the event of earthquake, the dam was inspected by the Panel of Experts. The distressed features observed are shown in fig 3 and described as follows.

- ◆ Series of cracks on top of the dam as well as on upstream and downstream slopes in the gorge portion. The cracks were about 30 to 40 m long, 15 cm wide and over 1 m deep.
- ◆ The pitching was heavily disturbed.
- ◆ Top of the dam settled by 1 to 1.5m in about 65m length in gorge portion. Slopes were sloughed.
- ◆ Peripheral crack was seen along upstream of the dam and all along low level reservoir boundary where slips occurred. Sand blows were noticed in the basin area. These were clear indications of liquefaction phenomenon.

- ① 0.45 m thick pitching is to be provided over 0.30 m thick graded filter
- ② Existing rock toe and filter
- ③ Toe protection as per IS 9429 – 1999
- ④ Sand filter

Stability analysis of existing earth dam revealed that upstream slope could be unsafe against earthquake loadings. Therefore, additional earth work was provided on existing upstream and downstream slopes. With additional earthwork, the values of final factor of safety were calculated as given in Table 5.

Values of SPT were taken into consideration for finalising the dam section. The minimum 'N' value is 13 at 1.5 m below ground level otherwise the 'N' values below G. L. are high. For stability of earth dam 8 m and 6m wide loading berms at R. L. 101.45 m and 100.45 m on up stream and down stream respectively were provided, at some locations they were extended up to 10 m and 15 m width on up stream and down stream respectively at above levels considering the

liquefaction aspects. It was also decided to remove the soil down to 1.5 m depth from the ground level in the new earthwork and same to be filled up with semi-previous material in upstream side and with sand in downstream side.
