International Conference on Case Histories in Geotechnical Engineering (2004) - Fifth International Conference on Case Histories in Geotechnical Engineering

Failure of an Excavation Support System

FAILURE OF AN EXCAVATION SUPPORT SYSTEM

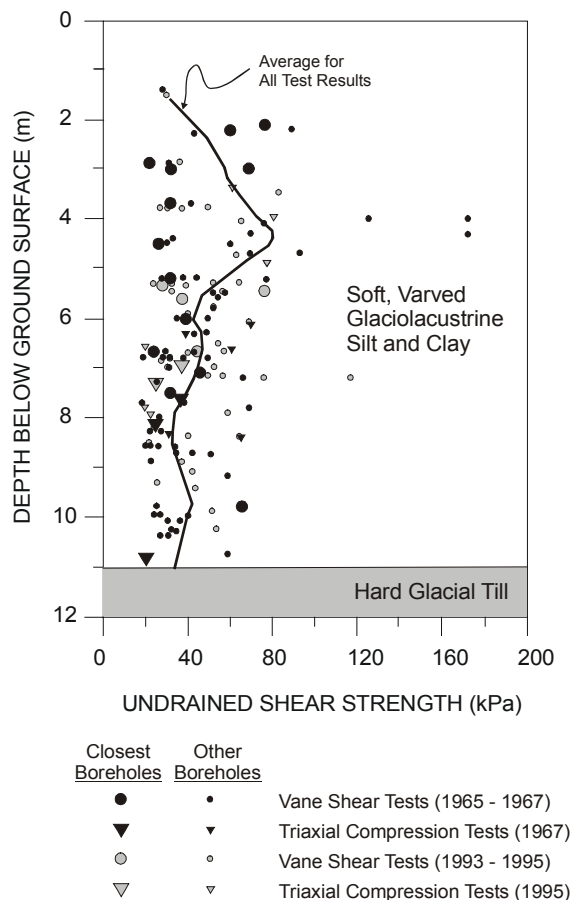
Construction of a new subway station required an 11 m deep, shored excavation through a thin layer of fill, varved silt and clay of variable strength (see Figure 1), and a hard cohesive glacial till underlying the soft deposits. Undrained shear strength of the hard glacial till deposit was about 300 kPa or greater.

Figure 1. Subsurface conditions in area of shoring collapse.

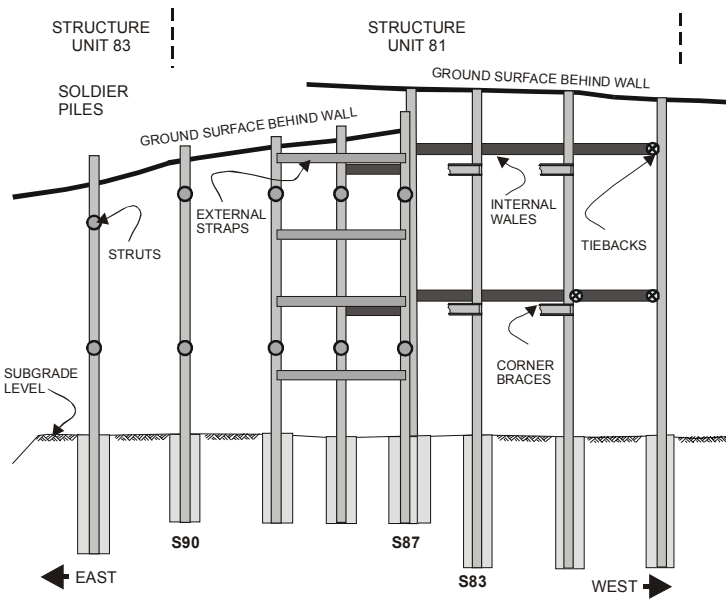
Figure 2. Shoring design in area of corner failure. Locations of soldier piles are noted as S81, S82, etc.

Case A: Construction up until the time of failure had not included installation of the steel straps along the north face, between piles S87 and S91, as indicated in Figure 2 and 4. In this case, there was no support to pile S87 in the east-west direction except for the pile's own bending resistance.

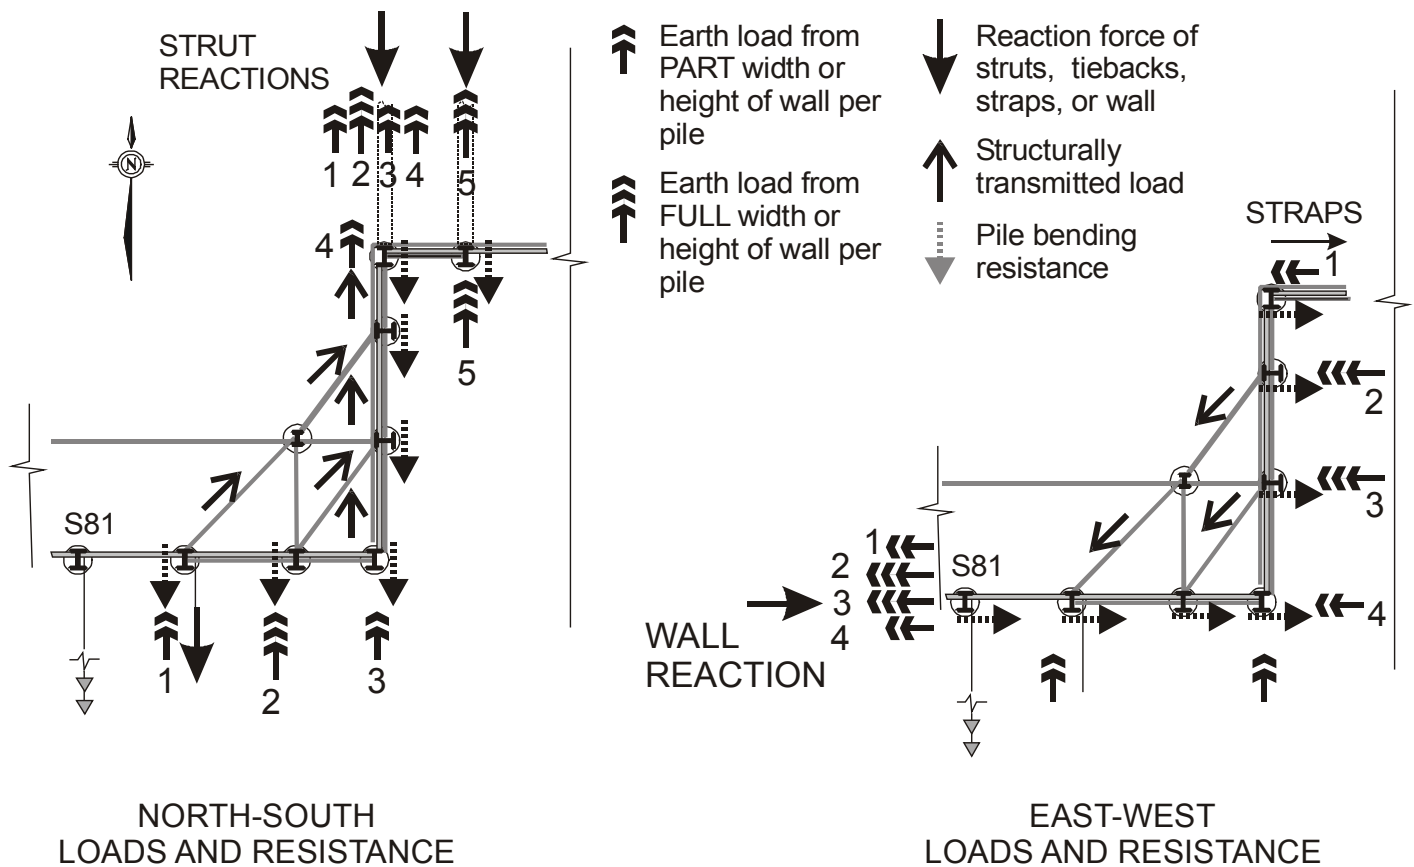
Figure 3. Earth loads and support mechanisms for shoring corner had all structural members been in place.

The NS load component in this case has to be resisted ultimately by the struts placed against pile S87 and the bending resistance of the piles S82 through S87. Prior to the failure, the contractor’s personnel and advisors considered that the northward loads would be resisted by earth berms left in place in front of piles S87 to S90.
