Mine Plug Integrity Evaluation

MINE PLUG INTEGRITY EVALUATION

The integrity of a mine plug impounding more than 30 million gallons of acidic mine drainage water (AMD) was investigated using a combination of technologies. A two-phase investigation program was adopted which allowed the full depth of the mine plug to be explored without release of detrimental AMD. The condition of the concrete, support rock, rock/concrete interface, and drainage pipes and valves was evaluated. Phase 1 included (1) a review of plug design documents and construction data, (2) review of data from other mines on acid attack of concrete, (3) detailed visual inspections, (4) use of nondestructive testing techniques to assess the condition of the concrete, and (5) geochemical testing of seepage and drain pipe waters. Phase 2 explored uncertainties identified during Phase 1 and included (1) coring into the concrete plug and adjacent rock, (2) cross-hole sonic logging, (3) laboratory testing of concrete and rock samples, (4) operational testing of valves, and (5) measurements of the thickness of pressurized piping components. While several minor defects were detected, none were significant enough to affect t

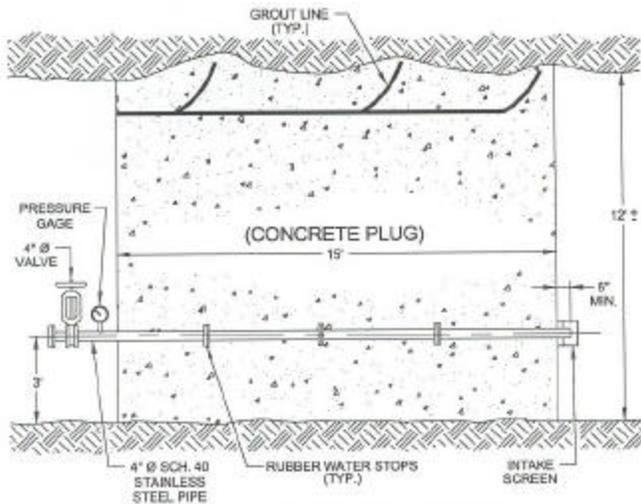
Fig. 1 Section through mine plug (SRK, 1985)

seal, in the Main Access Adit to stop AMD discharges. The seal is located at a distance of about 2,700 feet from the portal and is seated in granodiorite. Its cross section is about 9 feet wide by 12 feet high and its length is 15 feet (Figure 1). Two 4-inch-diameter stainless steel pipes controlled by rotary control valves are embedded in the seal to allow draining of the impounded water. A sampling port with a pressure transducer is mounted on one of the drain pipes, upstream of the control valve. The transducer is connected to a data logger monitored by the RWQCB.

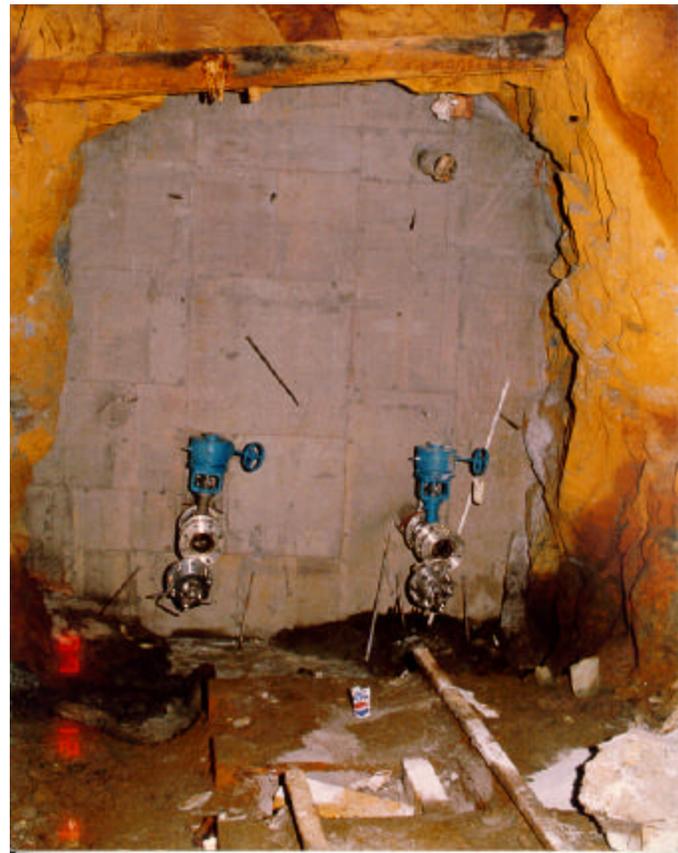
A view of the seal shortly after its construction in 1987 is shown on Photo 1. Prior to placement of concrete, soil debris was excavated from the tunnel invert, loose rock pieces were

Photo 1. Seal after construction (December 1987).

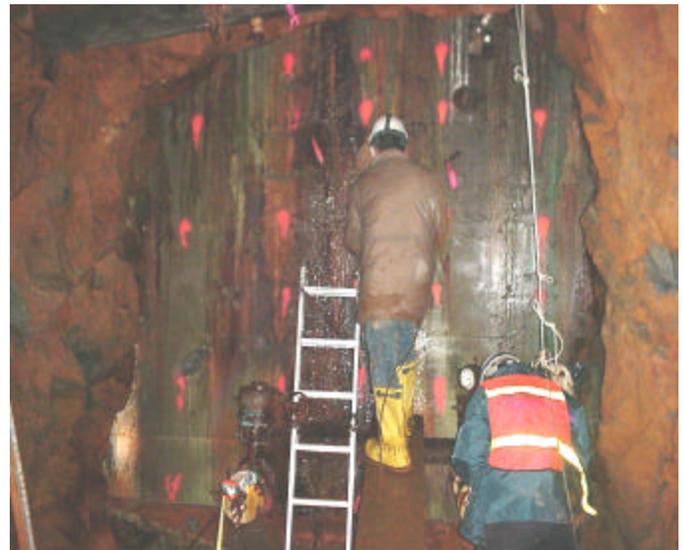
Except for those areas covered by deposits of iron hydroxide and calcium carbonate from seepage water, the original formed surface of the seal was plainly visible and in good condition (Mass, 2000). No surface erosion was observed. The concrete appeared dense and well consolidated. No cracking of any nature was observed on the seal face. The entire face of the seal was moist. Surface deposits appear to be associated with areas of seepage and seepage flow

(Photo 2). Efflorescence, whitish deposits of calcium carbonate, was isolated to two small areas at the lower left sidewall and upper right side of the seal. A green-colored copper sulfate staining was also observed on the right side of the seal and on the rock adjacent to the seal.

Photo 2. Seal on November 1, 2000. Red paint marks are impact points for nondestructive testing.

The center of the calcium carbonate deposit on the lower left side of the seal (Photo 2) was wet from active seepage flow. It was found that the thickness of the deposit ranged from 1 to 2

The area immediately below the protruding steel pipe that had been used for pumping concrete into the seal (Photo 2) was moist but there did not appear to be any evidence of seepage flow. The surface paste was found to be hard and sound and could not be removed by scraping.

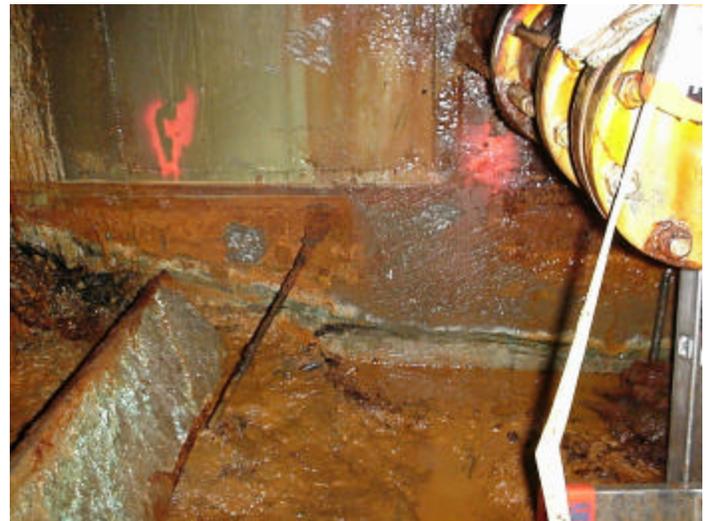
A horizontal water line on the concrete face, as evidenced by iron staining, was observed approximately 18 inches above the floor of the adit (Photo 3). This water line was generated by the presence of the ponded seepage against, and immediately downstream of the seal. The ponded water was removed for access and inspection.

The area above and below the water line that had been created by the ponded seepage were observed. Below the water line the concrete surface paste and mortar could easily be removed by scraping to a depth of 1 to 2 mm before hard, sound concrete was reached. Above the water line the depth of soft paste and mortar was approximately 1 to 1.5 mm (Photo 3).

Photo 3. Closeup of bottom left quadrant showing water line of seepage pool (Nov. 2,2000)

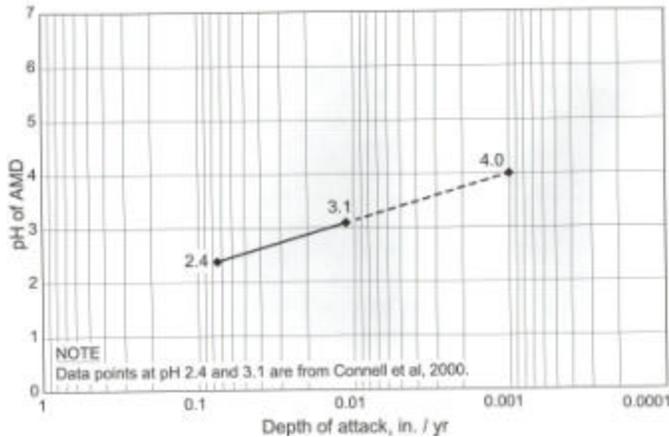
Fig. 2 Estimated rate of AMD attack of concrete based on Iron Mountain Mine studies.

this mixture, calculated as an average depth of surface loss, is plotted on Figure 2. Extrapolation of the curve predicts approximately 0.4 mm of surface softening in 13 years of service. Visual observations during inspection of the seal in November of 2000 indicated that the maximum depth of surface softening was on the order of one to two mm. The difference in these values may be attributed to differences in water chemistry, concrete composition, and exposure factors or to data inaccuracies.

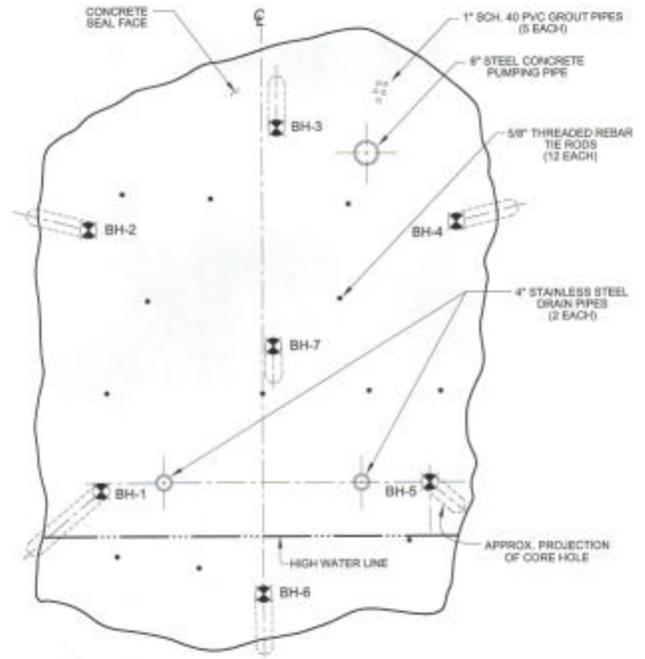
Fig. 3 Approximate borehole locations and orientations.

Seven HQ (3.78-inch-diameter) holes were cored through the downstream portion of the seal and adjacent rock to recover concrete and rock samples and to allow further nondestructive testing of the seal and the rock-concrete interface. The locations of the core holes are shown on Figure 3. Six of the core holes, BH-1 through BH-6, were located along the perimeter and angled away from the axis of the seal, with the objective of intersecting the rock-concrete interface within the middle third of the seal's length. This was in order to obtain maximum information on concrete and rock conditions while at the same time minimizing the risk of intercepting a pressurized seam. However, due to the extreme roughness of the rock walls, only four of the six holes intersected the rock-concrete interface. The seventh hole, BH-7, was drilled through the center of the seal and subparallel to its axis. The core hole lengths ranged from 7 to 10 feet.

Upon completion of drilling and nondestructive testing, the core holes that intersected the rock-concrete interface were pressure-grouted. A thin grout using microfine cement was injected to attempt to seal hairline cracks along the rock-concrete interface. Grout takes were minimal. Once grouting refusal was achieved, a thick, zero-bleed, non-shrink grout was used to backfill all holes. The collar pipes and plates were then removed, and the holes drypacked with portland cement grout.

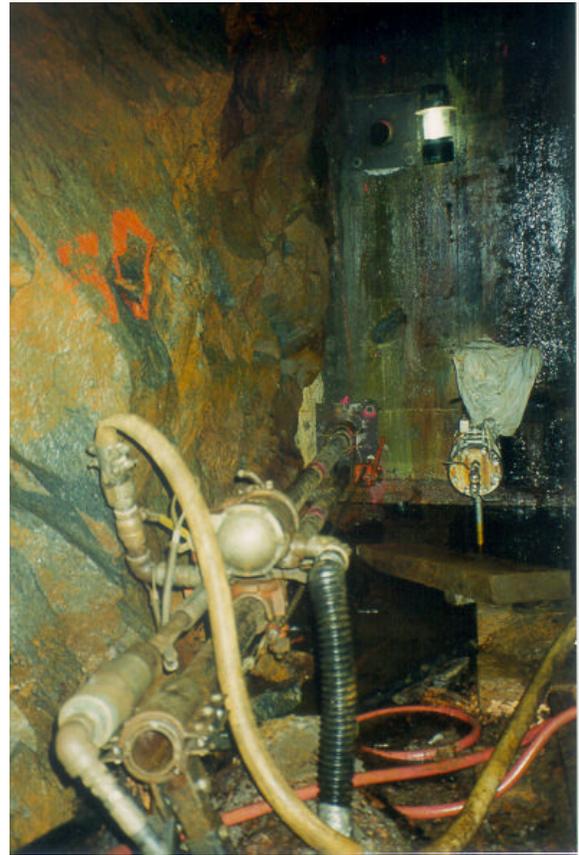
Photo 4. Coring of hole BH-1 (September 9, 2001).

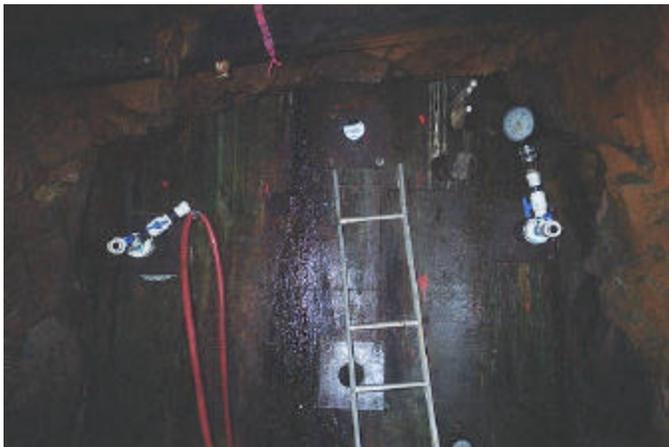
Photo 5. Core holes BH-2, -3, -4 and -7 in the upper half of the seal. Holes BH-2 and BH-4 are equipped with shutoff valves (September 10, 2001).

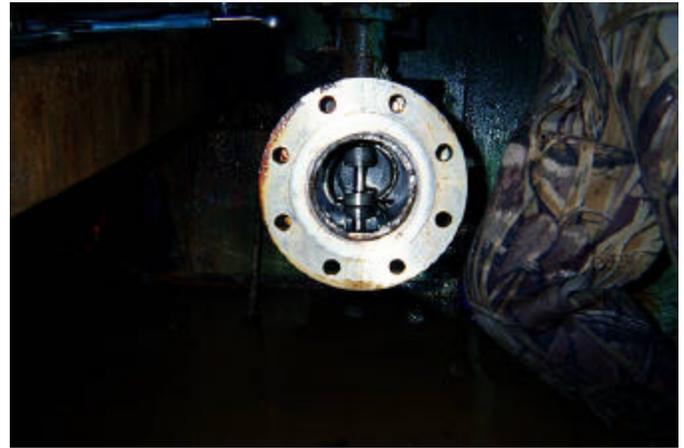
All valves in the drain pipe system were exercised and were found to be functional. The actuators of the shutoff valves were not frozen and operated smoothly. The valves gave tight shutoff upon closing. During the testing activities, the interior of the valves was observed from the downstream side (the nonpressure side, see Photo 6). Although this side of the valve contained AMD prior to the inspection, there was no discernible corrosion of the visible interior stainless steel components of the valves.

Photo 6. Interior of 4-inch control valve (June 13, 2001).
