Excavation Shoring Failure Threatens a Historic Church: Exploration of Causes and Remedial Measures

EXCAVATION SHORING FAILURE THREATENS A HISTORIC CHURCH: EXPLORATION OF CAUSES AND REMEDIAL MEASURES

Recently, excavation works adjacent to the Lady of Annunciation Church resulted in severe cracking and deformations within the walls and floors of the stone and brick structure. The shoring provisions which were executed within the excavated lot consisted of contiguous bored piles with pre-stressed anchors. The failure occurred when the excavation works had progressed to a level of about 12m below original grade. Faced with the imminent catastrophic collapse of the church, the Municipality of Beirut ordered the immediate backfilling of the site in order to limit further movements. The case study presented in this paper includes the details and results of the geotechnical forensic investigation which included an array of measures and efforts, all implemented in an environment of urgency, given the need to find the cause of the failure, and propose and implement remedial measures which would spare the church. The analyses, monitoring measures and actual remedial works adopted and succe

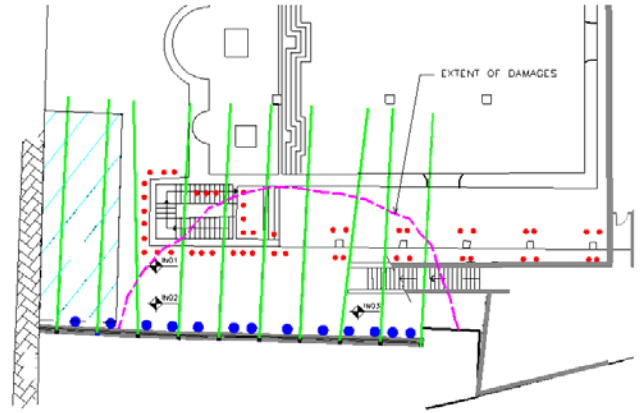
Fig. 3. Extent of ‘failed zone’ and micropile layout

Based on the comprehensive damage survey prepared for the structure, the areas of extensive damage appeared to be concentrated in the zone identified in Fig. 3. The damage patterns and the established subsurface conditions strongly suggest that the distress to the structure is due to a loss of soil and bearing support beneath the church foundations. The foundation system in this case consisted simply of shallow (1-2m) “piers” built with sandstone blocks and bearing on the sand layer for some and the underlying marl for others. As such, the remedial solution adopted for the church itself was to consolidate/strengthen the bearing soil and then strengthen the church walls.

As a result, the underpinning system was modified to include low capacity vertical and inclined micropiles installed in a dense array to act as root piles for the church. The micropiles are designed to both absorb the vertical loads and to consolidate the subsoil. Pre-jacking was not considered since it tended to increase the rigidity of the system and possible cause upward movement of the structure, which could have compounded the damage. The layout of the micropiles and typical details are shown on Figures 3 and 4.

The layout of the micropiles is shown on Fig. 3 and incorporates

two general schemes. Around the external 30-t columns, four inclined micropiles are installed in an “X” pattern as shown in Fig. 4. For the staircase walls, inside space was extremely tight and the micropiles were positioned outside the walls. A capping beam ties the top of the micropiles and connects through “finger” beams (openings made through the external walls) to an internal mat constructed inside the staircase. The micropiles were distributed in such a way to minimize interference with the future prestressed anchors of Lot 235.

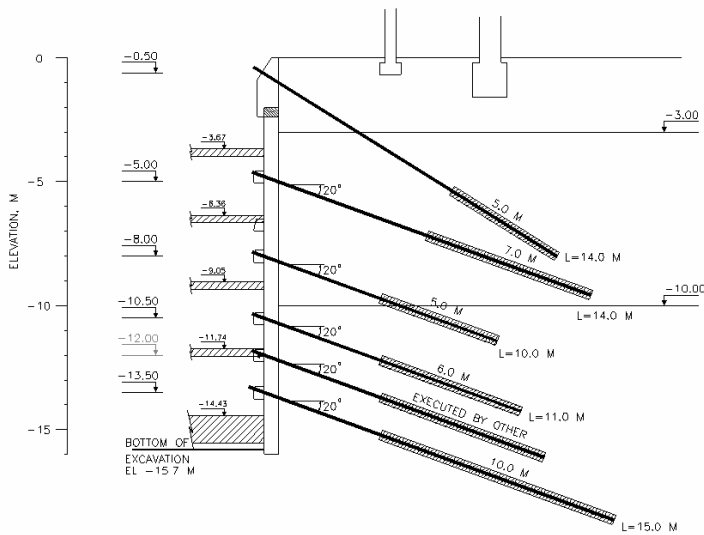
Fig. 6. Layout of the re-designed shoring system along lot-235

Five rows of anchors were used at the project as shown in Fig. 6. The moment capacity of the piles was verified but large deformations remained at the pile toe despite increasing the number of anchors and lowering the last row of anchors. The reason for these large deformations was attributed to the inadequate pile embedment. Nevertheless, these deformations were tolerated in the design with the assumption that the toe

The first row of anchor was installed on a new concrete wall constructed above the existing piles. This row was considered a key element in controlling top deformations.

The temporary prestressed anchors were designed in accordance with "Recommendations TA95". For a borehole size of 120 mm, the working shaft resistance used to determine the bond length of the anchors was 0.23 MPa and 0.35 MPa for the weathered marl and limestone formations respectively. Anchor capacities varied between 300 kN and 640 kN. A quality assurance plan was implemented for the anchors in the form of two destructive pull-out tests and conformity checks for each anchor to 20% above working load.

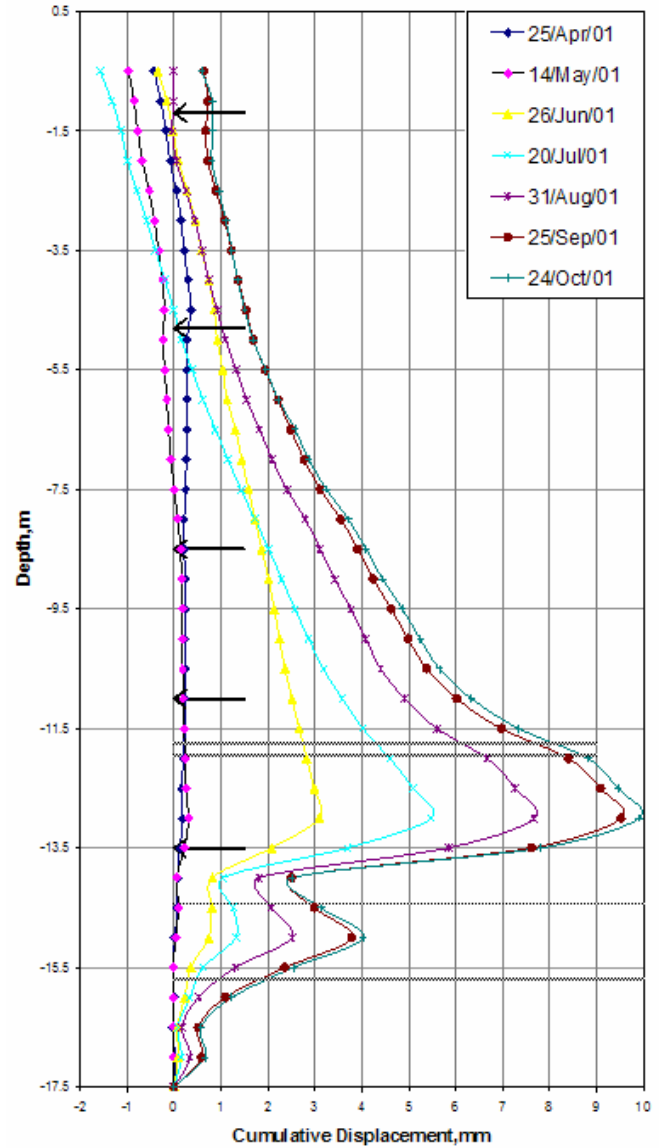
Fig. 7. Cumulative displacements at IN02

- ❑ Deformations at the top remained small and less than 1 mm.
- ❑ Deformations at the bottom of the pile are relatively large, reaching a maximum of 10 mm.
- ❑ Deformations usually increase during excavations and either regress or stabilize after anchor installation.
- ❑ Deformations at top anchors are not affected by subsequent excavation stages.
- ❑ Once the final excavation depth was reached, deformations continued to evolve but at a slightly slower rate than during excavation.
- ❑ Once construction of the building foundations and slab started, the rate of deformations decreased significantly to become almost nil.

The above findings were generally expected by design. However, it is interesting to note that deformations continued when reaching a stable level of excavation. Although the observed values were still smaller than anticipated, the observed behavior is unusual and may be associated with one or a combination of the following:

- ❑ Lack of pile embedment, which gives rise to an unstable toe; or
- ❑ Delayed reaction of the shoring system due to a natural long-term relaxation of the cohesion.

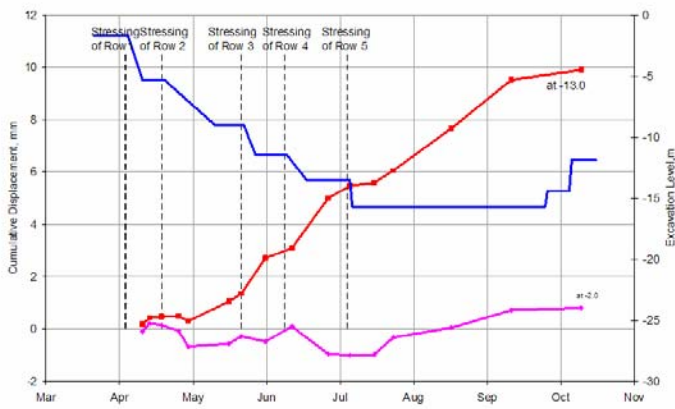
An unexpected behavior was noted in the deformation pattern of the excavation wall where deformations continued to take place for a few months with no additional excavation activity.
