## Failure Investigation of a Fill Slope in Putrajaya, Malaysia

A. N. Hussein  
*Public Works Department, Malaysia*

A. H. Mustapha  
*Public Works Department, Malaysia*

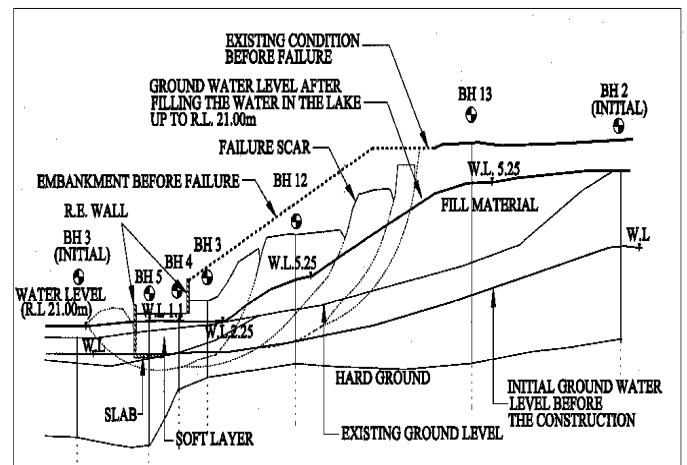
Fig. 6. Cross section of the failed area

A detail mapping of the cross section of the failed site was carried out as shown in Fig. 6. It can be seen that the groundwater table has risen to about 9 to 10m from the original groundwater table prior to the construction of the man made lake.

Detail investigation of the site shows the presence of a thin layer of soft clay that have been squeezed out at the bottom of the slope indicating that not all the soft material have been excavated during the construction of the fill slope as mention by the contractor's site staff.

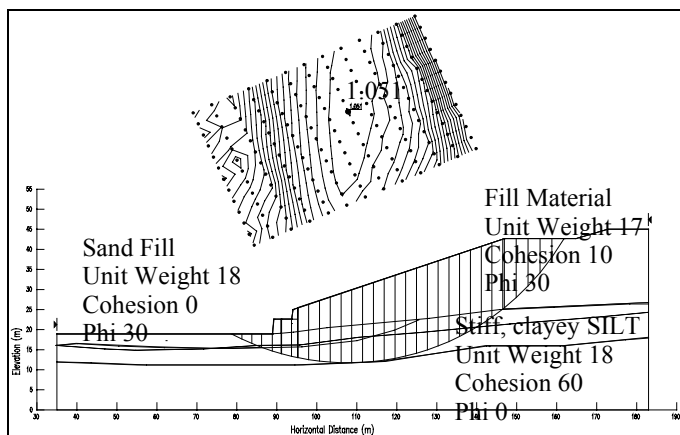
Fig. 7. Case I: Prior to Construction of the lake

For Case 1, Fig. 7, the Factor of Safety (FoS) was found to be about 1.051. This was much lesser than those obtained from the initial analysis carried out by the contractor, which was about 1.4 to 1.5. The differences in the Factor of Safety could

be due to the difference in values of the soil parameters use in the analysis although this could not be confirmed. Standard typical Malaysian soil parameters values were use as there was a delay in getting values from laboratory tests.

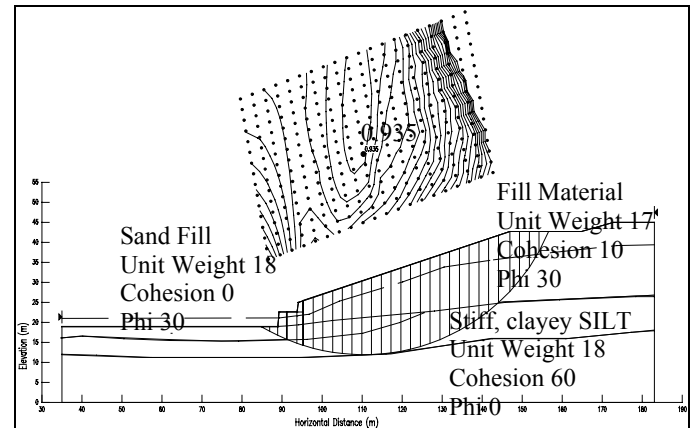
Fig. 8. Case II: After filling of water into the lake

For the second case, Fig. 8, the FoS was found to be just below one (0.935). This indicates that the slope was unstable, as the groundwater level has risen as a result of the filling of water into the lake.

3. There was a rise in the groundwater level in the failed slope after the filling of water into the lake. The rise in the groundwater level was about 9m as compared to previous readings of groundwater level before the construction of the fill slope. This has caused the slope to be unstable as the factor of safety (FoS) was reduced from 1.051 to 0.935 using assumed soil parameters.
