## Estimate the Magnitude and Nature of Distress the Various Structures Have Undergone Due to Recent Bhuj Earthquake

A. R. Katti

On January 26, 2001 one of the most destructive earthquakes ever to strike India occurred in Gujarat. More than 13,000 lives were lost in this earthquake. Several civil engineering sections have undergone moderate to severe distress. In this paper two cases of one port at Adani and a salt factory which has undergone severe distress has been covered.

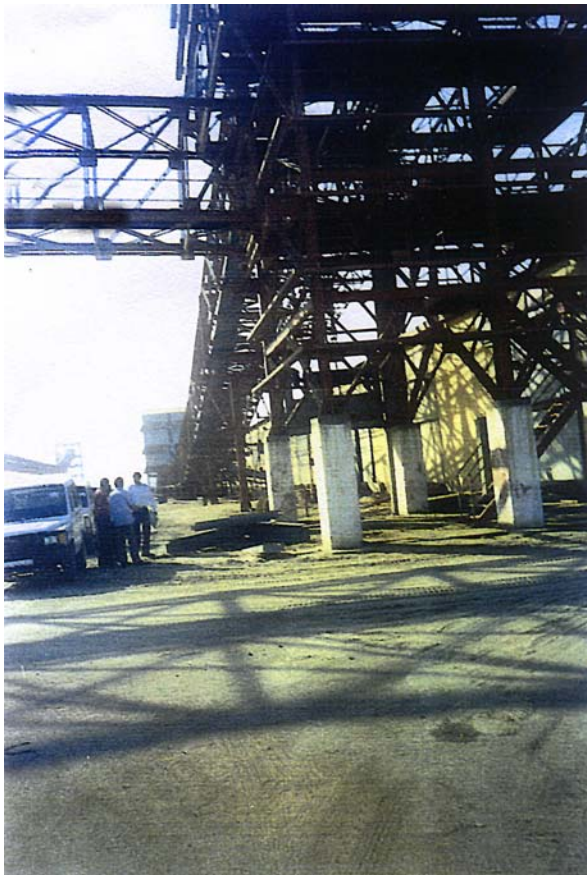
The bund area is the zone parallel to the conveyor belt connecting the service area and the jetty as depicted in Figure 2. The length of this approach bund approximately 700 m. It comprises of rock-fill embankment whose height varies from around 2 m to as high as 7 m. The top width of the approach bund is 12.5 m and the side slope is 1 in 1.5. As the height of

Crack is observed on the bund. It is seen that the cracks originate at pedestal 63 at chainage 44.7 m and go up to pedestal 76 at chainage 174.7 m. Subsequently no crack is observed between chainage 174.7 m and 344.7. Then again the crack is observed from pedestal 93 at chainage 344.7 m till pedestal 111 at chainage 524.7 m. The average thickness of the crack is around 6 cm.

Fig. 2. Bund area parallel to the conveyer belt

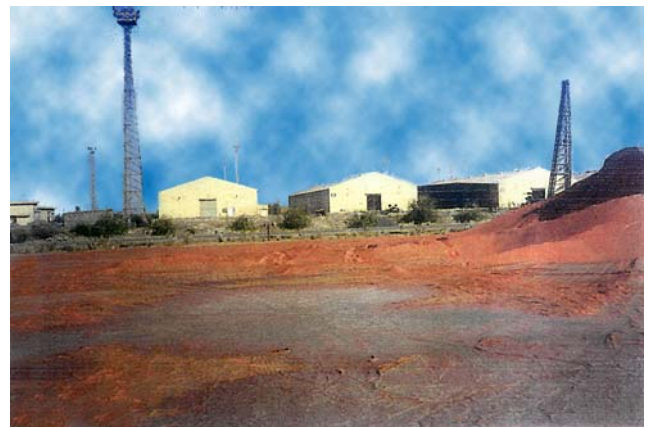
The open stacking yard and dry cargo area covers the major area comprising of: Open storage for sulphur, open storage enclosures 1 to 7, FRM go-down, new FRM go-down, closed go-downs 1 to 9, proposed area for silos, 16500 ton storage area with conveyor connectivity, 25000 ton storage area with conveyor connectivity, DOC open go-down and DOC covered go-down, etc. The entire area has undergone settlement and at several places water has oozed out on the surface and fine sand is spread over the entire area which can be clearly seen in Figure 3

Fig. 3. Open stacking yard and dry cargo area

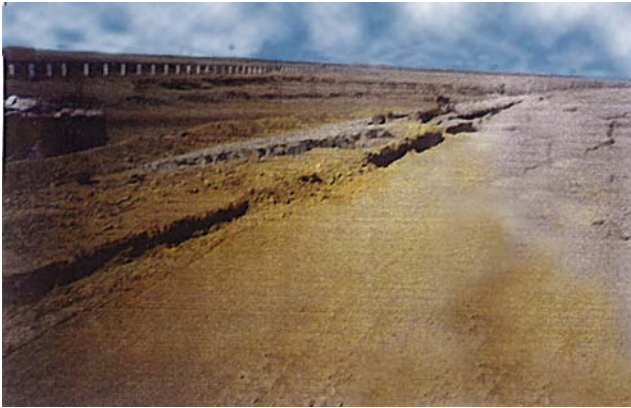
Major distress is observed on the railway embankment when the embankment crosses the road. Here 15 cm wide longitudinal cracks are seen over the entire width of the embankment as seen in Figure 4. The wing was displaced more than 15 cm away from the concrete structure.

Fig. 4. Longitudinal crack over the length of the embankment

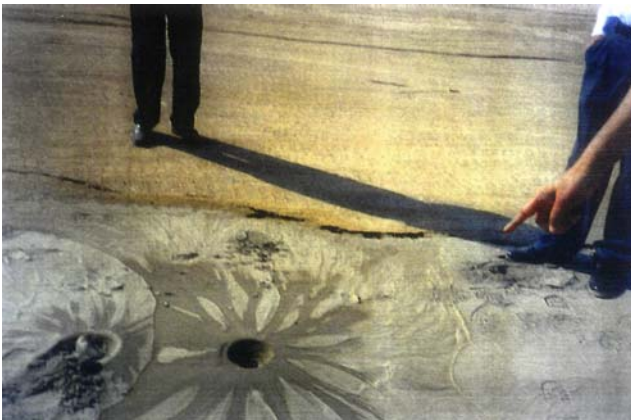
Fig. 5. Wet hole on February 11, 2001 from which water and silt had oozed out

On the top of the embankment at several places silt is oozed out from the embankment and spread over 3 m to 4 m. The diameter of these holes is as high as 10 cm as seen in Figure 5. The height of the water jet, which came out of the embankment, was around a meter or metre and a half. The depth of these cracks was as high as 2 m to 2.5 m.

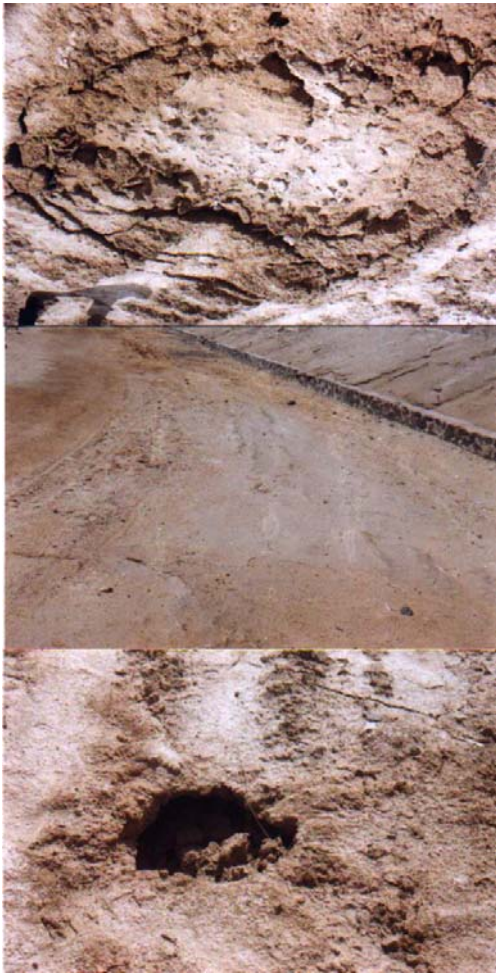
Fig. 7 Location from where the salt and water oozed out at salt factory at Bachau

The photographs, in Figure 7 which were taken just after the earthquake on the January 26<sup>th</sup>, 2001, also clearly indicate that the liquefaction has occurred at the site.

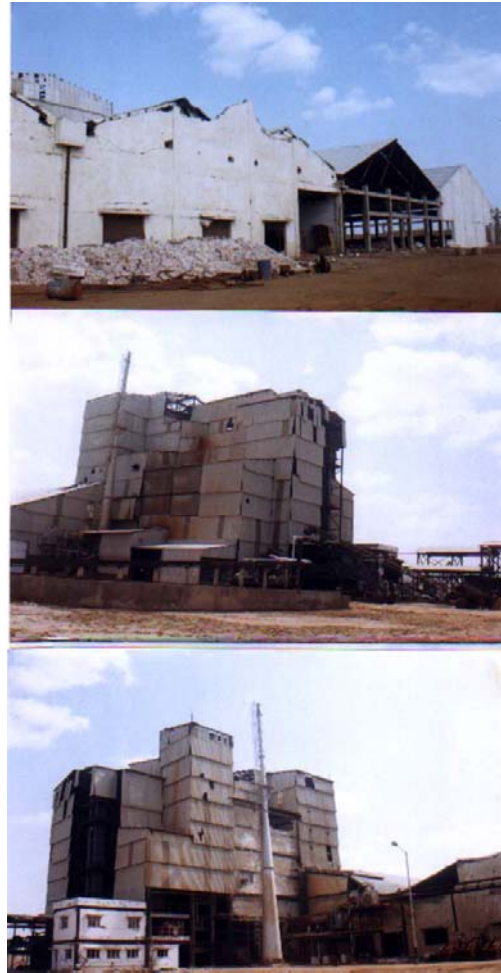
Fig. 8. Structure of salt factory after the earthquake

Figure 8 shows the structure of the salt factory, which clearly shows that the chimney is out of plumb and the entire structure has undergone severe damage.
