Preliminary Geotechnical Engineering Observations of the Tecomán, Mexico Earthquake of January 21, 2003

PRELIMINARY GEOTECHNICAL ENGINEERING OBSERVATIONS OF THE TECOMÁN, MEXICO EARTHQUAKE OF JANUARY 21, 2003

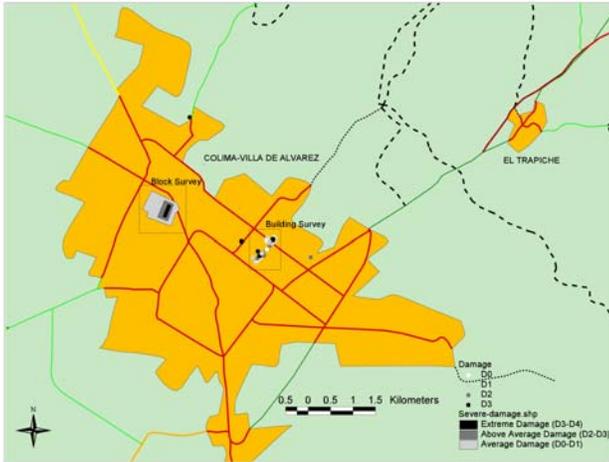
to facilitate documenting, mapping, analyzing and visualizing damage data. The use of PQuake permitted a digital data set of the earthquake effects to be created in a timely manner. Damage surveys were performed either by assigning an average damage index (D0 = no damage, D5 = collapse) to a whole block (Block Survey) or by assigning damage indices to individual buildings. Figure 3 shows the results of the damage surveys, clearly indicating locations of damage concentration around the neighborhoods of San Isidro (Villa de Álvarez) and Lomas de Circunvalación (Colima). In addition, damage to adobe housing in downtown Colima was extensive.

Fig. 3. Damage survey map of the city of Colima indicating areas of high damage concentration.

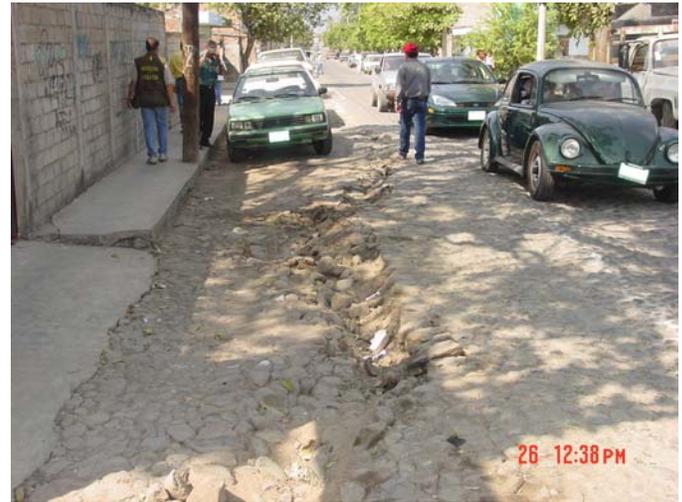
The San Isidro neighborhood is located near the *Arroyo de Pereira*, a small creek running north to south across Colima/Villa de Álvarez. Most of the damaged area overlies highly heterogeneous fill. Evidence of liquefaction was found in areas having high damage concentrations. Significant ground settlement was observed at various locations (Figure 4). Although construction quality in the San Isidro neighborhood is poor, other neighborhoods with similar construction did not suffer as much damage.

Fig. 4. Ground settlement along at street in San Isidro.

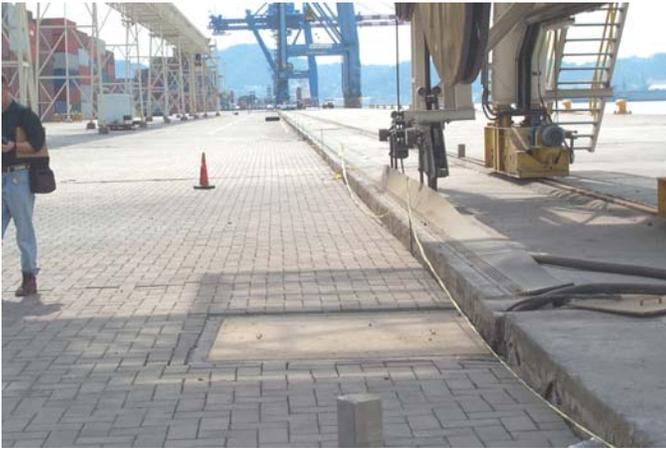
During the 1995 M_w 8.0 Manzanillo Earthquake, the Port of Manzanillo suffered considerable damage due to liquefaction. Since then, various ground-improvement techniques including stone columns and vibro-compaction have been used during repairs of new construction at the port to increase liquefaction resistance of the ground at critical locations. These ground improvement efforts were undertaken in response to the significant liquefaction that occurred at the port in the 1995 earthquake. It appeared that these improved sites generally performed well and no significant liquefaction-related ground deformation features were observed during the reconnaissance visit. Quantitative assessment of the performance of these improved areas will provide valuable information about performance of the ground improvement techniques used at the port. Other areas of the port where ground improvement had not been performed apparently suffered lateral spreading or seismic compression (i.e., earthquake-induced densification of unsaturated soil; see Figure 5).

Fig. 5. Strong shaking densified the unsaturated fill soils below the paving blocks (left), resulting in differential settlement of about 27 cm..

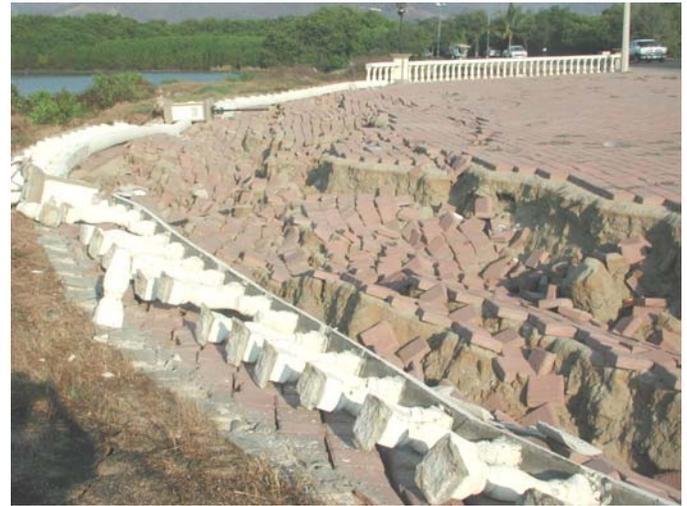
Fig. 6. Lateral spread at a promenade in Manzanillo.

Observed ground distortions (ground cracking and lateral spreading) in a residential district located about 3 km northeast of Manzanillo's city center suggest that liquefaction may have also occurred in this neighborhood, though this was not confirmed. This portion of town was reportedly underlain by miscellaneous fill. A majority of the waterfront liquefaction sites in Manzanillo were marked by lateral spreading of the ground toward the free face. The horizontal displacements varied between sites, but were often in the range of 1-3 m. Figure 6 shows lateral spread of a pedestrian promenade located off an undamaged major boulevard. The promenade surface consisted of paving blocks, whose post-earthquake positions preserve deformation caused by lateral spreading. Investigation at the site indicated that a 0.2-0.5 m thick crust of silty sand moved over an unknown thickness of liquefied ground. The ground slope was about 3% and maximum lateral spread displacements at the site were on the order of 2 m.

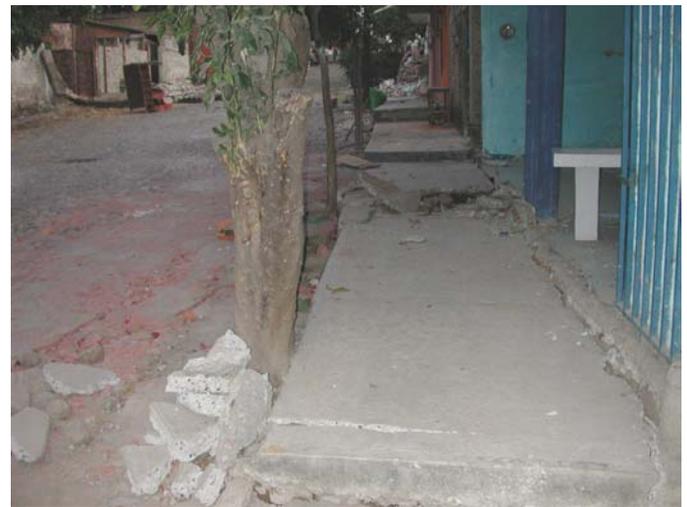
Fig. 7. Damaged street and sidewalk in the City of Colima.

In the city of Villa de Álvarez, just northwest of Colima, liquefaction and resulting lateral spread and shallow foundation failures damaged a number of residences in the San Isidro neighborhood. Portions of this neighborhood were reportedly built on reclaimed land adjacent to a small creek. Shallow subsurface materials at the site consisted of uncompacted or poorly compacted, miscellaneous fill. Local residents reported that immediately after the earthquake, muddy water was ejected from cracks in pavement surfaces and concrete floor slabs. In one structure in the neighborhood, a shallow foundation-supported concrete column experienced a liquefaction-related loss of bearing capacity and dropped about 30 cm, causing significant structural damage to the building. Liquefaction and consequent loss of strength, ground settlement, and lateral spreading are suspected causes of other damage to the neighborhood, including uplifted, sunken, or cracked concrete floor slabs; cracked and distorted pavements and sidewalks (Figure 7); and laterally displaced residential structures (Figure 8).

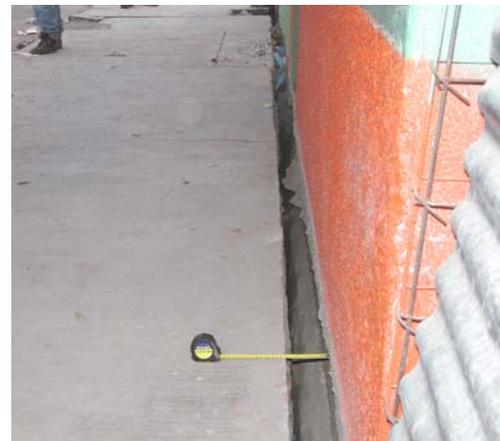
Fig. 8. Lateral spread caused this house to displace about 20 cm in the down slope direction.

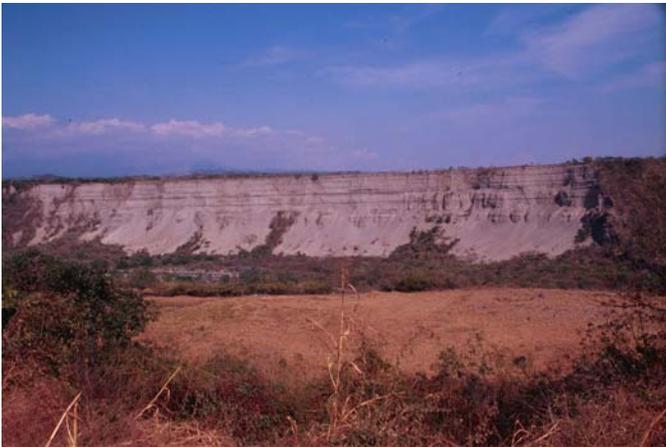
Especially high landslide concentrations were noted in two areas. The first area is located along the steep walls of the Armería River canyon and along its tributary, the Remate River, north of Colima in the vicinity of the town of Zacualpán. Along each river, a stretch of 6 to 8 km was subjected to such intense landsliding that material was removed from stretches of slope hundreds of meters to more than a kilometer long in each of several localities (Figure 9). Most or all of these areas were on the outside of meander bends. The vegetated cliffs where the landslide occurred were typically 150-200 m high and had slope inclinations estimated as ranging from about 70° to vertical. They were composed of very well graded volcanic debris-avalanche material reworked by fluvial action and interbedded with fluvial deposits. These materials had little or no matrix cementation. When this area was inspected on the ground about 10 days after the earthquake, the cliffs were so unstable that together they were still producing several falls each minute (Figure 10). These falls were typically small, ranging from a few cubic meters to perhaps 50 m³ of material each. The continuing instability of these cliffs, exacerbated by the ongoing removal of material by falls, indicates a possible continuing hazard to villages, dwellings, and other infrastructure in the areas located close to the cliffs.

Fig. 9. . Stretch of cliff along Rio Armería northwest of Colima denuded by landslides during the earthquake.

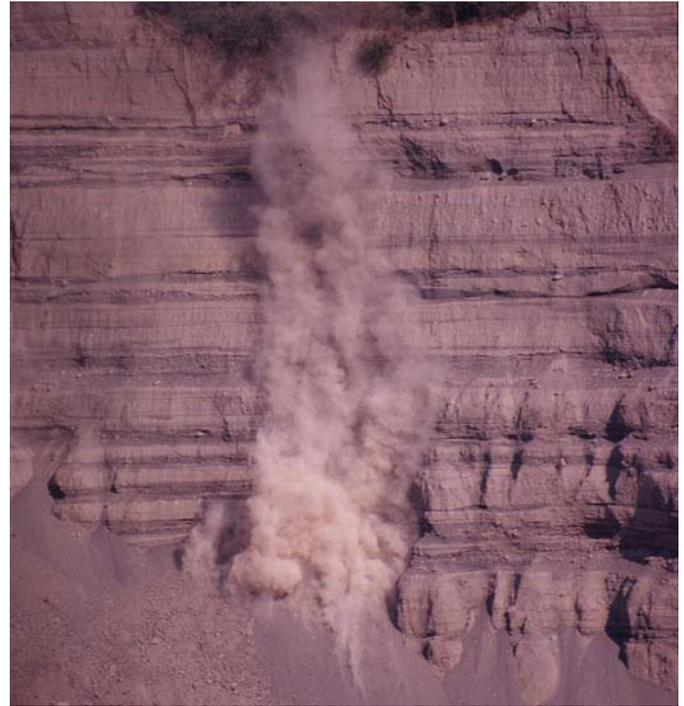
Fig. 10. . One of the larger falls observed from the Rio Armería cliffs on the afternoon of January 28, 2003. A plume of dust accompanied the fall, which had an estimated volume of 20 m³.

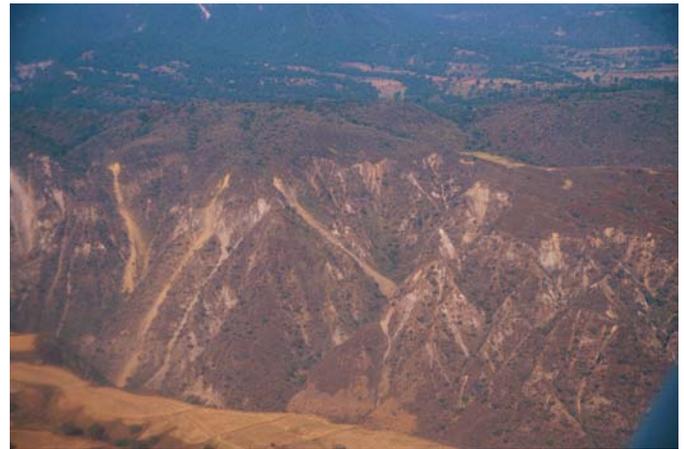
Colima, an inactive volcano. At this location, numerous rock falls, soil falls, rock slides, and debris slides occurred in volcanic materials exposed on canyon walls, typically consisting of an upper fine-grained pyroclastic deposit, a middle unit consisting of well-indurated lava, and a lower unit consisting of a pyroclastic block-and-ash flow deposit (Figure 11). Volumes of the individual landslides typically ranged from a few cubic meters to a few hundreds of cubic meters each, and the highest landslide concentrations ranged up to about 40 landslides per linear kilometer of canyon wall. Slopes were near vertical and ranged up to about 500 m high.

Fig. 11. Landslides along one stretch of canyon wall in the Barranca de Atenquique, on the east flank of Nevado de Colima volcano.
