International Conference on Case Histories in Geotechnical Engineering (2004) - Fifth International Conference on Case Histories in Geotechnical Engineering

FORENSIC ENGINEERING IN APPLIED CIVIL ENGINEERING AND GEO-DOMAIN

D.S. “Sax” Saxena, P.E., F.ASCE

ASC geosciences, inc.

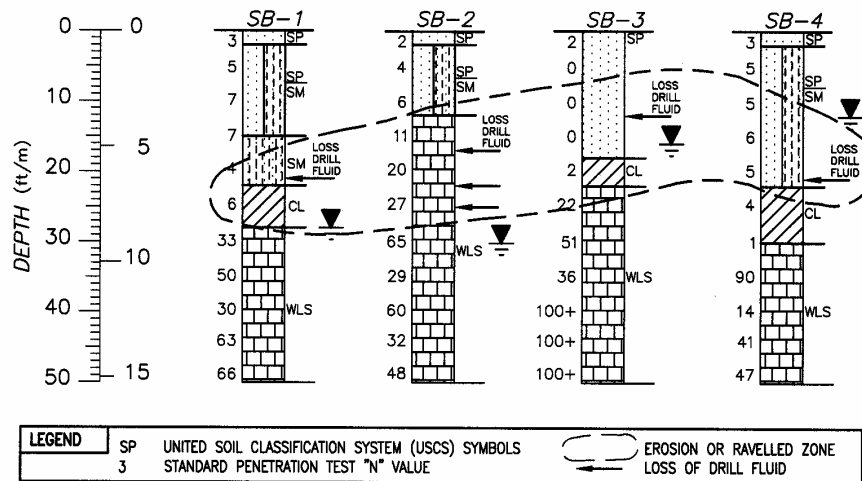
m) exist in all of the test borings. Stratigraphy of the project site for the solution cavity areas is illustrated in Fig. 2. Furthermore, depression or absence of the impermeable clay layer, as well as variable limestone elevations, was indicative of subsurface solution activity.

Fig.2. Project site Stratigraphy showing internal erosion and solution features

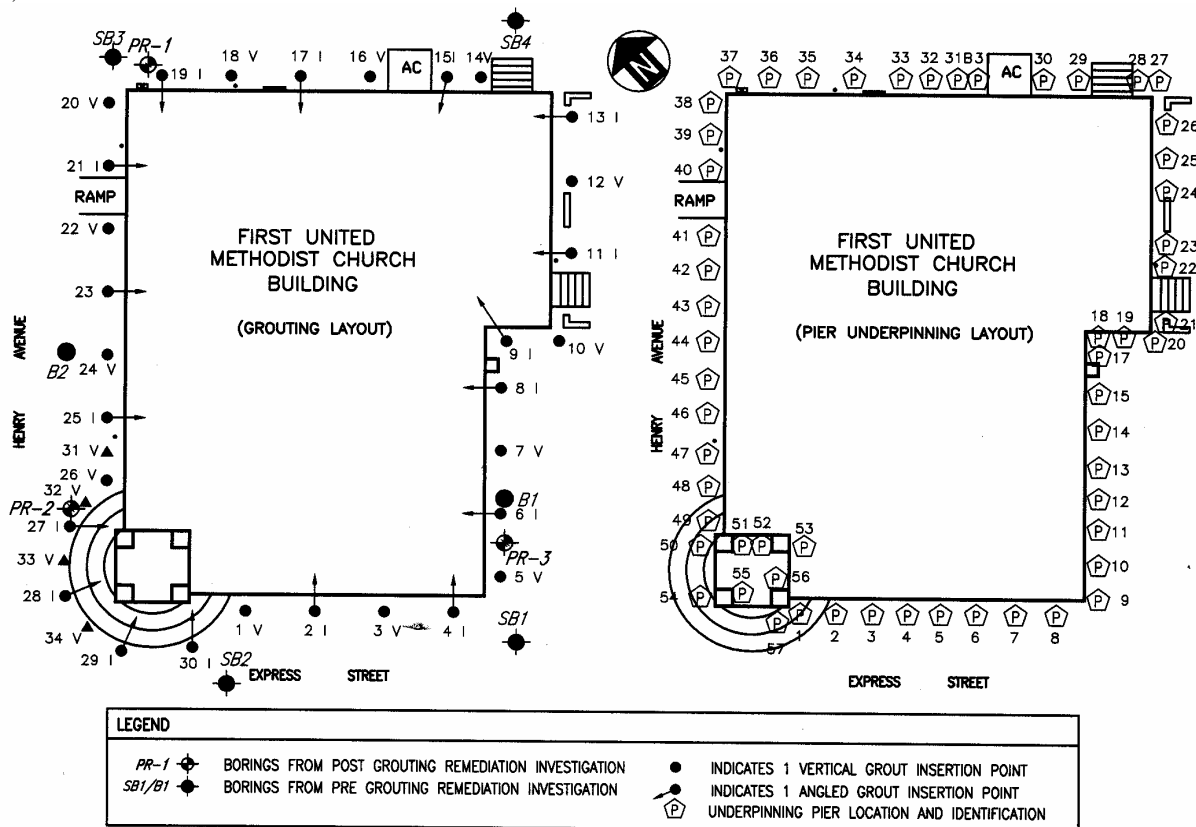
Fig. 3. Plan showing grouting points, underpinning piers, pre- and post-grouting test boring locations

2. Remediation program should be a primary grouting program consisting of 17 angled and 13 vertical injection points to 35 ft (10.6 m) foot depth and installation of a total of 57 underpinning piers at locations illustrated in Fig. 3.

10. Specific locations are illustrated in Fig. 3 with lengths ranging from 12.0 ft (3.7 m) to 28.0 ft (8.5 m).

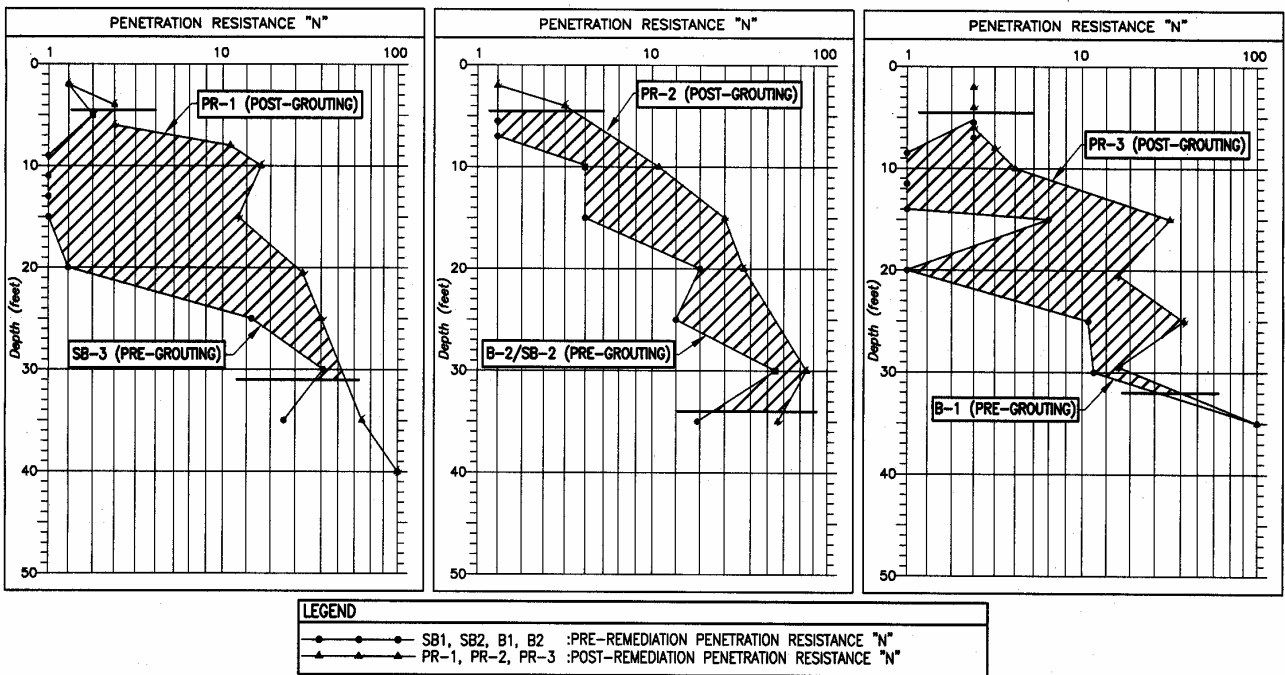
3. Post grouting test borings (PR1, PR2, and PR3) were performed to 40.0 ft (12.5 m) depth. Borings indicated that while grouting had been effective in filling the raveled zones, in most of the affected areas a localized area near boring PR1 (traversed by injection points 26-1 through 28-1) near the bell-tower entrance area, had not been effectively remedied. This was evidenced by loss of drilling fluid circulation in the area. Accordingly, a secondary set of four (4) vertical grouting points identified between locations 25-1, 26-1, 27-1, 28-1, and 29-1 were completed prior to initiating pier installation underpinning program during Phase 2.

Fig. 4. Pre-and post-remediation resistance "N" value profile

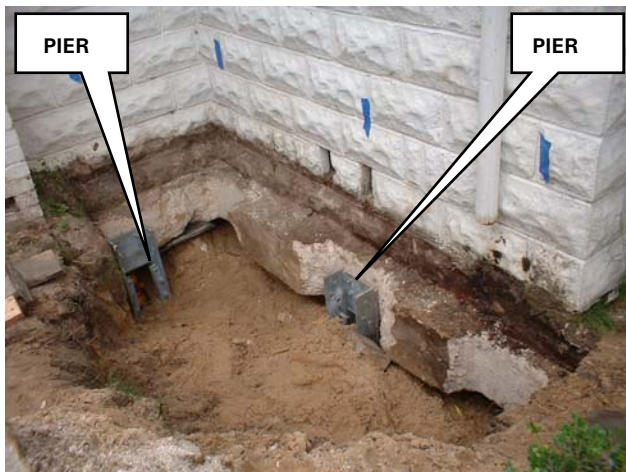
Fig 5. View of underpinning showing model AP2 ATLAS piers

Engineering representatives of the consultant monitored the stabilization and loading of the piers and documented locations, pier length, approximate vertical lifts, and the pressure at lift lock. View of a typical model AP2, 2-piece standard resistance ATLAS pier (as installed) is illustrated in Fig. 5. Because of the delicate nature of the footings, (brick and mortar) and the point loading provided by the piers, special steel beam support was determined to be necessary. A steel angle beam spanning between the piers was rigged up to distribute the footing support load and alleviate stress concentration and possible cracking.

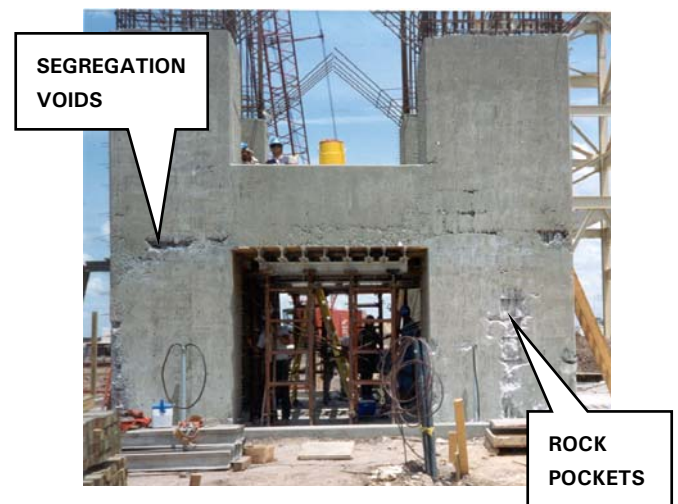
Fig. 6. View of structure upon removal of forms. Segregation, voids, and rock pockets are visible

Improper placement of concrete for a structure resulted in a visual appearance of segregated concrete and honeycombing, as illustrated in Fig. 6. Questions were raised regarding the structural integrity, and removal/replacement of the partially

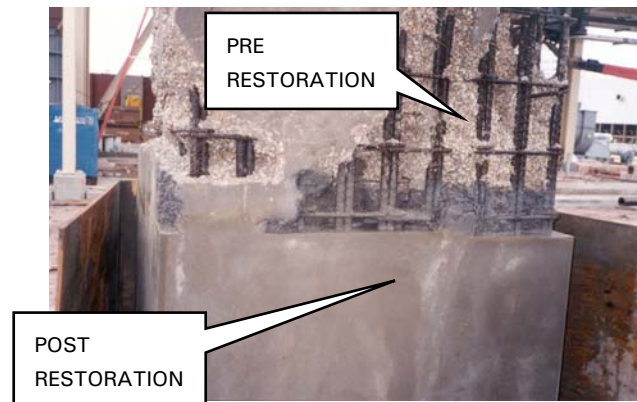
Fig. 8. View of column with pre- and post-restoration areas

During all stages of the Phase II remediation and restoration program, the retained consultant provided inspection services for various operations, quality of the grout, forming, and the application procedures. Any defects in workmanship or grouting quality were immediately noted and corrected by the specialty subcontractor. Overhead beam areas were determined to be lacking in bond as determined by visual separation in core specimens). These areas revealed insufficient bonding, and the specialty subcontractor was directed to chip the grout out for inspection and was further directed to re-perform the repairs. A typical photograph showing sections of a pre- and post-remediated column is illustrated in Figure 8.

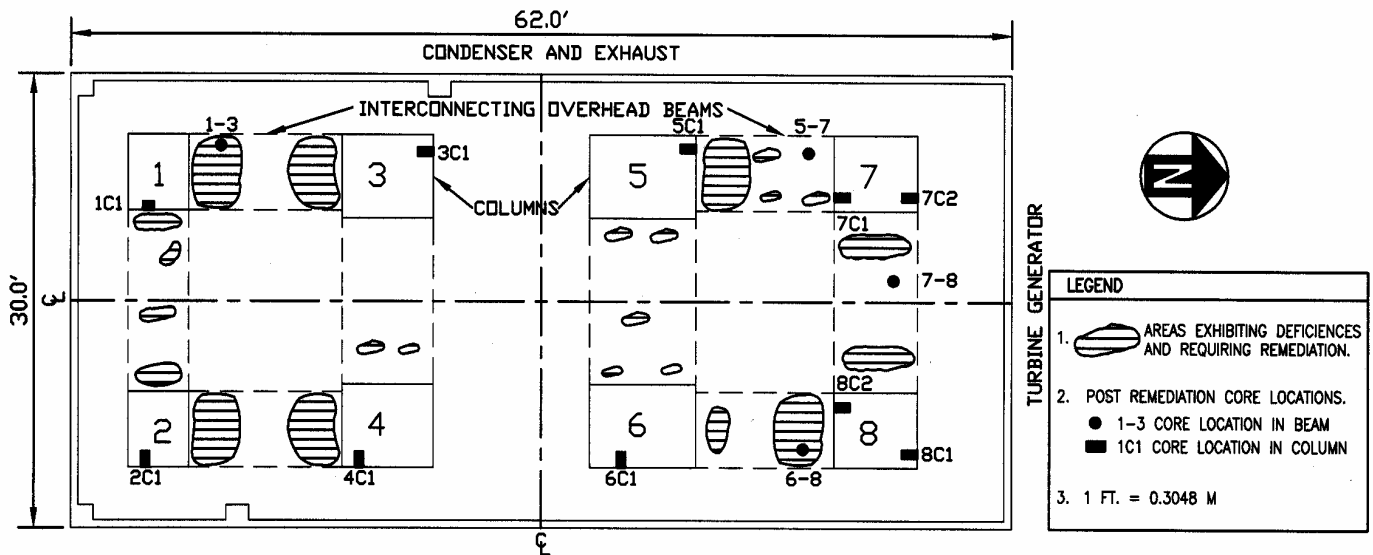
The STG structure layout showing areas exhibiting deficiencies and requiring remediation as well as the PostRS core locations is shown in Fig. 9 below.

Fig. 9. STG structure layout showing deficient area and post remediation core locations

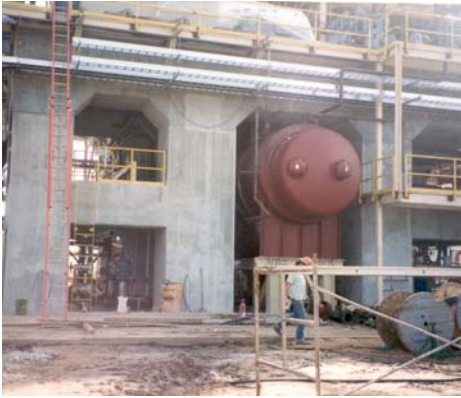
Fig. 10. View of restored STG structure.

- Following the close coordination between the consultant and the owner's representative, completion of the Stage II investigation, and based upon results of Stage III investigation, it was determined that the repair of 8 columns and overhead beams had been achieved satisfactorily.
- The final repair resulted in restoration of the STG structure to its originally planned and designed dimensions and load conditions, as illustrated in Fig. 10.
- Application of forensic engineering principles was a key factor in restoration of the STG structure.
- As a result of the monitored and satisfactory remediation program, the consultant recommended acceptance of the restored structure.
