14 Aug 2008, 4:30pm - 6:00pm

An Investigation on Failure of Embankments in Bangladesh

AN INVESTIGATION ON FAILURE OF EMBANKMENTS IN BANGLADESH

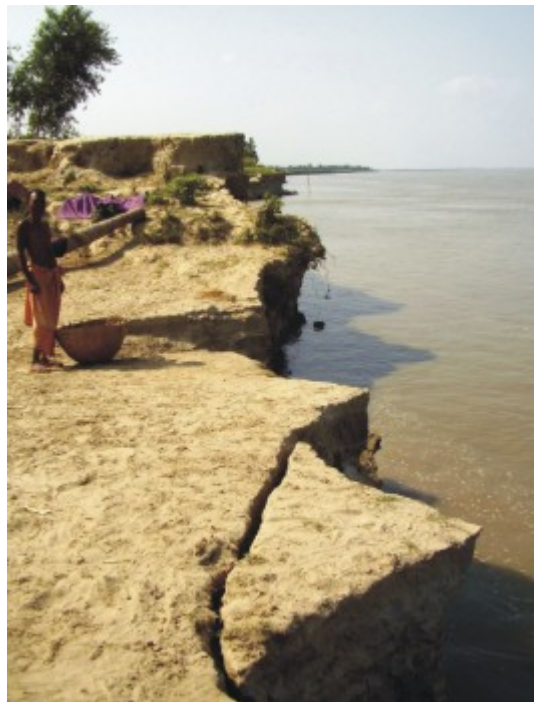
Fig.3. Jamuna flood control embankment in Bogura, The Daily Star 2007/05/02

The failure of Jamuna flood control embankment is shown in Fig.3. Over 150000 families have been affected due to the threat of Jamuna right bank flood control embankment at Talukderpara in Shariakandi upazila in May 2007 in Bogura. The daily star on May 2, 2007 reported that the local Union Parishad (UP) member Mr. Shahadat Hossain

Dulal said his house is likely to be devoured within a few days if erosion continues unabated. He said a major portion of the flood control embankment at Talukderpara point would be eroded within a short period if the erosion is not checked immediately.

Local people have apprehended damage of scores of houses. A large number of houses along the embankment eroded last year. The BWDB Sub-Divisional Engineer (SDE) Engr. Zahural Haque said more than 150000 families might be affected in Dhunat and Sharikandi upazila if erosion could not be checked without further delay. If the erosion continues in such a speed the flood control embankment may be washed away within a week. Engr. Zahural Haque said the department already invited a tender to protect the embankment at Talukderpara point. But fund was not allotted timely. A portion of Chandanbaisa hard point eroded last year which had been built to protect Chandanbisa and adjacent areas including part of Talukderpara. But the eroded point was not being repaired due to fund constraint. An amount of Tk 80 lakh is required to repair the hard point while Tk 99 lakh is required to protect the embankment at Talukderpara point.

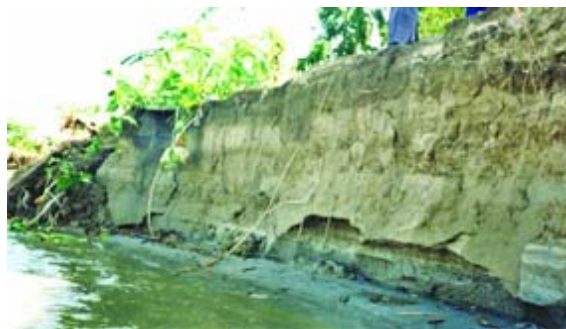
Fig.4. Padma river embankment damages at Rajbari., Naya Digonta 2007/06/16

The damage of Padma river embankment at Rajbari is shown in Fig.4. Nearly 50 km Padma river embankment at Rajbari from goalando to pangsar sengram has been damaged in June 2007 due to heavy current of padma river water that flooded and come from upstream part. This beribad at Rajbari was breached in 2004 causing numerous damages of lives and agricultures. Then, huge amount of money was being spent to repair the beribad in 2005 and 2006. It required about Tk.650 lakh for filling, repairing and reconstruction of the embankment. However, because there were lot of fault and complaints in the repair and reconstruction works, this beribad is now in great threat especially in the rainy season. Approximately 60 unions and 14 lakhs peoples within the beribad in Rajbari are passing their days with great fear and danger of flash flood owing to the sudden breach of the embankment. The villages of daulotdia, debgram, ujanchor, ratandia, kalikapur, bbahadurpur, habampur, sawrail, and kasaba as well as thousand of houses and families already destroyed near the Padma bank in just one week due to the thrust of water current.

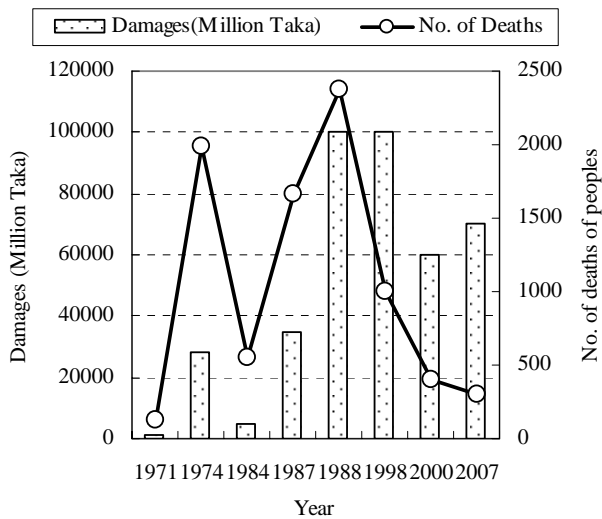
Fig. 5. Damages and number of deaths of peoples after independence of Bangladesh due to effect of flood and embankment failure

The damages and number of deaths of people owing to effect of major floods and embankment failure after the independence of Bangladesh to date are shown in Fig.5. It is evident that every year almost two-thirds of the country inundated in the monsoon and thus breached of embankments and relevant disruptions as well as damages caused were enormous. Bangladesh, being located at the GMB delta of the three mighty rivers (the Ganges, Meghna and Brahmaputra), is vulnerable to flooding every year during the monsoon. Flood has become frequent natural disaster in Bangladesh since long before resulting in failure of hundreds of embankments causing homeless of thousands of people. As a result the affected people are becoming poorer day by day. After the independence of Bangladesh, the maximum deaths of people occurred in the year 1988 although the flood in 1998 was extreme in the history of Bangladesh. In 1998, almost 80% of the country was inundated that damaged most of the houses, paddy fields and hundreds of kilometers of road-cum-flood embankments of rural Bangladesh.

observed that the number of deaths of people is getting to reduce in the recent years as compared to earlier despite the damages are enormous. This clearly indicates the alertness and awareness of government and the people of Bangladesh about the flood and flash flood due to the sudden breach of earthen embankments. Nonetheless, this phenomenon can not be considered enough and necessary steps in this direction especially protection of earthen embankment from failure should be taken into account urgently.
