Averted Piping Failure—Earth Dam on Permeable Foundation

Scott Newhouse

Bechtel Power Corporation, Frederick, MD

AVERTED PIPING FAILURE—EARTH DAM ON PERMEABLE FOUNDATION

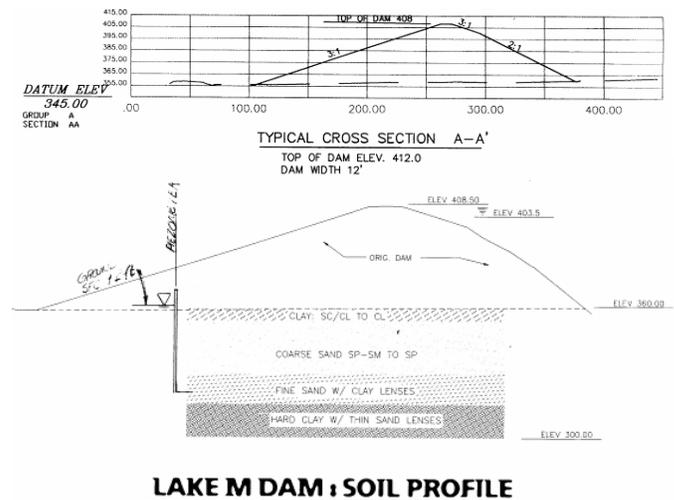
Lake Mailande Dam was originally built in 1994 as a homogeneous embankment (without filter/drain protection). Figure 1 depicts the typical cross section, taken from the construction plans, and depicts the soil profile beneath the dam. As shown in Fig. 1, design did not include seepage control—neither a cutoff in the foundation nor an internal filter/drain. The construction plans did not address foundation treatment at all, leading to extensive questions during construction regarding soft soils, high groundwater, and seepage control. The dam is about 55 ft high and 1,800 ft crest length, with 337,000 cu yd of embankment fill. The dam has sparse rural development downstream that includes houses in its flood path and a county road at the toe. Accordingly, it is classified high hazard. Lake Mailande is privately owned, used solely for recreation.

Fig. 1. Lake Mailande Dam—Typical Section and Soil Profile

After construction commenced, further exploration was performed to establish the soil conditions depicted in Fig. 1. Exploration shows:

- Significant layers of sand in the foundation
- Significant coefficient of hydraulic conductivity (k), of maximum 10^{-3} cm/s
- Artesian water pressure rising to near 2 ft above ground surface

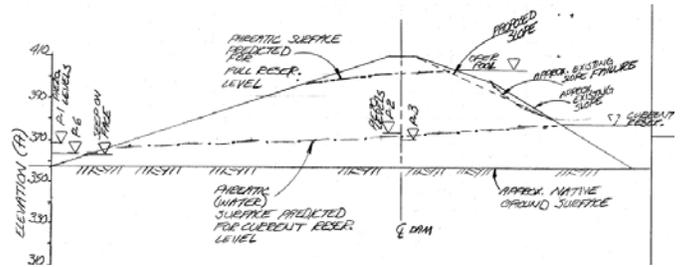
Figure 7 illustrates a predicted line of seepage within the dam for a full reservoir condition. The predicted line of seepage is based on the piezometer measurements shown taken during initial filling, at the low lake elevation shown. This predicted seepage line was sketched using methods from Cedergren (1989), based on the seepage line exhibited by piezometer measurements and flow net analysis based on an assumed $k_h:k_v$ ratio of 10. The piezometer data show that head and hydraulic gradient were increasing at the toe with increasing lake elevation. This figure illustrates that the dam as designed, with no foundation seepage cutoff and no internal drain to control seepage pressure, would develop intolerable water pressure and hydraulic gradient at the toe long before the lake reached its design elevation. Should this predicted condition be considered accurate? How will the seepage line develop in the dam at higher lake elevation?

Fig. 7. Predicted Line of Seepage at Full Reservoir

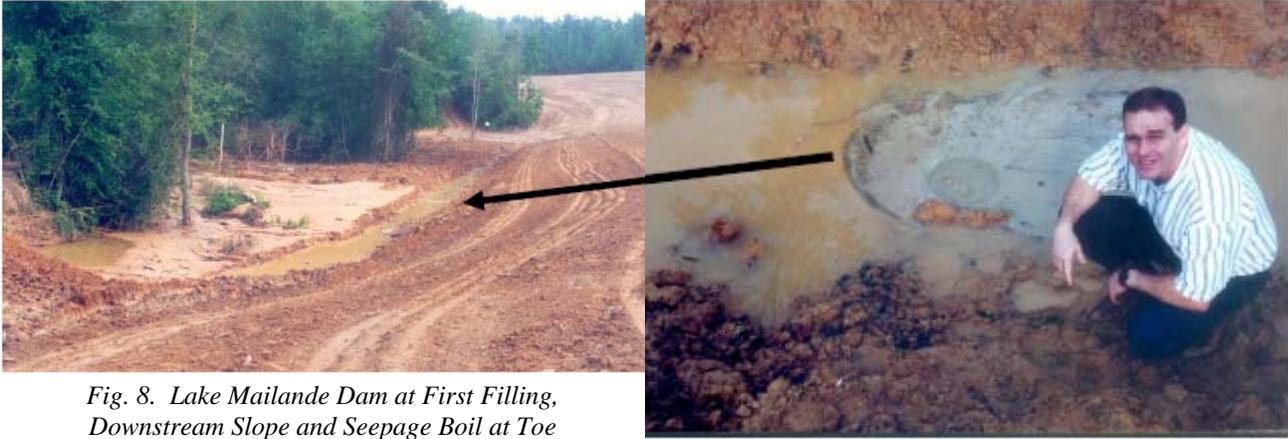
At the time conditions in the dam were as illustrated on Fig. 7 seepage problems developed. At this time, reservoir filling had begun, and the lake was less than 50% filled. The toe near maximum section became saturated, a shallow slide developed near the toe, and a seepage boil appeared, as illustrated in Fig. 8 (on page 5). Figure 8 shows the dam at its maximum section. At the time the boil and slide developed, a piezometer at this location indicated head at the toe nearly 12 ft above the ground surface.

The development of the boil indicates that excessive hydraulic gradient developed even with the lake less than 50% full, with a water head near 20 ft of the design 45 ft head. Conditions at this stage clearly showed that continued filling would result in internal erosion of soil from the foundation, and likely a soil pipe, resulting in a breach—the condition illustrated in Fig. 4.

Fig. 8. Lake Mailande Dam at First Filling, Downstream Slope and Seepage Boil at Toe

At the time the conditions depicted in Fig. 8 formed, the design engineer interpreted the boil as a harmless spring, and interpreted the piezometer level as an effect of consolidation due to pressure on the ground from the embankment. However, facts did not support these interpretations:

- The seepage boil clearly had a cone of deposition showing fine soil being eroded.
- The piezometer level showed steady increase with increasing lake elevation, not with increasing embankment height. Excess pore pressure from consolidation would correlate with the pressure applied by increasing height of embankment fill and would show dissipation over time instead of a steady increase.

The seepage boil was covered with a fabric filter and stone ballast to control erosion. State officials directed that the lake be lowered to a safe level until the dam was renovated. Lowering the lake level and covering the boils averted dam failure by erosion/piping through the foundation. The initial prediction that a homogeneous dam could be built on the permeable foundation at this site was obviously wrong.

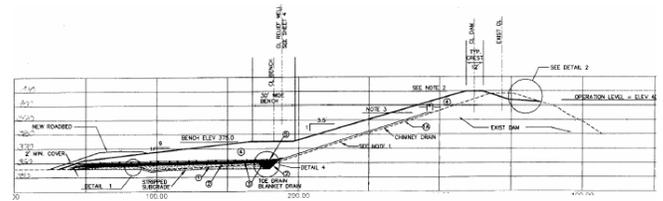
Fig. 9. Renovated Dam Cross Section

Figure 9 shows the typical cross section engineers developed to renovate the dam and ensure downstream slope stability and safety against piping. Engineers had difficulty in evaluating the need for a foundation seepage cutoff. As shown in Fig. 9, engineers decided that water pressure and hydraulic gradient could be controlled with drainage works, and that a cutoff was unnecessary. Modifications to the dam included a chimney drain, toe and blanket drains, and relief wells drilled into the artesian zone. The renovated dam was placed in service in 1997 and has performed well. The renovated dam’s

performance shows that predictions that the dam could be renovated without a cutoff were accurate.

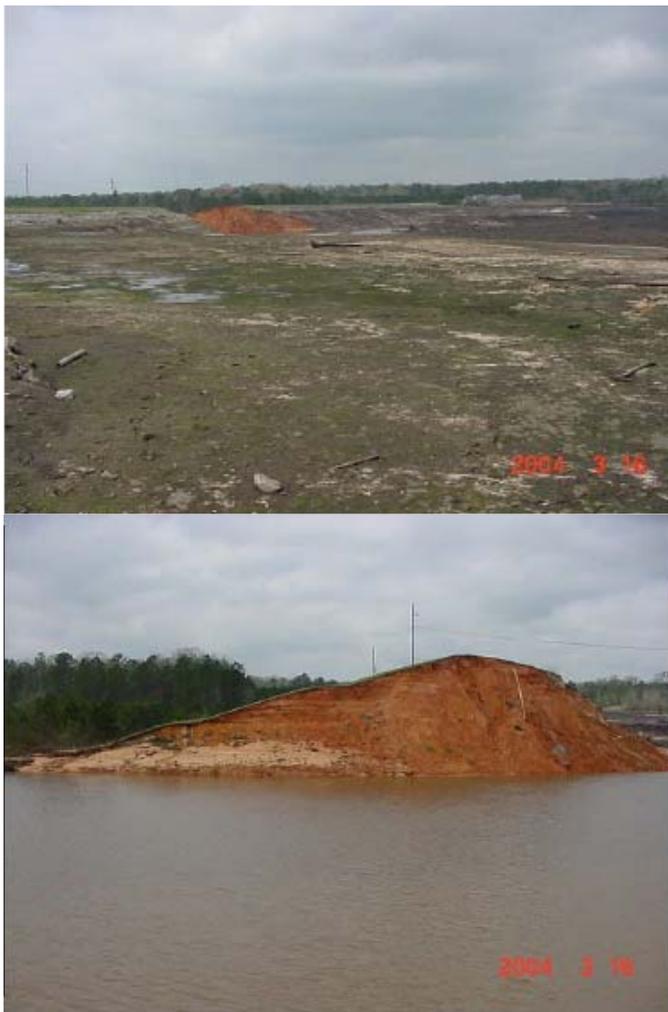
Big Bay Lake Dam. Big Bay Lake Dam (see Fig. 10), near Purvis, Miss., was built in 1991. It experienced a sunny day failure unexpectedly in 2004. The dam is a 57 ft tall earth embankment; the impounded reservoir was about 1,100 ac (ASDSO, 2005). The dam was evidently built with a blanket drain, but without a foundation seepage cutoff. The failure mechanism is theorized to be piping through the foundation.

Fig. 10. Big Bay Lake Dam Breach, Lamar County, Mississippi
(Photos from National Weather Service, Jackson, Miss.)

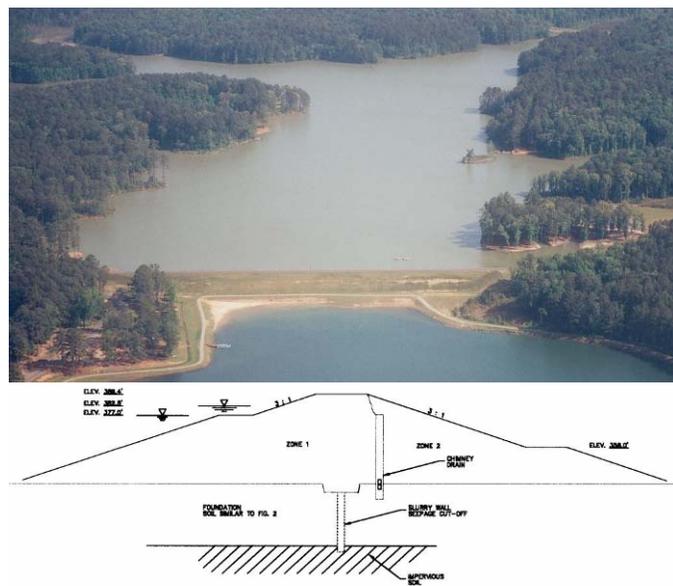
Fig. 11. Bonita Lake Dam Photo and Cross Section

Bonita Lake Dam. Bonita Lake Dam (see Fig. 11) is within 4 mi of Lake Mailande, with similar size of dam and reservoir. It was designed and built by NRCS for municipal water supply and flood control purposes. This dam is about 60 ft high and 1,500 ft crest length, with 380,000 cu yd of embankment fill. Soil conditions here are similar to Lake Mailande, but there is less thickness of alluvial sand in the foundation. Artesian groundwater pressure was not encountered at Bonita Lake.

Bonita Lake Dam was built with the elements that the BuRec design manual calls for—positive seepage cutoff and internal drain, although the drain here is a vertical chimney and not a horizontal blanket. The Bonita Lake Dam has performed without problems related to seepage.
