Back-Analyses of Landfill Slope Failures

BACK-ANALYSES OF LANDFILL SLOPE FAILURES

ABSTRACT

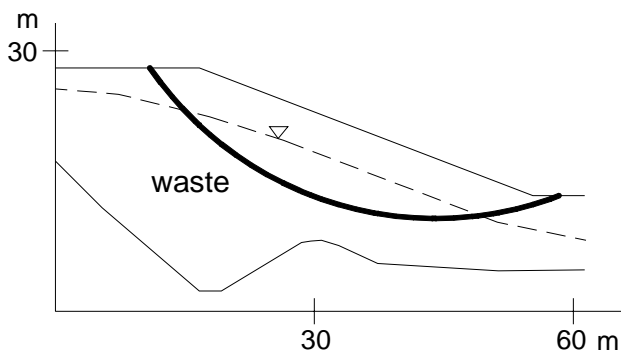
Based on piezometer records the groundwater/leachate level was found to be 3 to 5 meters below ground surface (Fig.1). No geosynthetic liner system was installed prior to waste placement and thus the waste is in contact with native materials and groundwater. The slope did not experience a large slide but tension cracks developed in buildings on top of the landfill indicating the onset of sliding. Some of the observed building cracks may be caused by waste settlement rather than slope movement but tension cracks were observed indicating the onset of slope instability. Because the slope did experience some movement, the Factor of Safety (F.S.) was assumed to be near unity for the back-analysis. To back-calculate an effective stress friction angle, the MSW was assumed to exhibit a cohesion intercept (c') of 0 kPa. The back-calculated friction angle (ϕ') of the WF is 21°. The back calculated friction angle is reasonable considering the age of the waste. The landfill is estimated to be 300 years old. Therefore, the back-calculated shear strength of MSW would be expected to be close to the shear strength of a cohesive soil even though the WF is the newest of the waste layers. The average effective normal stress on the observed failure surface through the waste is 106 kPa and the corresponding back-calculated shear strength is 40.7 kPa.

Fig.1 Approximate slope profile of Gnojna Grora landfill in Warsaw, Poland (from Bouzza and Wojnarowicz 2000)

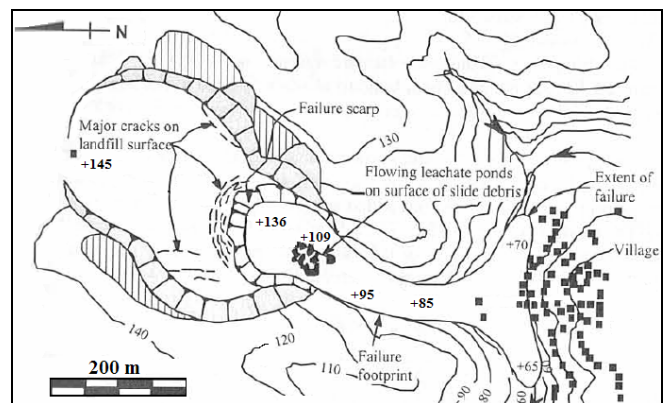
The catastrophic slope failure occurred on April 28, 1993 and resulted in 27 casualties and involved approximately 500,000 m³ to more than 1,000,000 m³ of waste (Fig. 2 shows a site plan view after the failure). Before the slide, 3 to 5 m of demolition debris and soil was placed on top of the uncompacted waste starting in mid-1992 to provide cover for the waste and to increase income obtained from the fees of dumping of demolition debris. Fires were known to be burning on the surface of the waste at several places during most of the year before the slide (Figs. 3 and Fig. 4 are photos from the landfill).

Fig. 2. Site plan view after slope failure (modified from Koerner and Soong 2000)

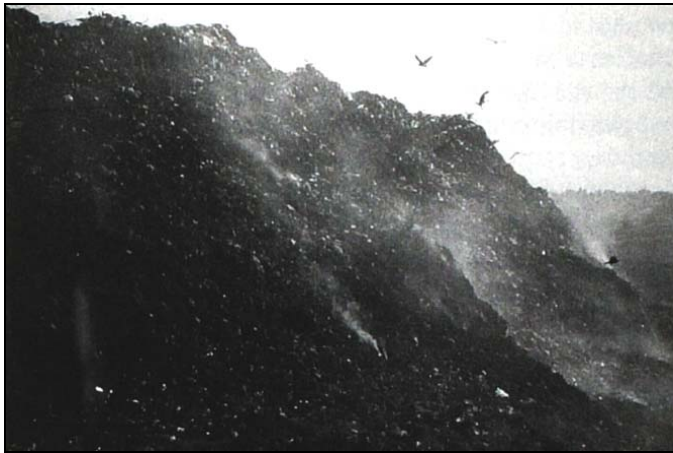
Fig. 3. Front slope of the MSW before slope failure showing surface fires and steep slope of the MSW (Kocasoy and Curi 1995).

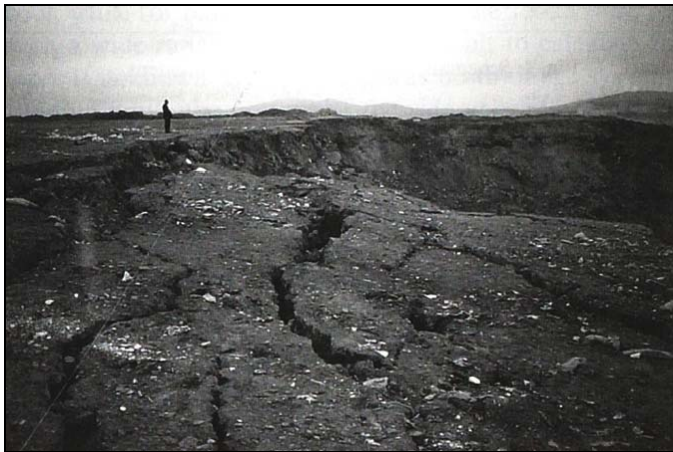
Fig. 4. Tension cracks on top of landfill and steep backscarp in MSW after slope failure (Kocasoy and Curi 1995)

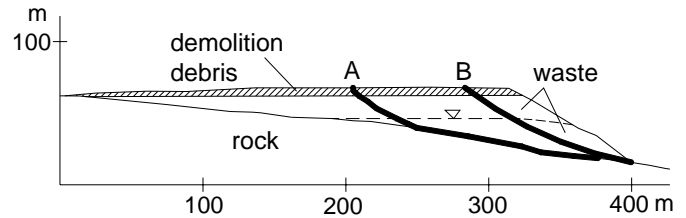
The approximate cross section of the landfill and the leachate level is shown in Fig. 5. The location of the actual failure surface in the field is not known. Search for the critical failure surface passing through the slope toe was performed and it is failure surface B in Fig. 5. This search resulted in a failure surface closer to the one described by Kocasoy and Curi (1995) than Koerner and Soong (2000). The figure in Kocasoy and Curi (1995) study didn't include a scale therefore the failure surface couldn't be used for this study. It is assumed

that their failure surface is the most reliable because it is based on based on their observations at the site and data they obtained from the municipality of Istanbul. A noncircular failure surface is assumed by Koerner and Soong (2000) and shown as failure surface A in Fig. 5. Water level from Koerner and Soong (2000) is at about 21 m below the top of the waste. Fires and explosion are not modeled in the slope stability analyses.

Fig. 5. Approximate cross-section of landfill and estimated slip surfaces (modified from Koerner and Soong 2000)

Because the observed failure surface at the time of failure is not known, both failure surfaces (A and B) in Fig. 5 are considered in the analyses. Weighted average values of the back-calculated average effective normal and shear stress pairs along the base of the failure surface are $(\sigma'_n, \tau) = (170, 62 \text{ kPa})$ and $(76, 68 \text{ kPa})$ for failure surfaces of A and B respectively. A circular failure surface (B) passing through the slope toe results in lower factors of safety than the noncircular failure surface (A) if one uses the same shear strength parameters for both cases. If a higher leachate level (leachate level at about 10 m below the top of the waste surface, not shown in Fig. 5) would be assumed (Kocasoy and Curi 1995, Koerner and Soong 2000), the corresponding backcalculated pair is $(54, 77 \text{ kPa})$. High leachate levels are believed to be more representative of the field conditions, therefore an average value of the two circular analyses $(\sigma'_n, \tau) = (65, 72.5 \text{ kPa})$ is listed in Table 1.

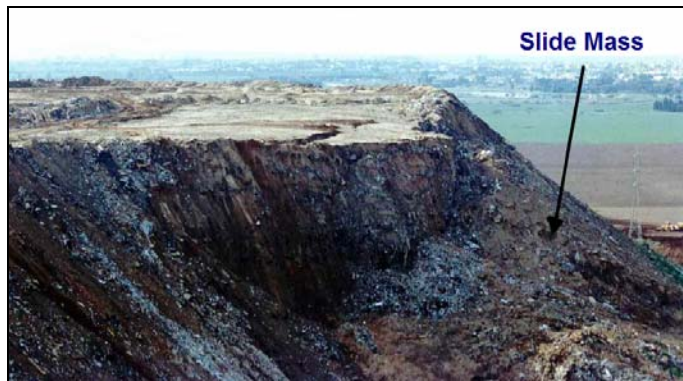
Side slopes of Hiriya landfill range from 1.3H:1V to 1.6H:1V with an average 1.44H:1V. The slopes are covered with a thin irregular soil cover, with waste exposed in some areas. Slope heights range from 43 to 64 meters, averaging 56 meters as measured above surrounding level terrain. As a result of the steep slopes, the lack of vegetation, drainage and erosion controls, the landfill has experienced small and large instability problems. In the winter of 1997-98 a major slope failure (Figures 6 and 7) occurred in the northern face of the dump, following a period of heavy rain, and the Ayalon River was blocked for some days.

Fig. 6. 1997 Hiriya landfill slope failure (Isenberg, 2003)

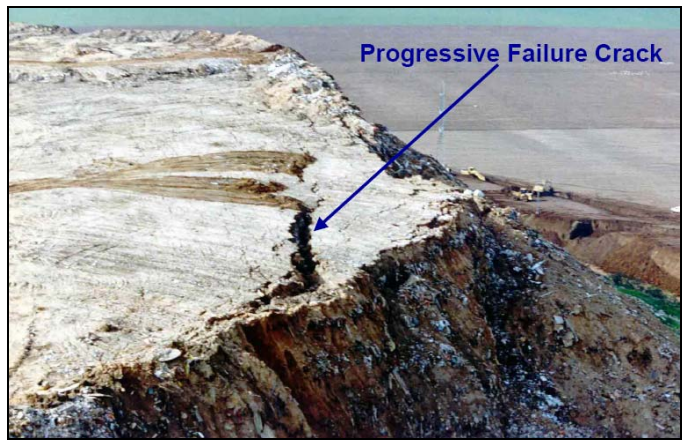
Fig.7. Top of Hiriya landfill after slope movement (Isenberg 2003)

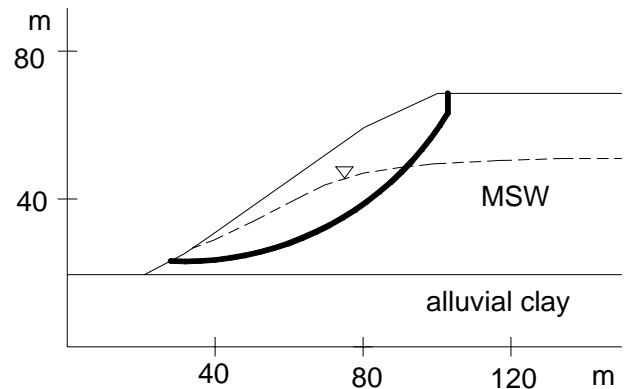
Figure 8 shows the cross section of Hiriya landfill, and the results of the back-analysis are presented in Table 1.

Fig. 8. Cross section of the Hiriya landfill (modified from Isenberg 2003)

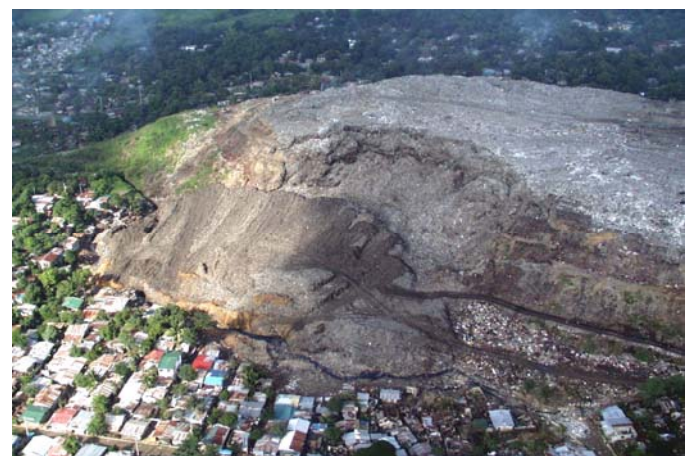
Fig. 9. Payatas landfill slope failure in 2000. (Kolsch and Ziehmman, 2004)

The picture of the observed failure in the field is shown in Fig. 9. Although the exact location of the failure surface is not

known, looking at the near vertical scarp, the thickness and movement of the displaced waste mass, and no sign of bulging at the toe to indicate a deeper seated failure surface through the underlying clay, the failure surface in the field seems to be shallower and mostly through the waste than failure surface A in Fig. 9. Therefore a critical circular failure surface was found using UTEXAS3 (shown as failure surface B in Fig. 11). This failure surface, together with unit weights of MSW from Merry et al. (2005), were used in a back-analysis. The weighted average effective normal stress along the failure surface is 45 kPa and the corresponding shear strength is 35 kPa.

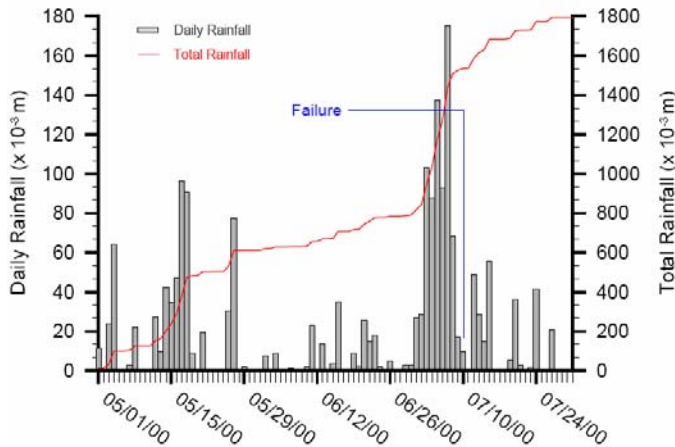
The exact mechanism of failure is not clear, but several factors probably contributed to the failure. These include heavy rains (68 cm rainfall caused by two typhoons that occurred in the area in the two weeks prior to the failure, see Fig.10) leading to the likely saturation of the entire waste mass; building up of waste that caused the side slopes to be steeper than recommended (1.5H:1V at the time of failure); ponding of water on the top of the slope; the construction of drainage trenches at the top of the slope to drain this ponding water; construction of a 2 to 3 m deep drainage ditch at the toe of the slope; and the potential build-up of landfill gas (Merry et al. 2005).

Fig.10. Precipitation record at Quezon City Weather Station in Philippines during May thru July 2000 (Merry et al. 2005).

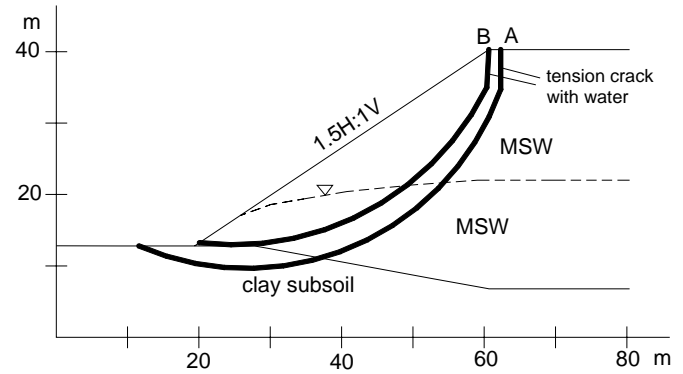
Merry et al. (2005) assume that the failure surface passes through the waste and the underlying natural clay (failure surface A in Fig. 11). In this study, using the failure surface A in Fig. 11, and using the unit weights of MSW and clay substrata, and shear strength of clay substrata given by Merry et al. (2005), a cohesion of 20 kPa, and a friction angle of 32 degrees are back-calculated for the MSW. The back-analysis is correct if the location of the failure surface used in the analysis represents the observed failure surface in the field, and the shear strength of the underlying clay strata is known. The weighted average effective normal stress along the portion of the failure surface that passes through the waste is 62 kPa and the corresponding shear strength is 59 kPa. Although Merry et al. (2005) did not back-calculate the shear strength of the MSW, they suggest using a cohesion of 19 kPa

and a friction angle of 28 degrees based on Geosyntec (1998) and Kavazanjian (2001). These parameters lead to an average effective normal stress along the failure surface through the MSW of 62 kPa and a shear stress of about 52 kPa, which is in agreement with the back-calculated shear strength parameters in this study.

Fig. 11 Cross section of Payatas landfill slope failure (modified from Merry et al. 2005)

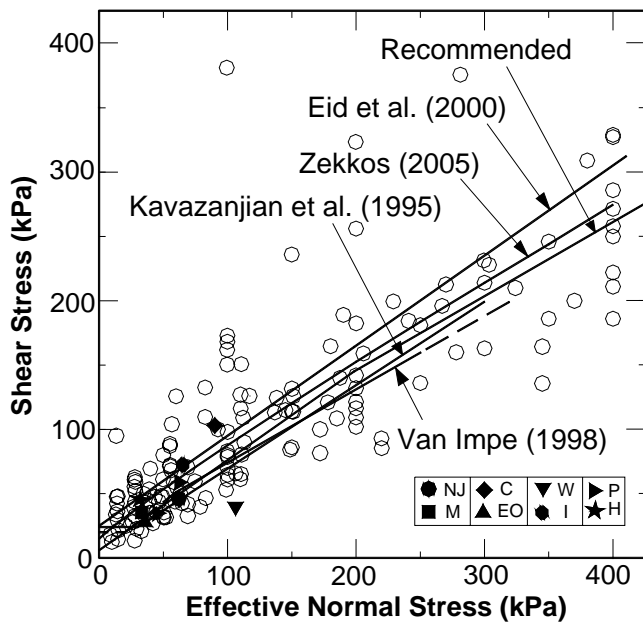
Figure 12 shows a summary of back-calculated MSW shear strengths given in Table 1, together with other four landfill slope failures back-analyzed and reported by Stark et al. (2000) and Eid et al. (2000). These previously analyzed cases are located in New Jersey (NJ), Maine (M), Cincinnati (C) and Eastern Ohio (EO) landfills. Also in Fig. 12 various published shear strength envelopes for MSW are presented. A recommended strength envelope is developed by Stark et al. (2007) based on an extensive literature review on the laboratory and field measurements of shear strength of MSW, which are shown as open circles in Fig. 12. The cases analyzed in the current study have low effective normal stress range. It would be interesting to look at cases where the effective normal stress on the failure surface along the MSW is large. This would aid in determining the MSW shear strength at large effective stresses. The interest in mega-landfills with effective stresses in the waste up to more than 1,000 kPa is necessitating MSW shear strength parameters at high effective stresses.

Fig.12. Summary of back-calculated MSW shear strength shown with four other landfill slope failures, and published failure envelopes (modified from Stark et al. 2007)

More case history analyses and laboratory and field testing of shear strength is needed on fresh waste and degraded (old) waste to better understand its mechanical behavior and shear strength. In the interim, a bilinear shear strength envelope is recommended based on Stark et al. (2007) and this study. The recommended bilinear envelope is, $c' = 6$ kPa and $\phi' = 35^\circ$ degrees for effective normal stresses less than 200 kPa, and $c' = 30$ kPa and $\phi' = 30^\circ$ degrees for effective normal stresses more than 200 kPa.
