International Conference on Case Histories in Geotechnical Engineering (2008) - Sixth International Conference on Case Histories in Geotechnical Engineering

Back-Analyses of Landfill Slope Failures

BACK-ANALYSES OF LANDFILL SLOPE FAILURES

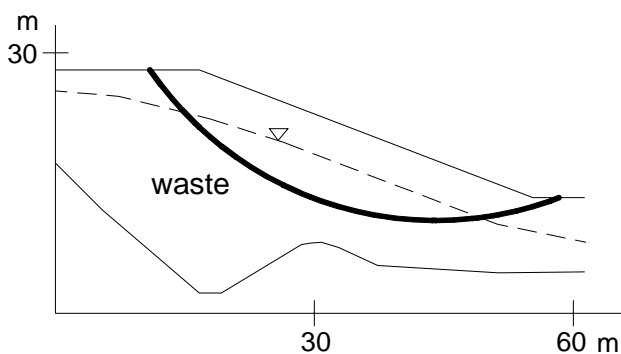
Based on piezometer records the groundwater/leachate level was found to be 3 to 5 meters below ground surface (Fig.1). No geosynthetic liner system was installed prior to waste placement and thus the waste is in contact with native materials and groundwater. The slope did not experience a large slide but tension cracks developed in buildings on top of the landfill indicating the onset of sliding. Some of the observed building cracks may be caused by waste settlement rather than slope movement but tension cracks were observed indicating the onset of slope instability. Because the slope did experience some movement, the Factor of Safety (F.S.) was assumed to be near unity for the back-analysis. To back-calculate an effective stress friction angle, the MSW was assumed to exhibit a cohesion intercept (c') of 0 kPa. The back-calculated friction angle (ϕ') of the WF is 21°. The back calculated friction angle is reasonable considering the age of the waste. The landfill is estimated to be 300 years old. Therefore, the back-calculated shear strength of MSW would be expected to be close to the shear strength of a cohesive soil even though the WF is the newest of the waste layers. The average effective normal stress on the observed failure surface through the waste is 106 kPa and the corresponding back-calculated shear strength is 40.7 kPa.

Fig.1 Approximate slope profile of Gnojna Grora landfill in Warsaw, Poland (from Bouzza and Wojnarowicz 2000)

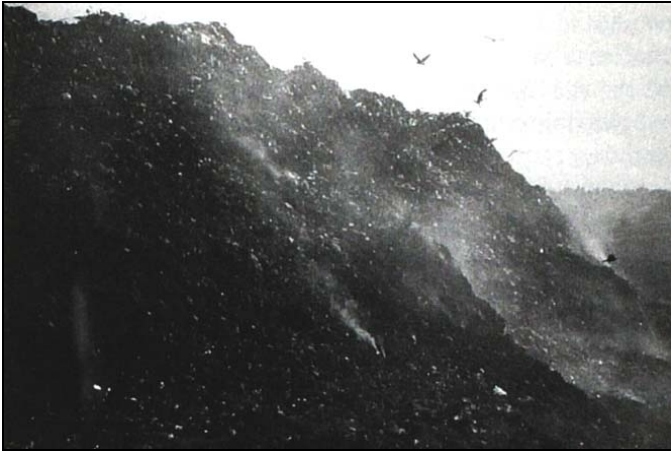
Fig. 3. Front slope of the MSW before slope failure showing surface fires and steep slope of the MSW (Kocasoy and Curi 1995).

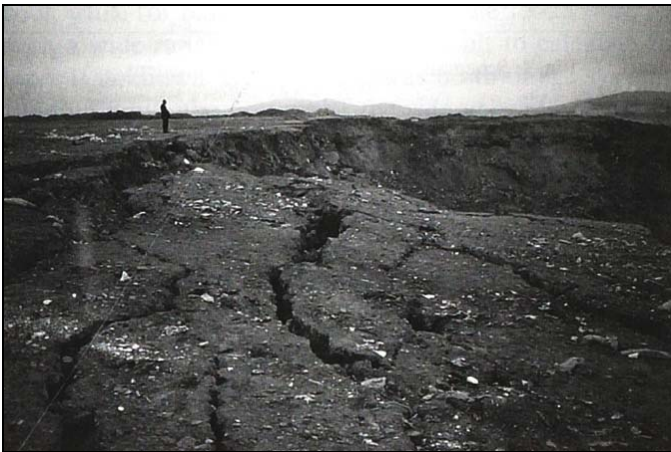
Fig. 4. Tension cracks on top of landfill and steep backscarp in MSW after slope failure (Kocasoy and Curi 1995)

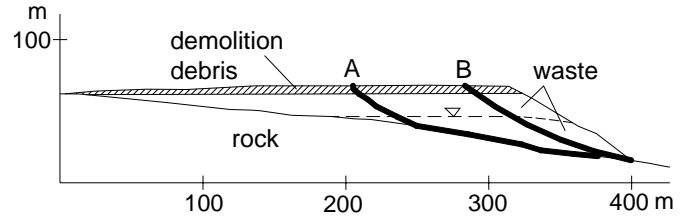
The approximate cross section of the landfill and the leachate level is shown in Fig. 5. The location of the actual failure surface in the field is not known. Search for the critical failure surface passing through the slope toe was performed and it is failure surface B in Fig. 5. This search resulted in a failure surface closer to the one described by Kocasoy and Curi (1995) than Koerner and Soong (2000). The figure in Kocasoy and Curi (1995) study didn't include a scale therefore the failure surface couldn't be used for this study. It is assumed

that their failure surface is the most reliable because it is based on based on their observations at the site and data they obtained from the municipality of Istanbul. A noncircular failure surface is assumed by Koerner and Soong (2000) and shown as failure surface A in Fig. 5. Water level from Koerner and Soong (2000) is at about 21 m below the top of the waste. Fires and explosion are not modeled in the slope stability analyses.

Fig. 5. Approximate cross-section of landfill and estimated slip surfaces (modified from Koerner and Soong 2000)

Because the observed failure surface at the time of failure is not known, both failure surfaces (A and B) in Fig. 5 are considered in the analyses. Weighted average values of the back-calculated average effective normal and shear stress pairs along the base of the failure surface are $(\sigma'_n, \tau) = (170, 62 \text{ kPa})$ and $(76, 68 \text{ kPa})$ for failure surfaces of A and B respectively. A circular failure surface (B) passing through the slope toe results in lower factors of safety than the noncircular failure surface (A) if one uses the same shear strength parameters for both cases. If a higher leachate level (leachate level at about 10 m below the top of the waste surface, not shown in Fig. 5) would be assumed (Kocasoy and Curi 1995, Koerner and Soong 2000), the corresponding backcalculated pair is $(54, 77 \text{ kPa})$. High leachate levels are believed to be more representative of the field conditions, therefore an average value of the two circular analyses $(\sigma'_n, \tau) = (65, 72.5 \text{ kPa})$ is listed in Table 1.

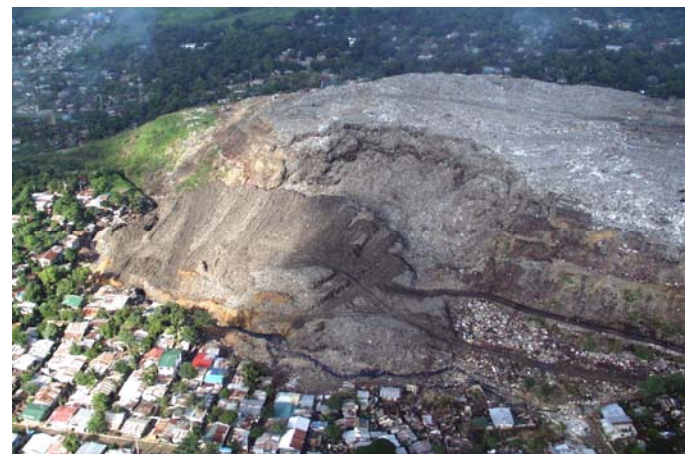
Fig. 9. Payatas landfill slope failure in 2000. (Kolsch and Ziehmman, 2004)

The picture of the observed failure in the field is shown in Fig. 9. Although the exact location of the failure surface is not

known, looking at the near vertical scarp, the thickness and movement of the displaced waste mass, and no sign of bulging at the toe to indicate a deeper seated failure surface through the underlying clay, the failure surface in the field seems to be shallower and mostly through the waste than failure surface A in Fig. 9. Therefore a critical circular failure surface was found using UTEXAS3 (shown as failure surface B in Fig. 11). This failure surface, together with unit weights of MSW from Merry et al. (2005), were used in a back-analysis. The weighted average effective normal stress along the failure surface is 45 kPa and the corresponding shear strength is 35 kPa.
