International Conference on Case Histories in Geotechnical Engineering (2008) - Sixth International Conference on Case Histories in Geotechnical Engineering

Case History of Labor Accident Due to Slope Failure During Slope Excavation and Its Countermeasure Work

CASE HISTORY OF LABOR ACCIDENT DUE TO SLOPE FAILURE DURING SLOPE EXCAVATION AND ITS COUNTERMEASURE WORK

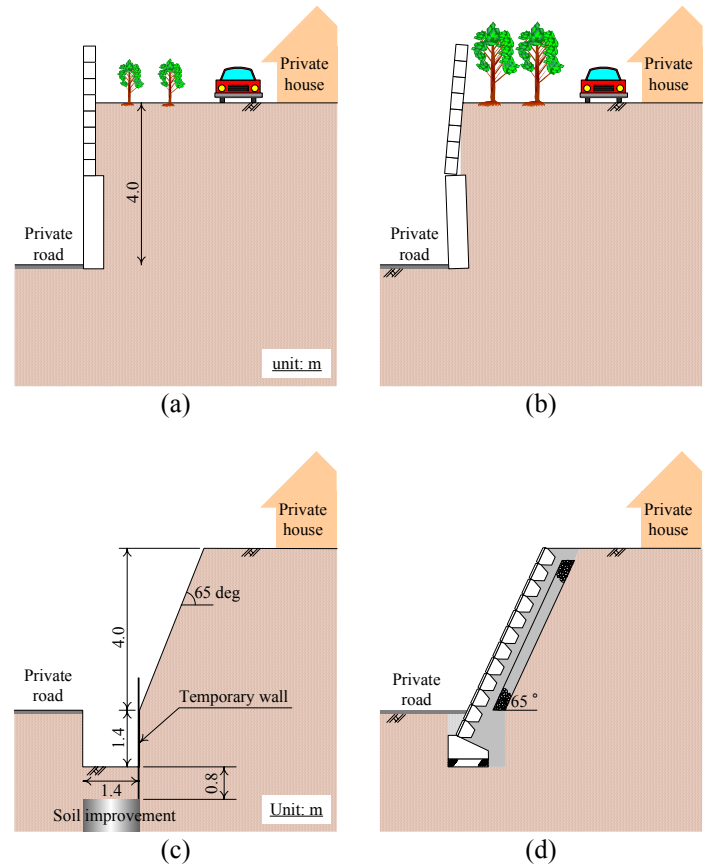
Fig. 4. Sequence of the retaining wall construction.

The private house was rebuilt to extend a new room at the first floor. It was necessary to construct new retaining wall because the existing retaining wall was in danger of collapse as shown in Fig. 4(b). This retaining wall is composite structures made by cinder block wall on concrete gravity wall. The existing concrete gravity wall moved forward as a bottommost portion of the wall is fixed and the cinder-block wall moved as bottommost portion of the wall is freed. The owner and contractor had a plan to make a new 4.0 m high concrete block retaining wall, according to the construction plan; a finished shape of new retaining wall is shown in Fig. 4(d). The construction comprises excavating a 1.4 m x 1.4 m trench at the base of the retaining wall for concrete foundation (Fig. 4(c)). In this construction site, soil cement column was used for settlement control of natural soft ground supporting a weight of new retaining wall. The target unconfined compressive strength c_u was 1.1 MPa, and maximum

embedded depth was 8.0 m under a bottom of the trench. Because a shoring plan was not formulated, a simple temporary wall system was used during the trench excavation. Steel pipes for temporary construction were driven with a spacing of 0.5 m into the ground using a mini excavator. Composite panels were placed directly against the front of the pipes as a soldier pile wall system. The embedded depth of steel pipe was only 0.8 m due to a stiff improved ground under the bottom of trench. The accident occurred on the second day after constructing a base of retaining wall. On the day of accident, only three workers worked in the construction site. Worker A operated the mini excavator to excavate the trench, worker B (victim) remained in the trench for checking designed excavation depth and worker C (victim) smashed the soil cement column using a portable breaker for smoothing of the base and after that the worker C smashed concrete of private road in the trench. The labor accident took place around 11:30 a.m., a sudden slope failure occurred without any clear signs of failure (Fig. 5). According to the slope failure, the simple temporary wall that collapsed was not shored or otherwise protected from earth movement. A section of trench caved in, striking and burying the victims to their whole bodies and two workers lives were lost in slope failure. In the case history mentioned above, the occurrence of slope failure might be caused by the influence of wall stiffness and embedded depth of wall on prevention of slope failure. This influence will be examined by means of centrifuge model tests.

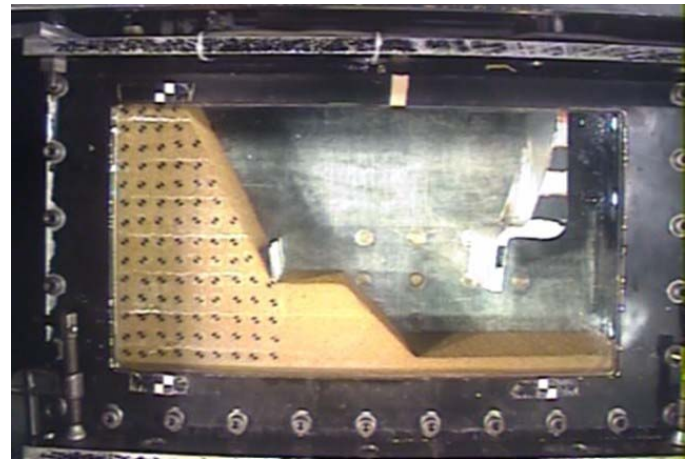
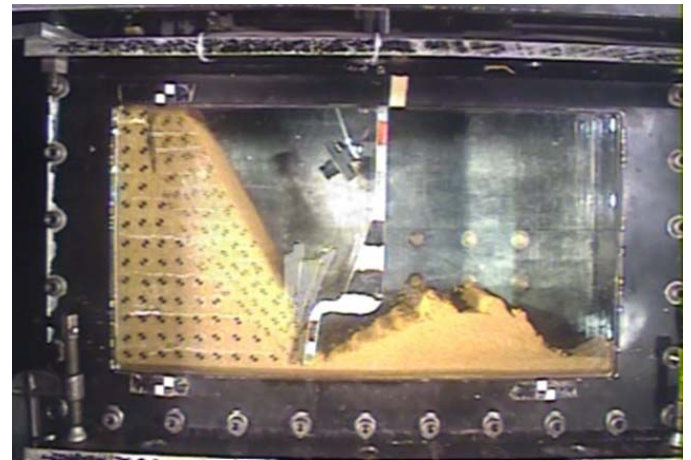
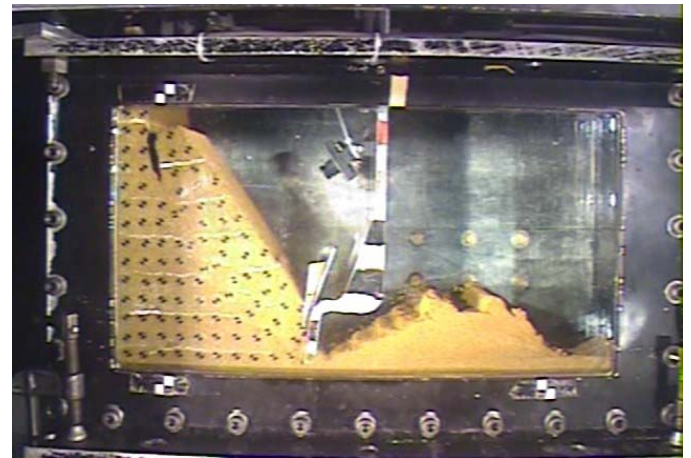
Fig. 11. Model Slope during the centrifuge test (case 1).

Figures 11 and 12 show the recorded images of the model slopes during the centrifuge tests for the simple temporary wall with the embedded depth of 0.8 m and 0.4 m, respectively. In the model slope case 1 (actual condition at the time of labor accident), rapid deformation and slope failure were observed at the excavating process of 1.4 m as can be seen from the blurring failure images captured by the digital CCD camera. (Fig. 11(b)). In the model slope case 2 with a shallower embedded depth, slope failure occurred rapidly after the excavating process of 1.3 m (Fig. 12(b)).

This indicated that the toppling failure of simple temporary wall is likely to bury workers in the trench and there was no sufficient time for the workers to escape from the trench. In addition the plastic deformation of model steel pipe, which is considered to be caused by yield strength of the model steel pipe due to large load by slope failure, was also clearly recognized. In other words, the simple temporary wall used during the trench excavation in this case history could not protect to worker from the slope failure.

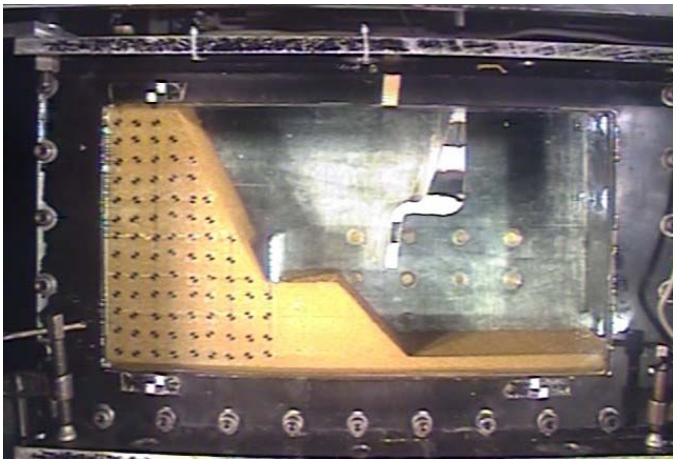
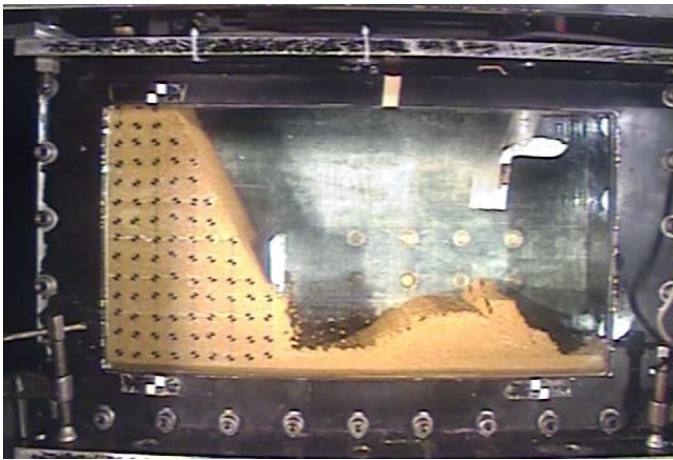
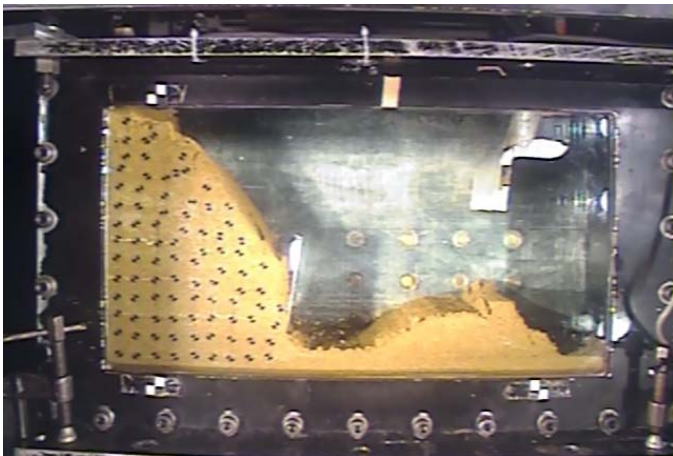
Fig. 13. Model slope during the centrifuge test (case 3).

As mentioned above it is necessary to provide a better shoring system to prevent the worker from the slope failure. In this paper the sheet pile wall method was purposed. Figure 13 shows recorded images of the model slope case 3 at different stages. In this case, slope failure did not occur with the excavating of 1.4 m at 25g, and the model sheet pile wall rarely or never develop to large deformation as can be seen in Fig. 13(b). In order to investigate the mechanism of slope failure in this case, the self-weight of the model slope was gradually increased until failure occurred.

When the centrifuge acceleration reaches to 36g where the excavation depth was about 5.8 m in the prototype scale, it can be seen that the displacement increase gradually such as in the case of landslide, it indicates that the slope reach the failure state (Fig. 13(c)). By comparing to the failure in the simple

temporary wall, it was found that the use of sheet pile wall as a shoring system can protect the worker's life from the slope failure. In addition it is possible that the workers can escape safely from the trench because deformation caused by slope failure is suppressed by the sheet pile wall.
