Evaluation of the Taum Sauk Upper Reservoir Failure

EVALUATION OF THE TAUM SAUK UPPER RESERVOIR FAILURE

Quentin Gehring

Ronaldo Luna

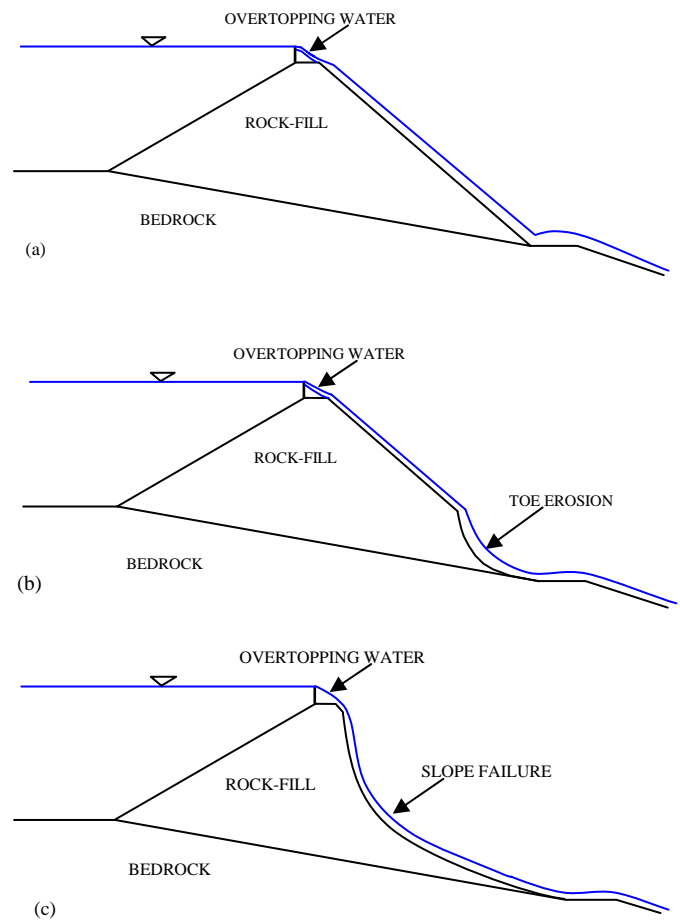
over the concrete parapet wall was allowed to flow down and along the downstream slope surface of the dike. If the water flowing along the surface reached the toe of the slope with a sufficient flow rate, a hydraulic jump could have been formed. Once a hydraulic jump formed, erosion could have been initiated at the downstream toe of the reservoir. This erosion process removed rock-fill material beginning at the downstream toe and progressively moved upward along the slope. The removal of material is similar to that of the localized downstream toe stability and could have affected the global slope stability of the dike. Once a sufficient amount of material was removed, the downstream global slope stability was severely compromised to the point of failure. The capacity of the rock-fill dike to hold back the contained water, after global slope failure, would have been severely compromised. Complete failure due to erosion at the toe and reduced slope stability could have resulted. Figure 6 illustrates sketches of each stage of the proposed failure mechanism.

Fig. 6. Failure mechanism #2. (not to scale). (a) water flowing across downstream slope, (b) progressive toe erosion, (c) resulting slope failure, (d) catastrophic failure with progressive erosion, same as Fig. 5(c).

Through the analyses it was determined that a sufficient flow could have existed to mobilize granular material at the toe and initiate the erosion process. If this process occurred it would have severely weakened the rock-fill dike structure in terms of global slope stability. This effect would be similar to the effect that a localized toe failure would have on global slope stability. In areas where the overtopping flow was not sufficient to keep mobilized granular material suspended, deposition of the material along the downstream slope and along the downstream toe occurred. Evidence of an accumulation of granular material at the toe of the dike in non-failed, overtopped, areas suggests that a similar condition may have occurred in the breach segment before failure.

Analyses were conducted to quantify the possibility that overtopping water could initiate the erosion process along the downstream slope. The infinite slope analyses revealed that the downstream slope was marginally safe with respect to sloughing and planar failure and exhibited a safety factor of 1.1. Flow across the surface of the downstream slope or infiltration as water flowed down the slope could have reduced the safety factor and increased the effects of erosion, leading to either increased crest erosion, reduction of the embankment cross-section, and/or increased toe erosion.

The possibility that erosion could take place at the downstream toe of the Upper Reservoir existed given the condition that no material mobilization occurred at the downstream crest or along the downstream slope as water flowed downstream. The aforementioned discussion and post-failure evidence in other areas that experienced overtopping discount the likelihood of this process occurring. From the discussion and analyses, downstream toe erosion was likely not responsible for the rock-

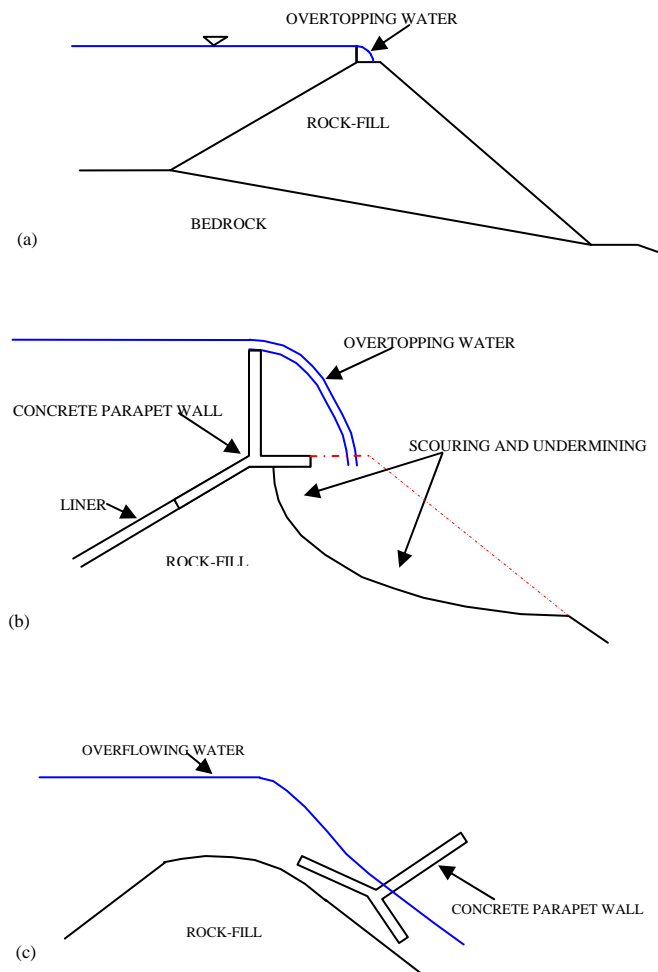
The following summarizes failure mechanism #3: As overtopping of the reservoir was initiated, water spilling over the concrete parapet wall caused erosion and scouring at the downstream crest of the dike. This process began to undermine the concrete parapet wall foundation. As undermining and scouring progressed, the rock-fill material was transported down the slope. Once the undermining process removed a sufficient amount of rock-fill, the stability of the concrete parapet wall and the shear capacity of the rock-fill directly below the wall became severely compromised to the point of either wall failure and/or shear failure. After the aforementioned wall/crest failure(s), more water (10-feet) and consequently more flow was released in the area of the breach. The additional flow continued the erosion process down to the toe of the reservoir yielding the catastrophic failure. Figure 7 illustrates sketches of each stage of the proposed failure mechanism.

Fig. 7. Failure mechanism #3. (not to scale).
(a) overtopping water, (b) scouring and undermining, (c) parapet wall failure, (d) catastrophic failure with progressive erosion, same as Fig. 5(c)

As undermining, scouring, and erosion progressed, the possibility existed that enough rock fill material was removed directly beneath the base of the wall to cause a localized soil shear failure. If localized soil shear failure occurred, the effects would have been similar to sliding or overturning instability of the wall. Both proposed circumstances could have caused wall failure, leading to the eventual complete discharge of stored water in the reservoir. The near 700-foot wide breach suggests, in the opinion of the writer, a sudden collapse of parapet wall segments and continued erosion and scouring down to bedrock.

analyses support the concrete parapet wall instability and subsequent erosion of the rock-fill dike as a possible mode of catastrophic failure. From the discussion and analyses, the concrete parapet wall failure and resulting erosion of the rock-fill dike were likely mechanisms for the reservoir failure.

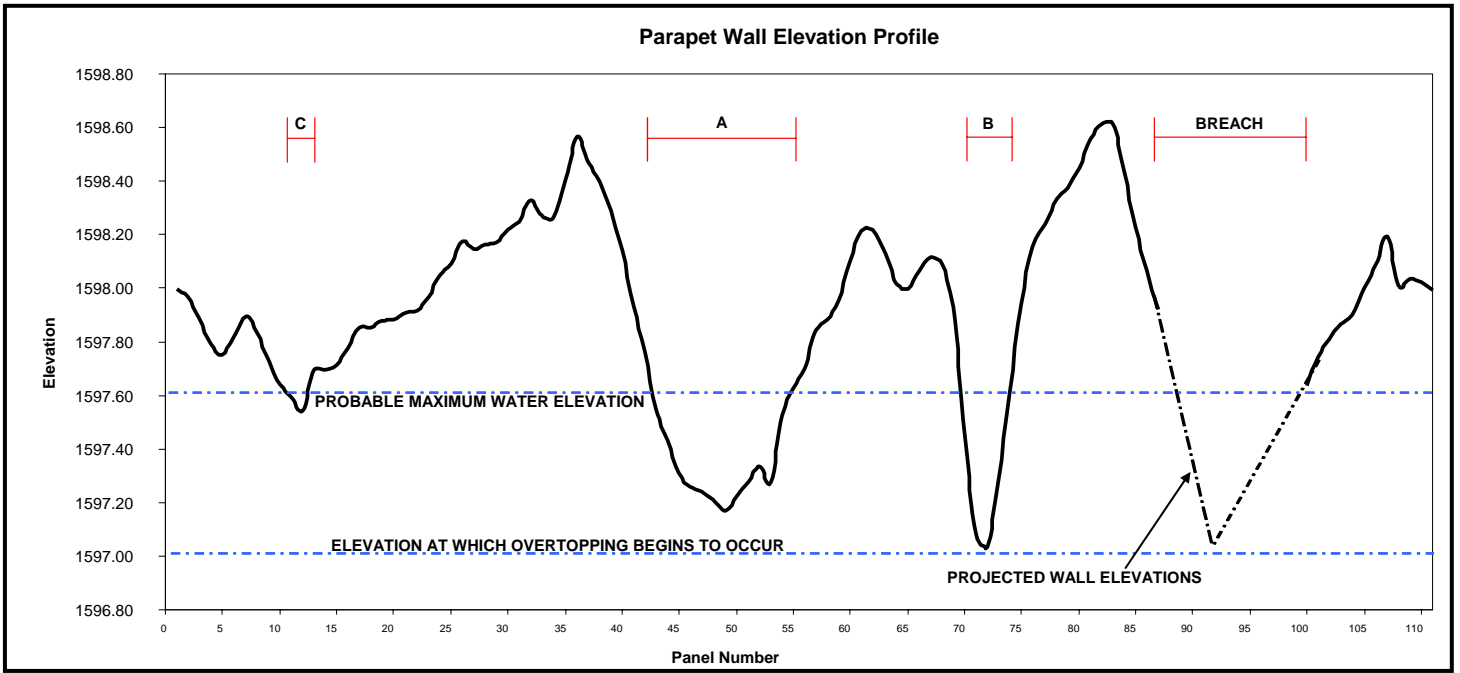
Analyses were performed to quantify overtopping water flow and scouring and undermining at the downstream crest. Figure 8 illustrates the concrete parapet wall profile, the probable elevation at which overtopping started, and the probable maximum water elevation during the failure events. The analyses revealed that overtopping flow could initiate scouring and undermining. The extent of scouring and undermining varied as a function of the parapet wall crest elevation and overtopping flow depth at various locations. Flow depth was defined as the height of water flowing over the parapet wall sections.

The segment between panel 70 and panel 74 experienced a greater effect from scouring and undermining than the location between panel 43 and panel 54. Due to the lower wall crest elevations between panel 70 and panel 74 and the resulting higher flow rates exiting the reservoir at this location. Also, the segment between panel 70 and panel 74 began overtopping before the segment between panel 43 and panel 54. The time factor associated with scouring and undermining caused less scouring and undermining between panel 43 and panel 54. The maximum differential settlement between the two locations was approximately 0.2-feet. If the parapet wall segments in the breach area experienced settlements similar to panel segments 70 through 74, the effects of scouring and undermining could have been similar.

Fig. 8. Parapet wall elevation profile (source: MoDNR data).

Based on calculations presented in Gehring (2006), there was a relatively high potential for the rock-fill material at the crest to be scoured and eroded. To evaluate the effects of scour undermining on the stability of the parapet wall, an incremental approach to the extent of undermining was applied to sliding and overturning stability calculations. As expected, the resulting safety factors decreased with increased scour undermining. A safety factor of 1.0 was obtained for overturning stability when the scour undermining distance was roughly 3.3 feet, measured from the downstream toe of the parapet wall. Similarly, a safety factor of 1.0 was obtained for sliding stability when the scour undermining distance was roughly 2.0 feet, measured from the downstream toe of the parapet wall. A safety factor of 1.0 corresponds to impending failure. The analyses results supplement visual evidence of scouring and undermining within non-failed overtopped areas. If wall crest elevations in the breach area were similar to other overtopped segments, the effects of scouring and undermining could have been similar.
