International Conference on Case Histories in Geotechnical Engineering (2008) - Sixth International Conference on Case Histories in Geotechnical Engineering

Horizontal Translational Failures of Levees Due to Water Filled Gaps

HORIZONTAL TRANSLATIONAL FAILURES OF LEVEES DUE TO WATER FILLED GAPS

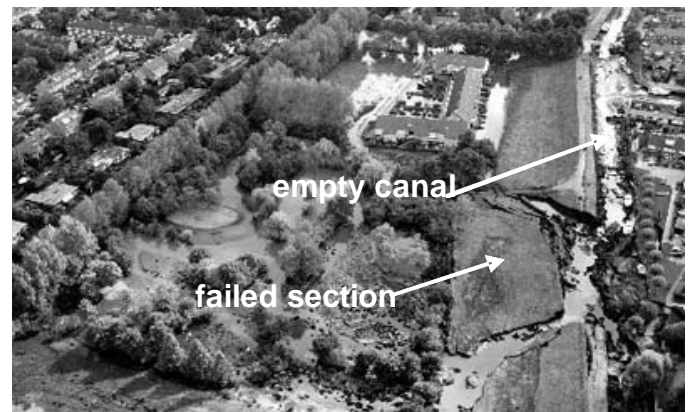
In the summer of 2003, a peat dyke at Wilnis in the Netherlands failed during a very dry period. The failure mode was not a Bishop type circular failure used in routine dike stability analyses in The Netherlands, see figure 1.

The failed dike segment was displaced horizontally over 6 m. The failure plane was found to lie at the boundary between peat and the underlying sand. It was concluded that a chain of events including weight loss and shrinkage of the peat, due to the dry weather conditions, are considered important factors causing failure. Analyses of peat behaviour made it clear that several processes, controlled by hydrological conditions in the unsaturated and saturated zones in the embankment, resulted in fracturing of the peat. The fracturing, along with a very high-strength anisotropy of the peat, resulted in a connection between the water in the canal and the water in the sand,

thereby raising the piezometric head in the sand by several meters, allowing the dike to simply ‘float’ away for over 5 m, pushed by the water in the canal. A detailed description of this failure can be found in Bezuijen et al. (2005).

Fig. 1. Failed canal dike at Wilnis, August 2003.

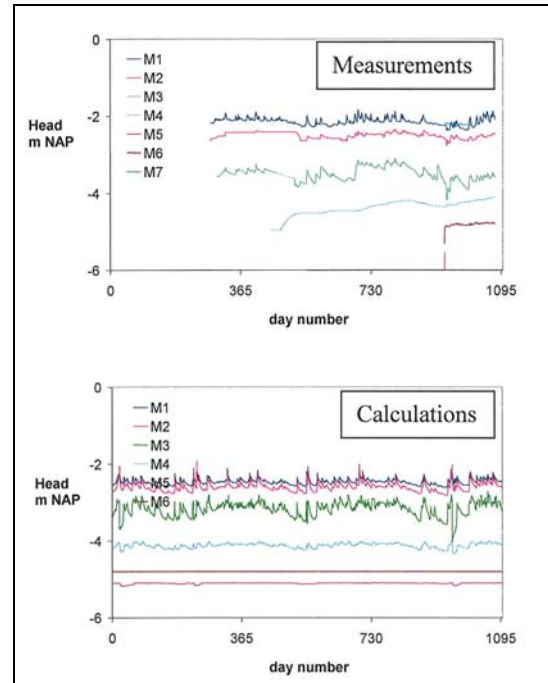
The water pressure field obtained for the summer of 2005 is shown in Figure 3 as an example. Measured heads in the observation wells and calculated heads in corresponding nodes are given over a period of three years in Figure 4, starting (= day 0) on 1 January 2004. Both signals show a seasonal variation due to evapo-transpiration and a high-frequency response mainly due to precipitation.

Fig. 4. Measured and calculated groundwater levels

From these results, it was concluded that calculated data resembled the measured data quite well although it was hard to reproduce measured head data exactly because the measurement data already showed a wide variability due to the natural spatial variability of peat material and the three-dimensional shape of the levee surface.

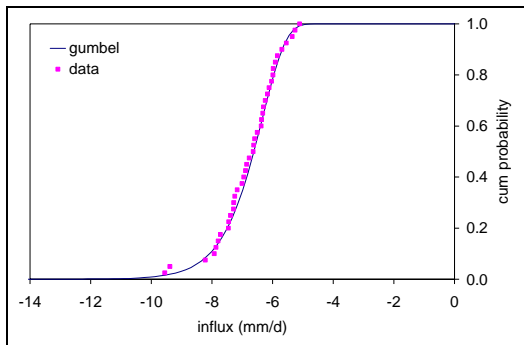
Precipitation and evapo-transpiration data were analyzed over a period of 40 years. For each year, maximum net precipitation and maximum net evapo-transpiration data were assembled in a histogram. Figure 5 shows the cumulative frequency distribution of maximum values of daily outflux data per year and the fitted cumulative Gumbel distribution.

Fig. 5. Extreme daily inflow data

The maximum difference in position for extreme loading occurring only once every 400 years gives a difference in the position of the water table of 1.3 m.

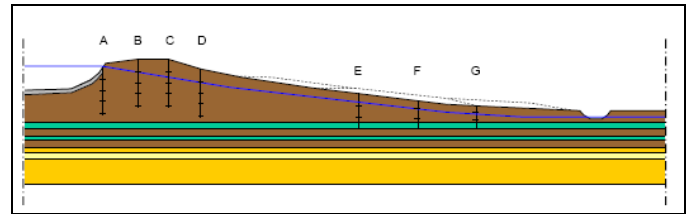
The question remains whether or not a shrinking crack in a longitudinal direction can initiate a stability problem. Therefore, for the Wilnis case, a number of FEM calculations have been made with cracks from 2 to 4 m deep (see figure 6); the cracks are numbered with letters A to G.

In figure 7 the shear strain is shown for the situation without cracks. Cracks A and B give a small reduction of 2 to 3% in the safety factor; for Cracks C and D the reduction is 1% or less. Furthermore, the calculations show that Cracks C and D will close due to deformations. This means that during a real stability problem in the levee, Cracks C and D will also close.

Cracks E, F, and G reduce the initial stability; but due to the deformations, these cracks will close with little influence on the final stability.

Fig. 6. FEM calculation, A to G represent cracks in geometry.

The influence of water in Crack B is studied. If the crack is fully filled with water, the influence on the calculated safety factor is a reduction of 16%, which is a substantial reduction.

It is concluded that the most dangerous cracks in the longitudinal direction are those on the outer side of the levee crown that are or can become filled with water.

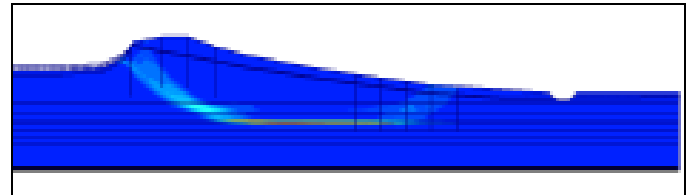
Fig. 7. Calculated shear strain.

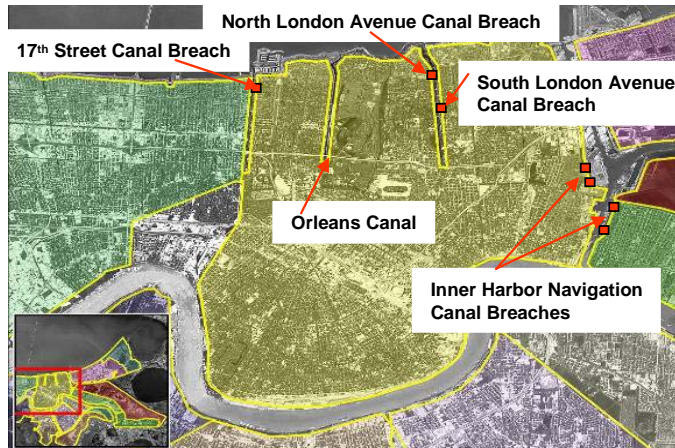
The performance of levees and floodwalls varied significantly throughout the New Orleans area. The investigation conducted post-Katrina indicates that the two main causes of breaches in the floodwall and levee system were erosion due to overtopping and instability due to soil foundation failure. Breaches due to instability of floodwalls occurred at one

location on the 17th Street Canal, two locations on the London Avenue Canal, and one location on the IHNC, as shown in Figure 8.

Fig. 8. Location of breaches in Orleans Parish, East Bank

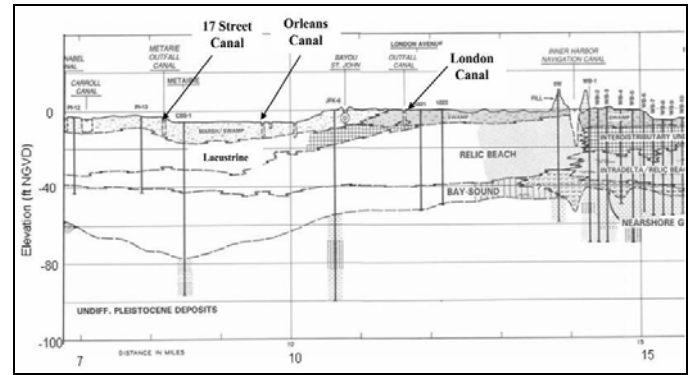
The site of the levee breach at the 17th Street Canal is located on the northern side of the beach ridge where the sand ridge is thinner. There is a layer of clay between the sand and the marsh layer; whereas both of the London Canal breaches are located over the thickest part of the barrier beach ridge complex, the sand deposit lies directly beneath the marsh layer, as shown in Figure 9.

Fig. 9. Geological cross section extending west to east across eastern Jefferson Parish and into western Orleans Parish. Section runs from near the 17th Street Canal to the Inner Harbor Navigation Canal. Major outfall canals in Orleans Parish are noted on the section.

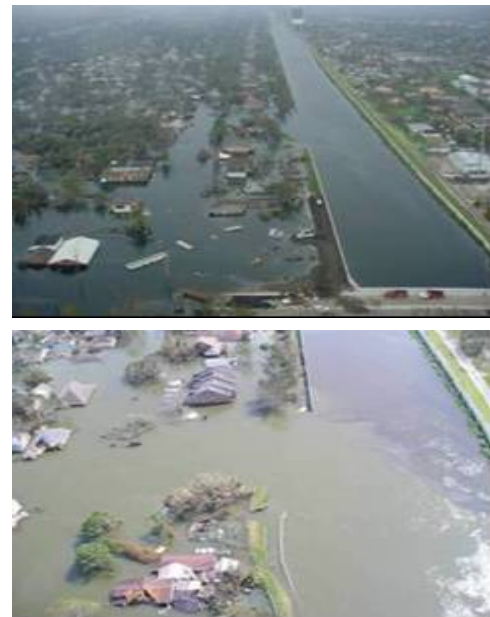
Observations made of the breach at the 17th Street Canal show that the most likely cause of the breach is a soil foundation failure. Figure 10a shows an aerial photo of an approximately 450-ft (140-m) breach in the floodwall along the east side of the 17th Street Outfall Canal south of the old Hammond Road Bridge. Figure 10b shows that a section of levee has moved more than 40 ft (12 m) inward to the landside. It appears that the water flowing through the breach washed away the remaining levee section making up the breach. The top of the I-wall section of the floodwall in the breach can be seen adjacent to the levee section that moved into the landside.

Fig. 10. (a) aerial view of breach, (b) aerial view showing I-wall and embankment translation.

After the emergency closure was complete and the water levels were drawn down, large blocks of the marsh were found strewn in neighborhoods surrounding the breach. A close examination of the marsh blocks revealed that an approximately 1-ft (0.3-m) clay layer was attached to the bottom of the marsh blocks. In order to inspect the failure plane or zone, a backhoe trench was excavated to expose a vertical surface through the slide block. Observations made in the trench confirmed that a portion of the clay layer, which was initially located beneath the marsh layer, was displaced upward and over a portion of the marsh layer by the lateral displacement that occurred during the failure. The failure plane of the slide block was within the clay under the levee, and the failure plane came upward through the marsh layer further landward.

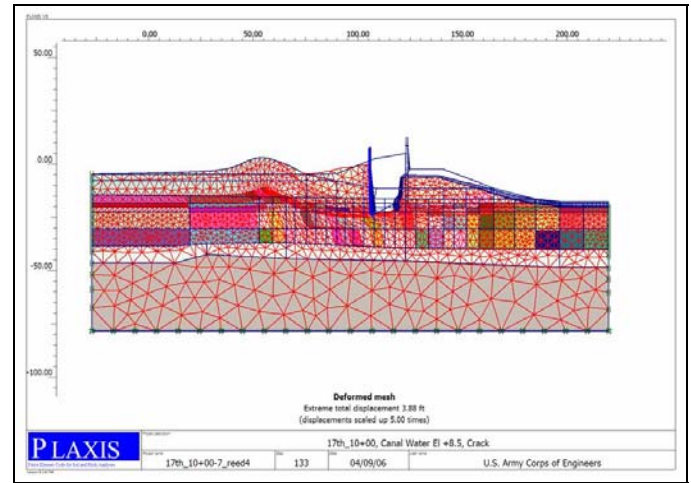
Two-dimensional finite element soil-structure interaction analyses with PLAXIS and FLAC using a nonlinear hyperbolic soil stress-strain model were conducted to provide a third approach to the development of a complete understanding of the 17th Street Canal breach mechanism. The finite element analyses show that a gap formed as the water rose on the canal side of the wall. The criterion for gap formation was earth pressure against the wall was less than the hydrostatic water pressure at that depth. When that condition was reached, the finite element mesh was adjusted to separate the soil elements from the wall elements with a gap. The gap began to open when the water in the canal rose to elevation 6.5 ft (2.0 m). Eventually, the gap extended to the tip of the sheet pile, which was at the lacustrine clay-marsh interface. Factors of safety were computed using the strength-reduction method. The strength-reduction method involves performing a series of finite element analyses using values of the strength parameters c and ϕ (or c' and ϕ') that are reduced by dividing them by assumed values of factor of safety. The correct factor of safety, as determined by this method, is the smallest value that results in unstable conditions in the analysis. When the gap developed and filled with water, the factor of safety decreased suddenly by about 25%, from 1.45 to 1.16. The

development of a gap, which immediately filled with water, resulted in a marked increase in calculated displacements. As the water in the canal rose from 6.5 to 9.0 ft (2.0 to 2.7 m) NGVD, the maximum lateral deformation increased from 1.6 to 5.3 ft (0.5 to 1.6 m) and the factor of safety decreased from 1.16 to 0.98. A figure representing the analysis is shown in Figure 11. More details can be found in IPET 2007.

Fig. 11. Deformed mesh for canal water elevation 9.0 ft (2.7 m) (canal water elevation not to scale in figure).
